Contact : reach.mapping@impact-initiatives.org
File: IRQ_DOMIZ_WASH-Greywater_A1_2DEC2013

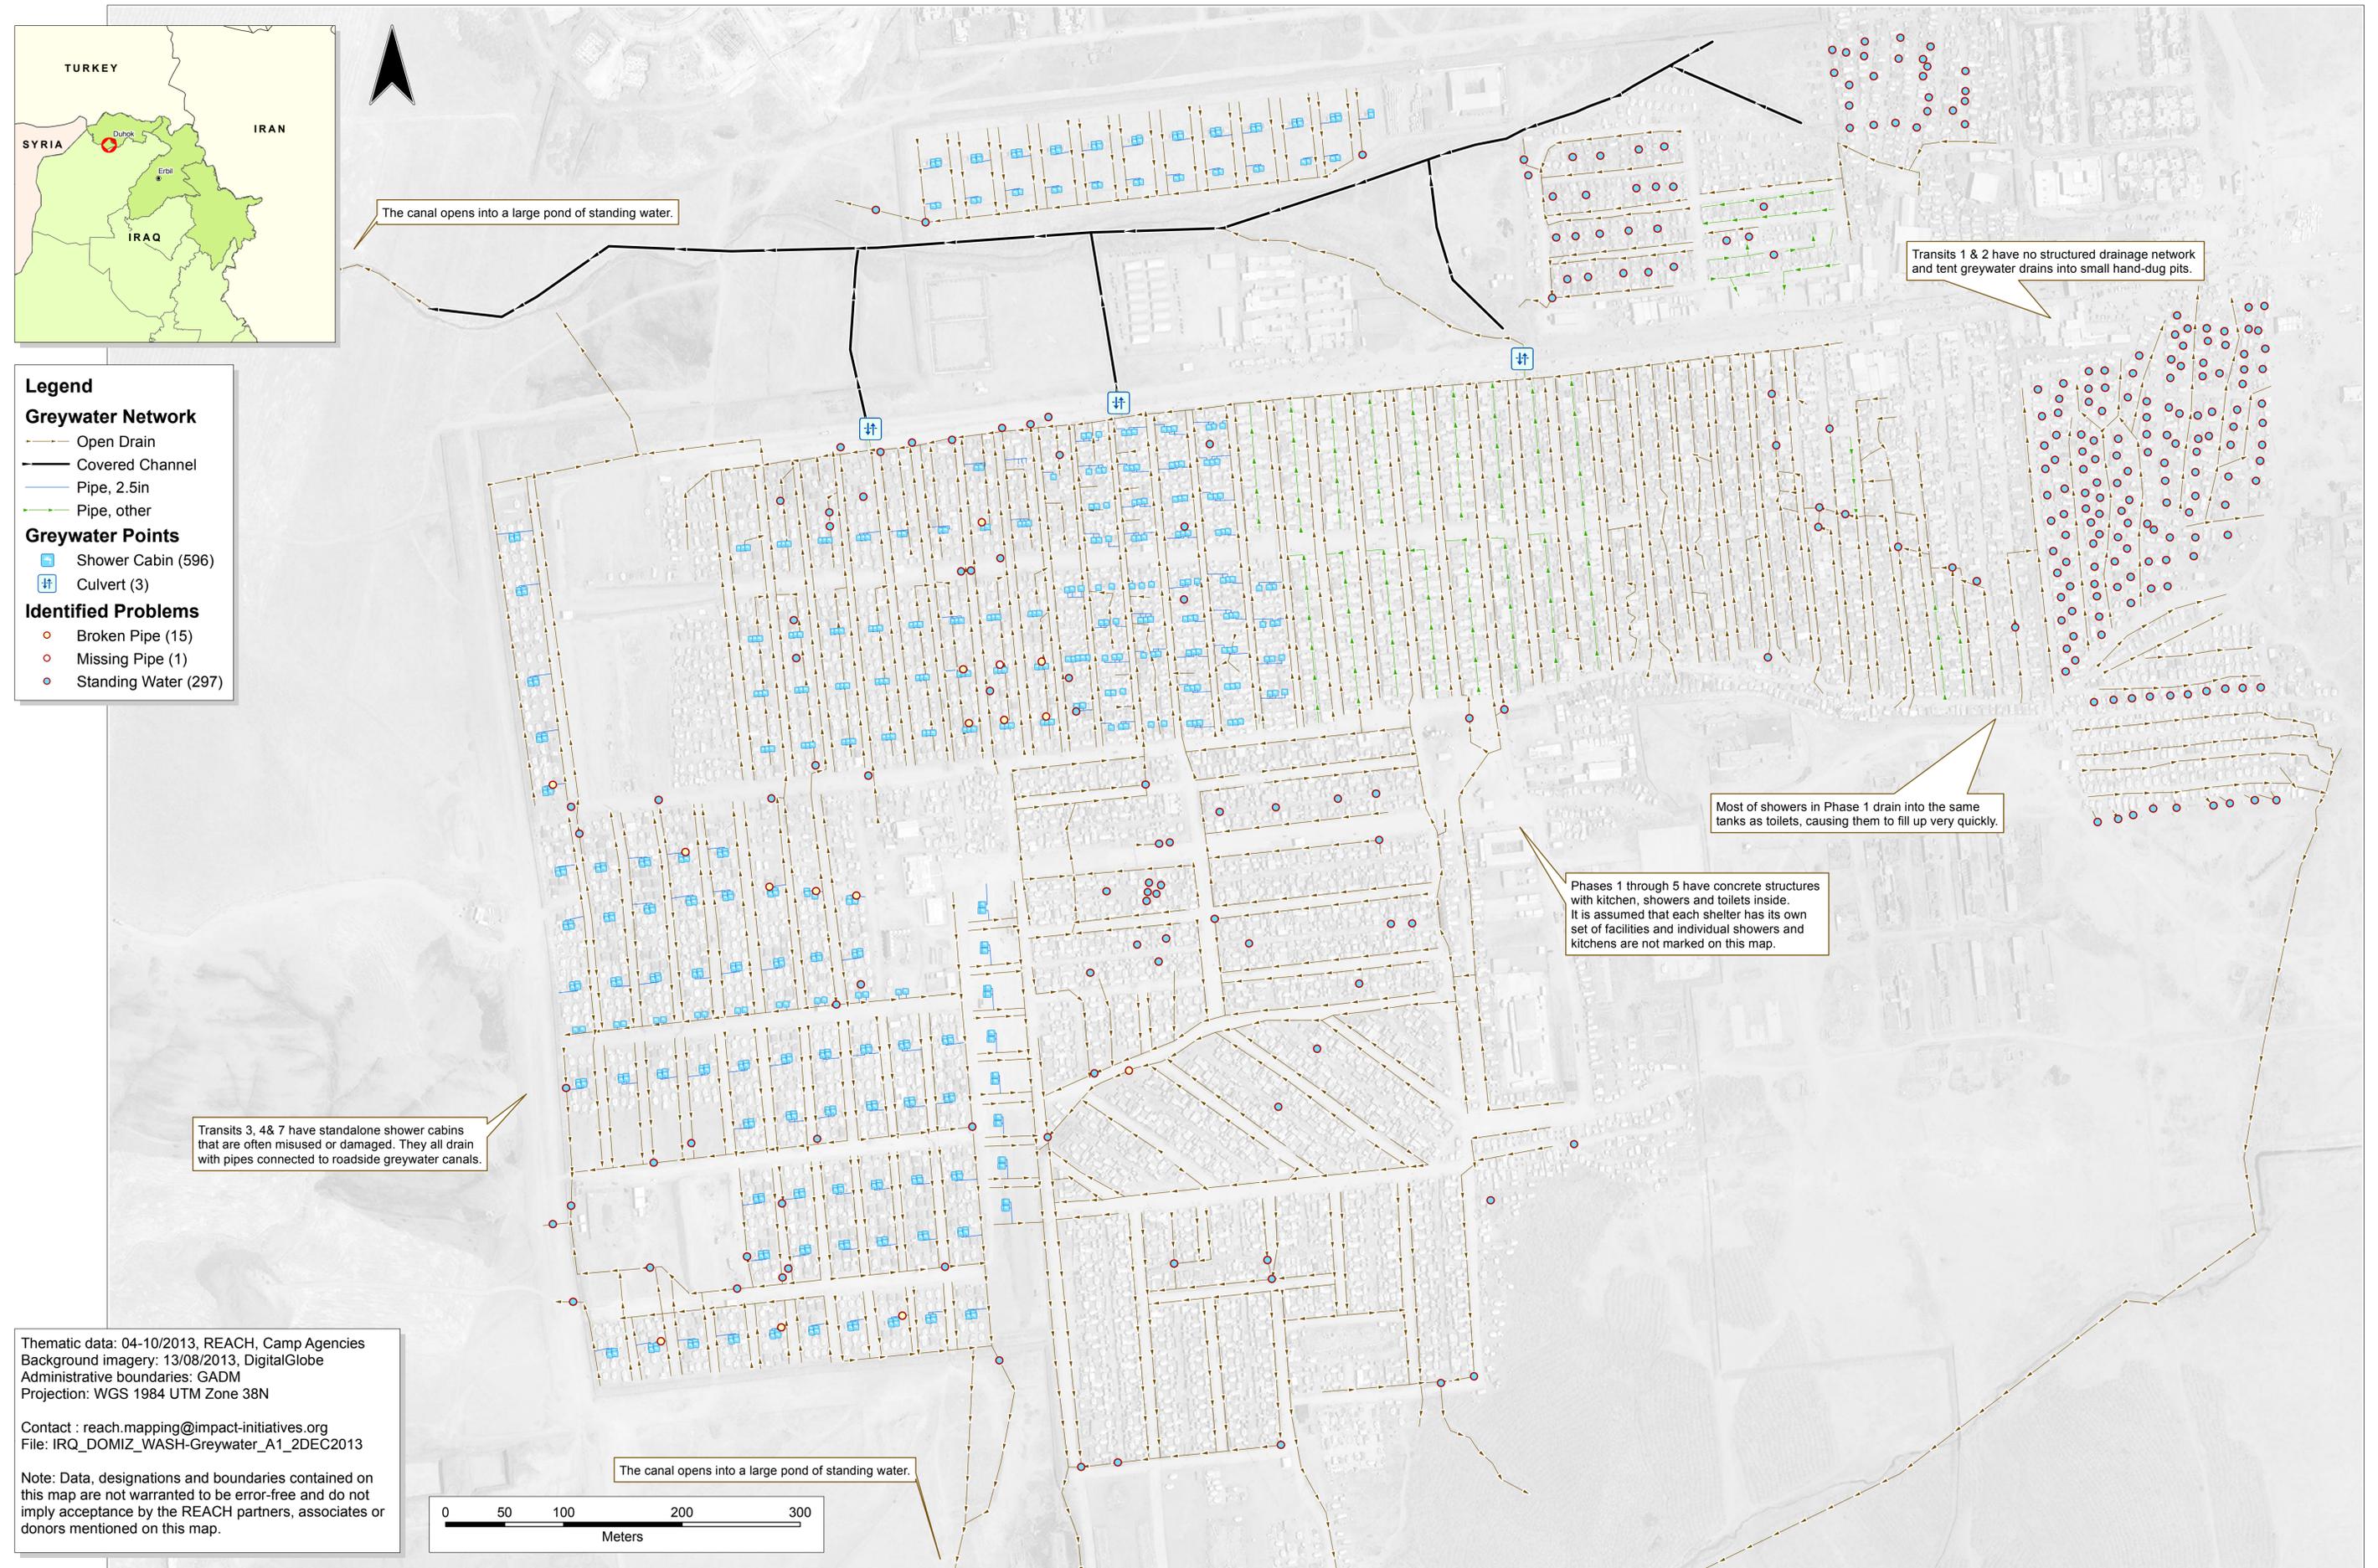
The canal opens into a large pond of standing water.

Transits 1 & 2 have no structured drainage network and tent greywater drains into small hand-dug pits.

Most of showers in Phase 1 drain into the same tanks as toilets, causing them to fill up very quickly.

Phases 1 through 5 have concrete structures with kitchen, showers and toilets inside. It is assumed that each shelter has its own set of facilities and individual showers and kitchens are not marked on this map.

Transits 3, 4 & 7 have standalone shower cabins that are often misused or damaged. They all drain with pipes connected to roadside greywater canals.
