Overview - Village 3 & Village 6

WASH CENTRES

TAP STANDS

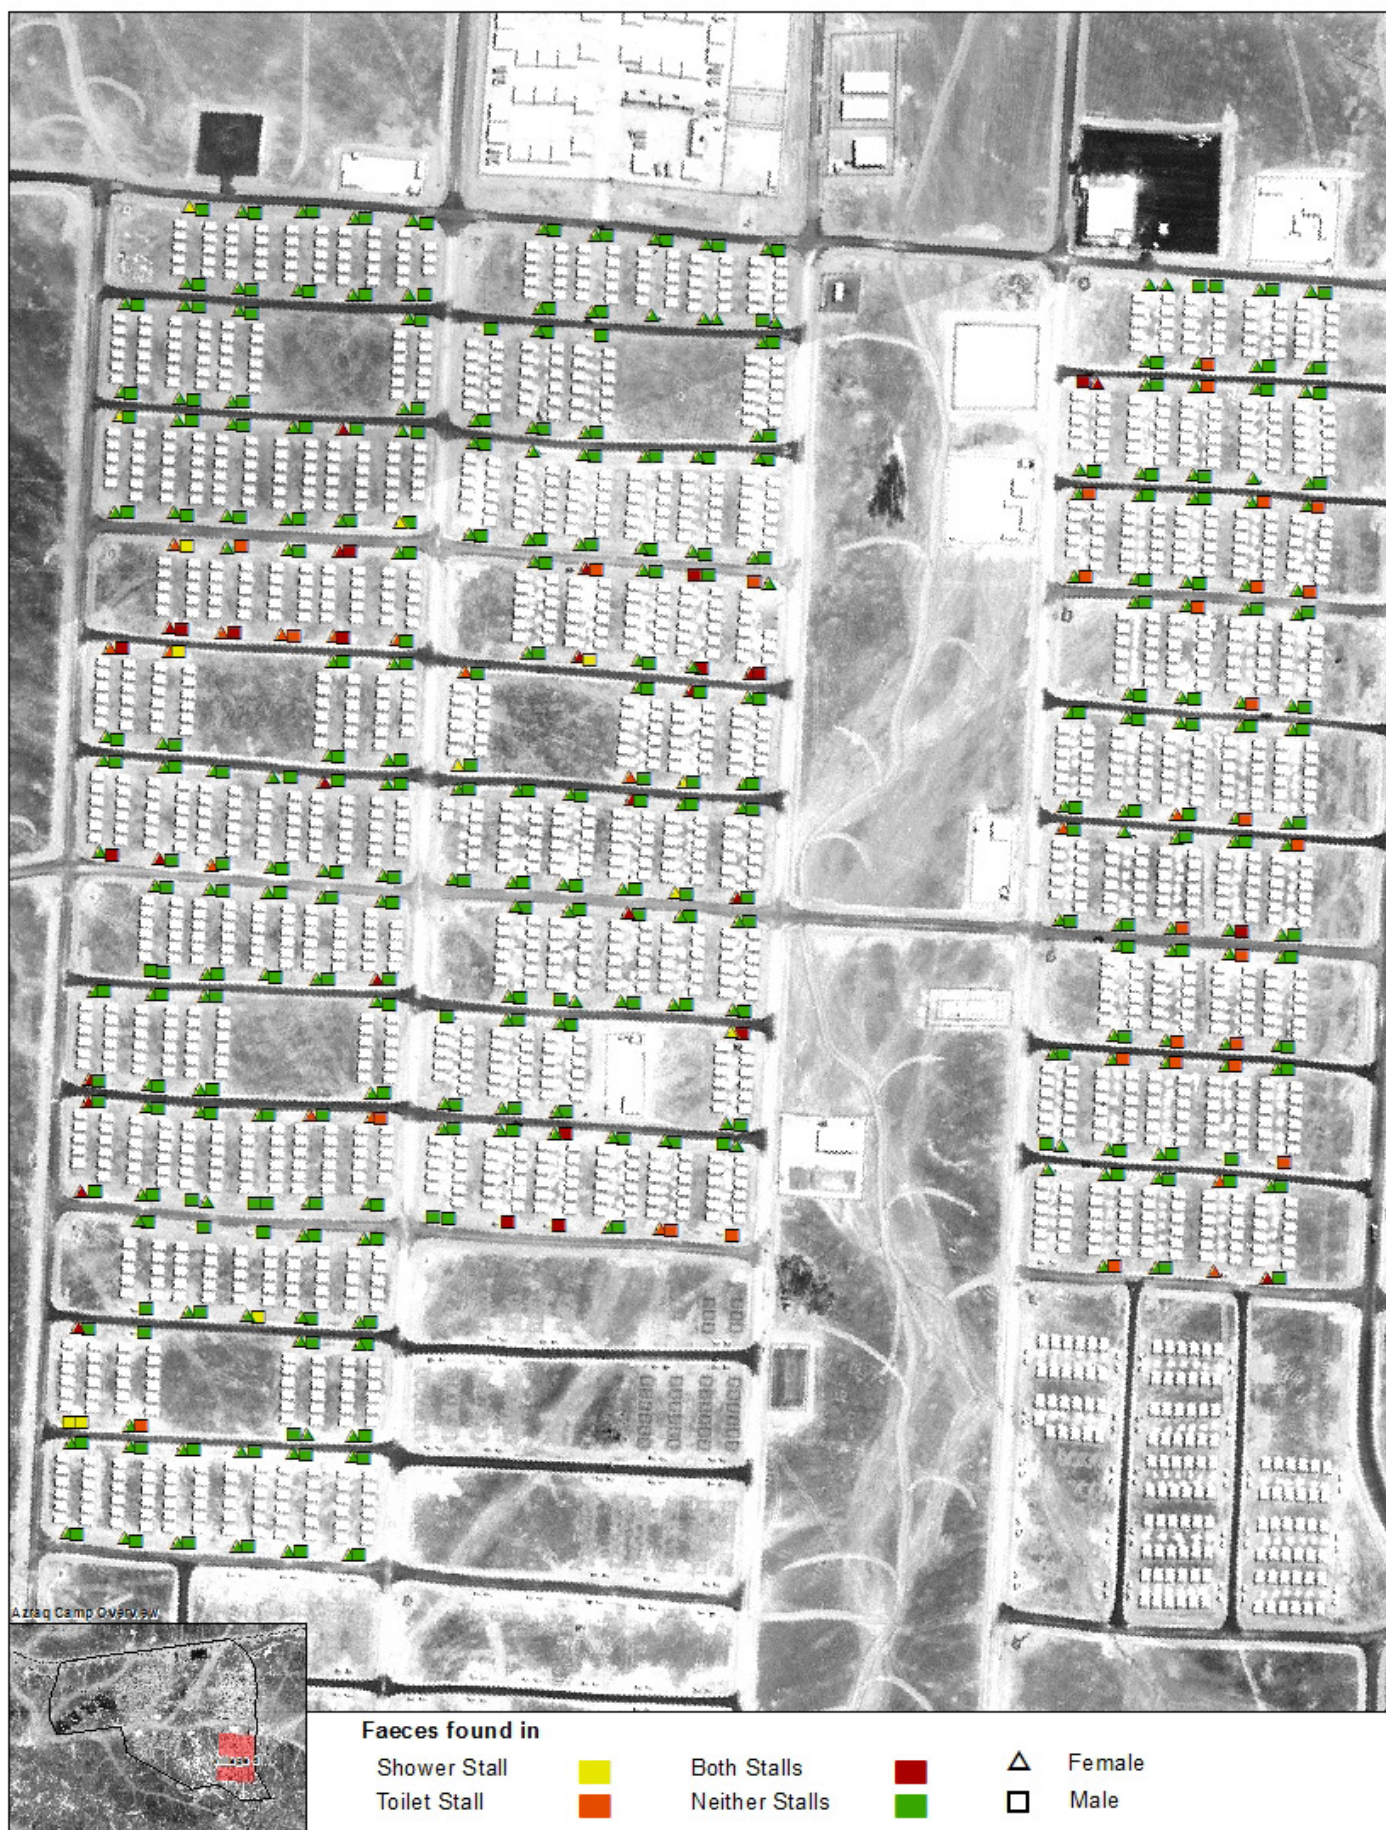
Map 2: Faeces found inside WASH centres in Village 6

This Week	2 weeks ago
There is no rubbish inside both stalls	440 (75%)	440 (76%)
There is no faeces inside both stalls	477 (81%) >5%	408 (71%)
There is no faeces outside the structure within 5m	552 (94%) >5%	477 (83%)
There is no standing water outside this structure within 5m	581 (99%)	568 (99%)

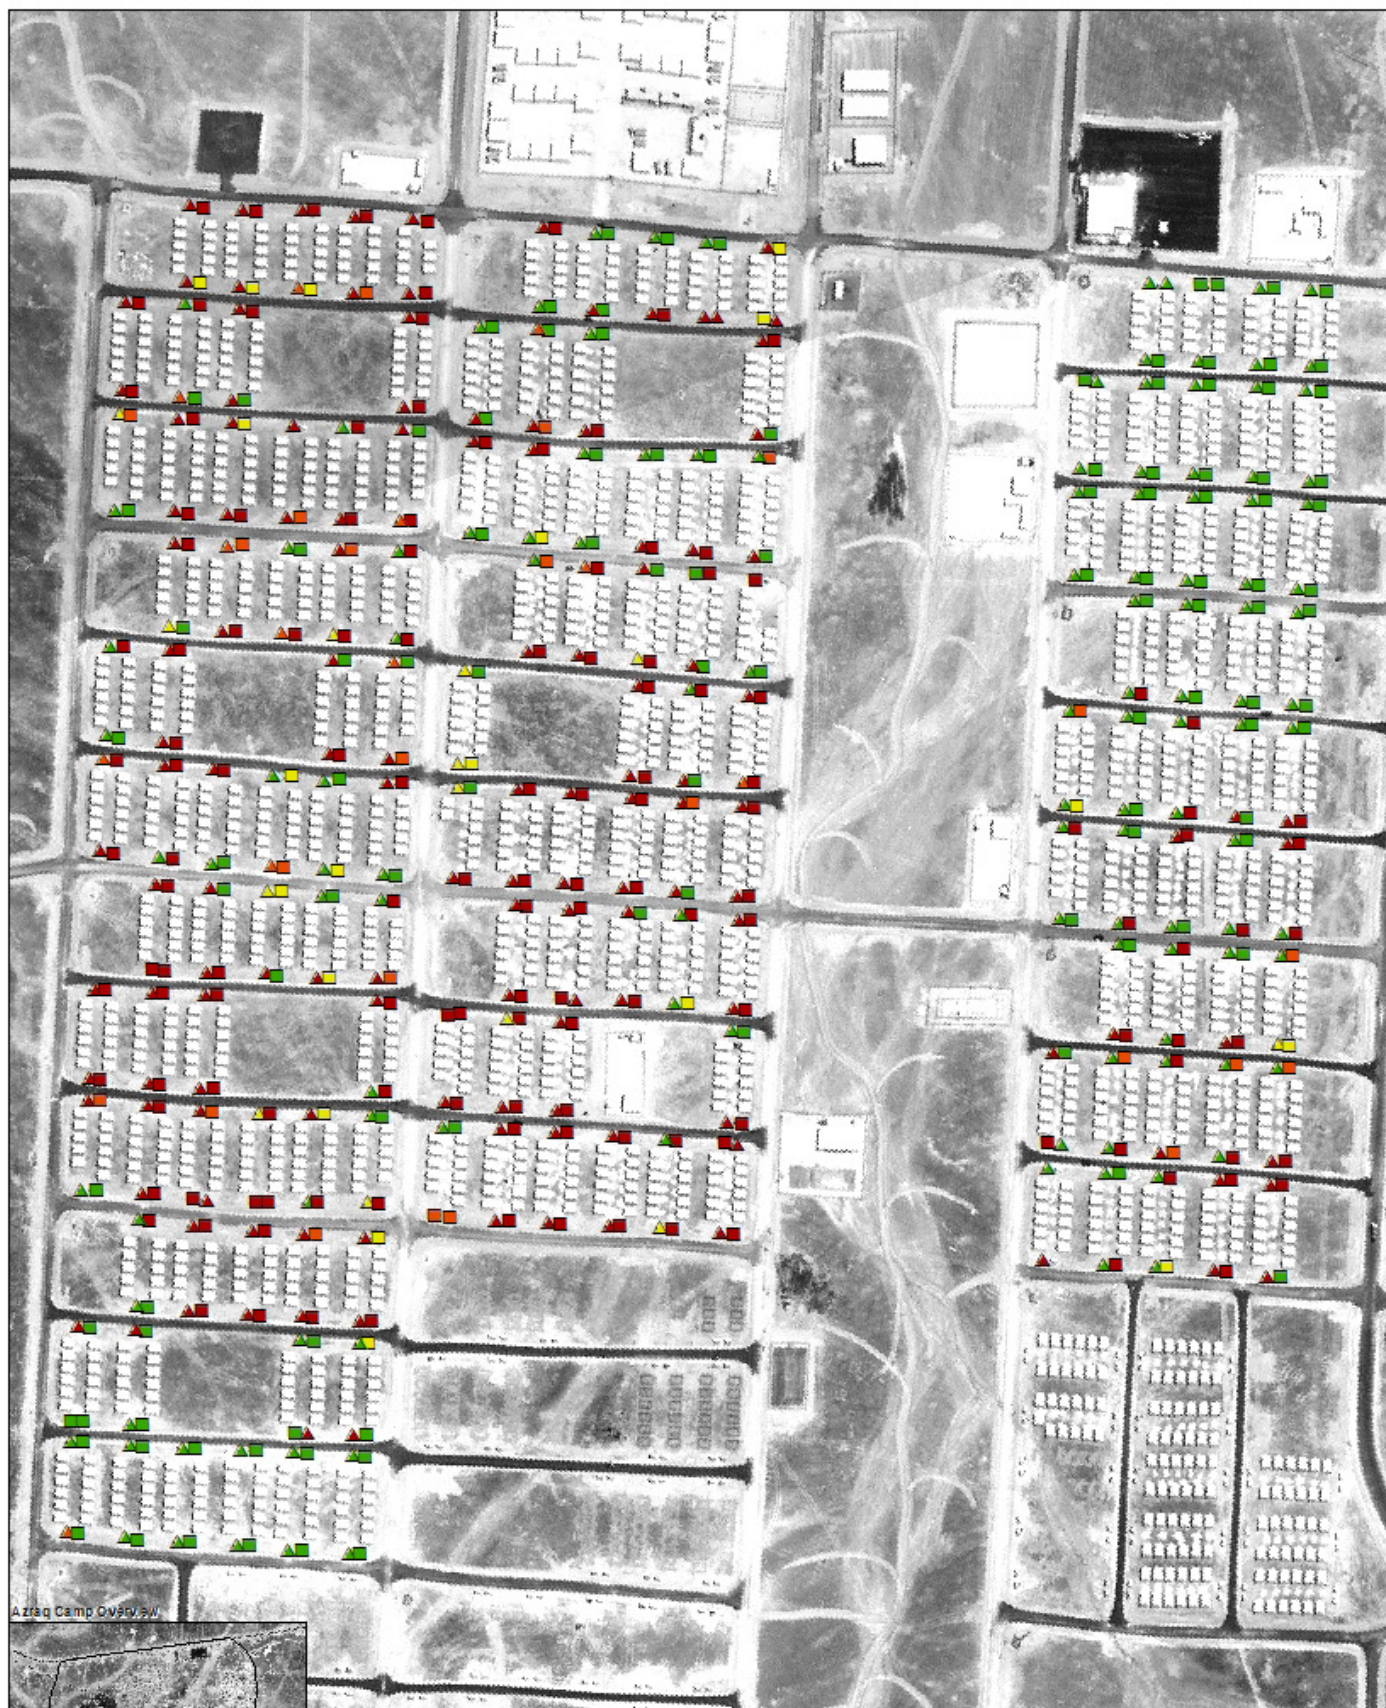
Map 6: Outside locks at the height of 1.2m from the ground or lower in Village 6

This Week	2 weeks ago
Door handles are at a child-friendly height (≤1.2m)	37 (6%)	46 (8%)
Outside locks on both doors are at a child-friendly height (≤1.2m)	239 (41%) >5%	184 (32%)
Inside locks on both doors are at a child-friendly height (≤1.2m)	515 (87%) >5%	535 (93%)
Both WASH centre doors are not privately locked	565 (96%)	552 (96%)
# of WASH centres dedicated to disabled persons	59 (10%)	61 (11%)
# of WASH centres with finished access ramp	59 (10%)	56 (10%)
Disabled toilet is still present in toilets for disabled persons	33 (56%) >5%	43 (70%)

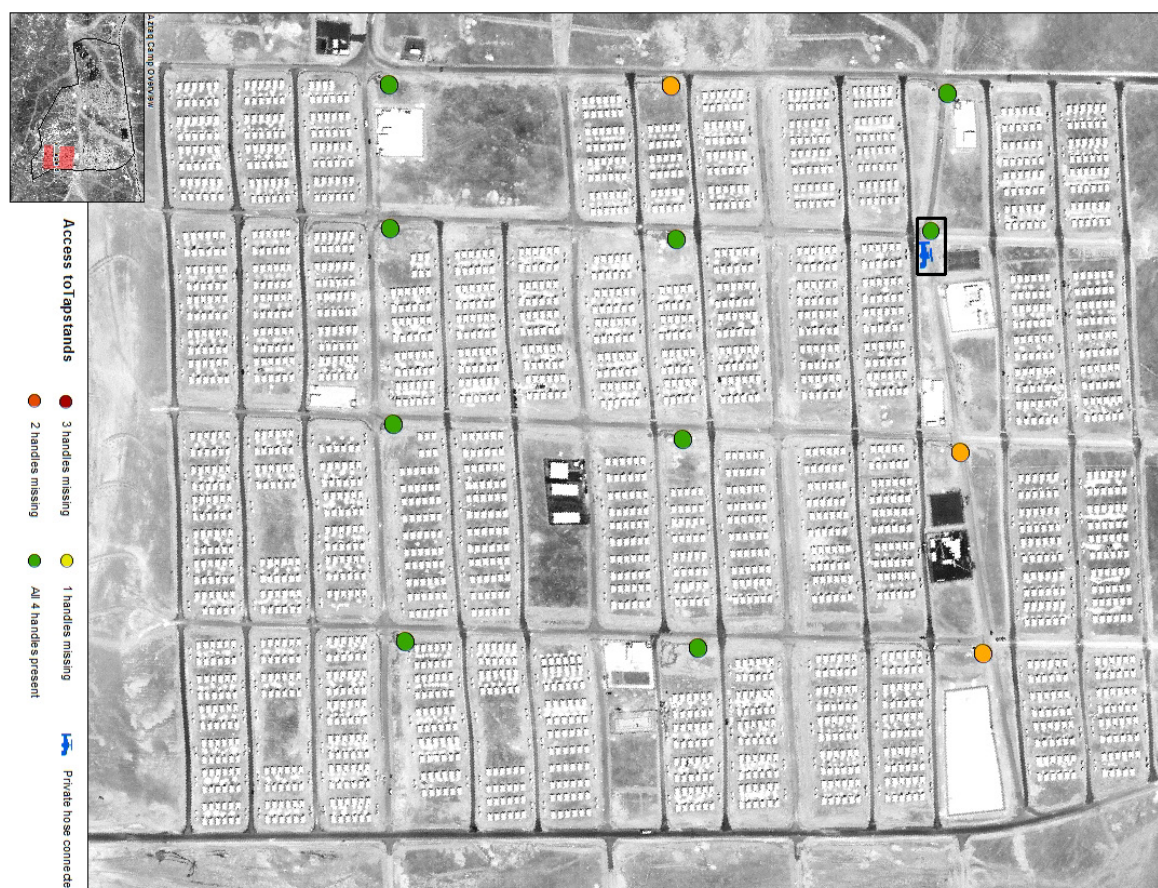
Map 7: Missing tapstand handles and private connections in Village 3

This Week	2 weeks ago
The tapstand provides water during its operational hours	10 (83%)	10 (91%)
The tapstand has all 4 taps attached	10 (83%)	10 (91%)
All tap handles are present on all remaining taps at the tapstand	11 (92%) >10%	9 (82%)
All remaining taps on the tapstand provide water when turned on	12 (100%) >10%	9 (90%)
All remaining taps at the tap stand are protected by tap guards	11 (92%)	10 (91%)
The concrete base of the tapstand is in decent shape*	12 (100%)	11 (100%)

This Week	2 weeks ago
There is no faeces on the ground within 10m of the tapstand	10 (83%) >10%	6 (55%)
# of private hoses connected to individual taps	1	0
Average # of people queuing at the tapstand	3	0.47
Flow calculation based on # of seconds it takes to fill a 1L bottle	0.26	n/a

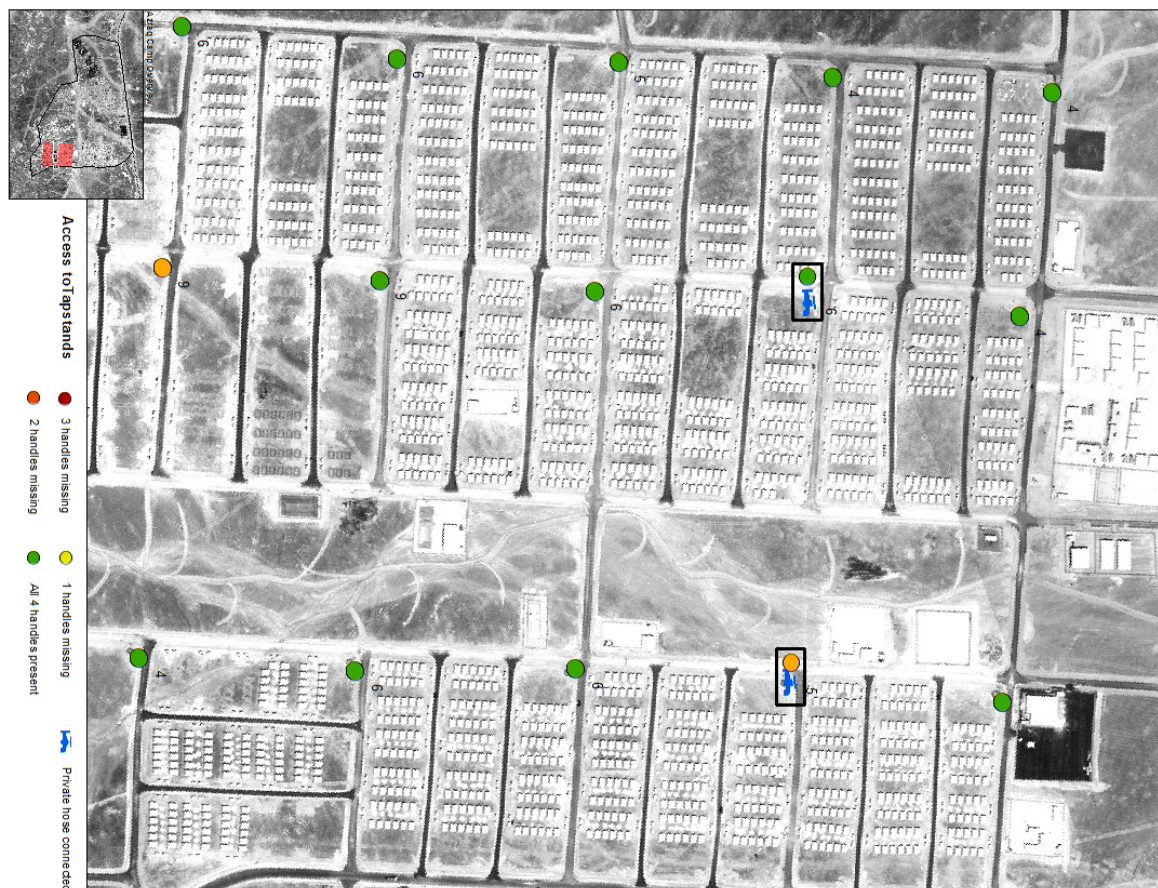
Map 8: Missing tapstand handles and private connections in Village 6

This Week	2 weeks ago
The tapstand provides water during its operational hours	17 (94%)	17 (94%)
The tapstand has all 4 taps attached	18 (100%)	18 (100%)
All tap handles are present on all remaining taps at the tapstand	16 (89%)	17 (94%)
All remaining taps on the tapstand provide water when turned on	18 (100%) >10%	14 (82%)
All remaining taps at the tap stand are protected by tap guards	17 (94%)	18 (100%)
The concrete base of the tapstand is in decent shape*	18 (100%)	18 (100%)

This Week	2 weeks ago
There is no faeces on the ground within 10m of the tapstand	16 (89%) >10%	10 (56%)
# of private hoses connected to individual taps	2	0
Average # of people queuing at the tapstand	1.5	0.10
Flow calculation based on # of seconds it takes to fill a 1L bottle	0.19	n/a
