CCCM YEMEN – FIELD MISSION REPORT

IBB 04 TO 08 SEPTEMBER 2022

This mission to Ibb is to assess the situation in this Hub, especially at the end of the rainy season. Main purpose is to visit sites managed by partners, monitor response, gaps, needs, and potential improvements or challenges encountered by site management agencies. Visits were coordinated with participation of shelter and protection colleagues.

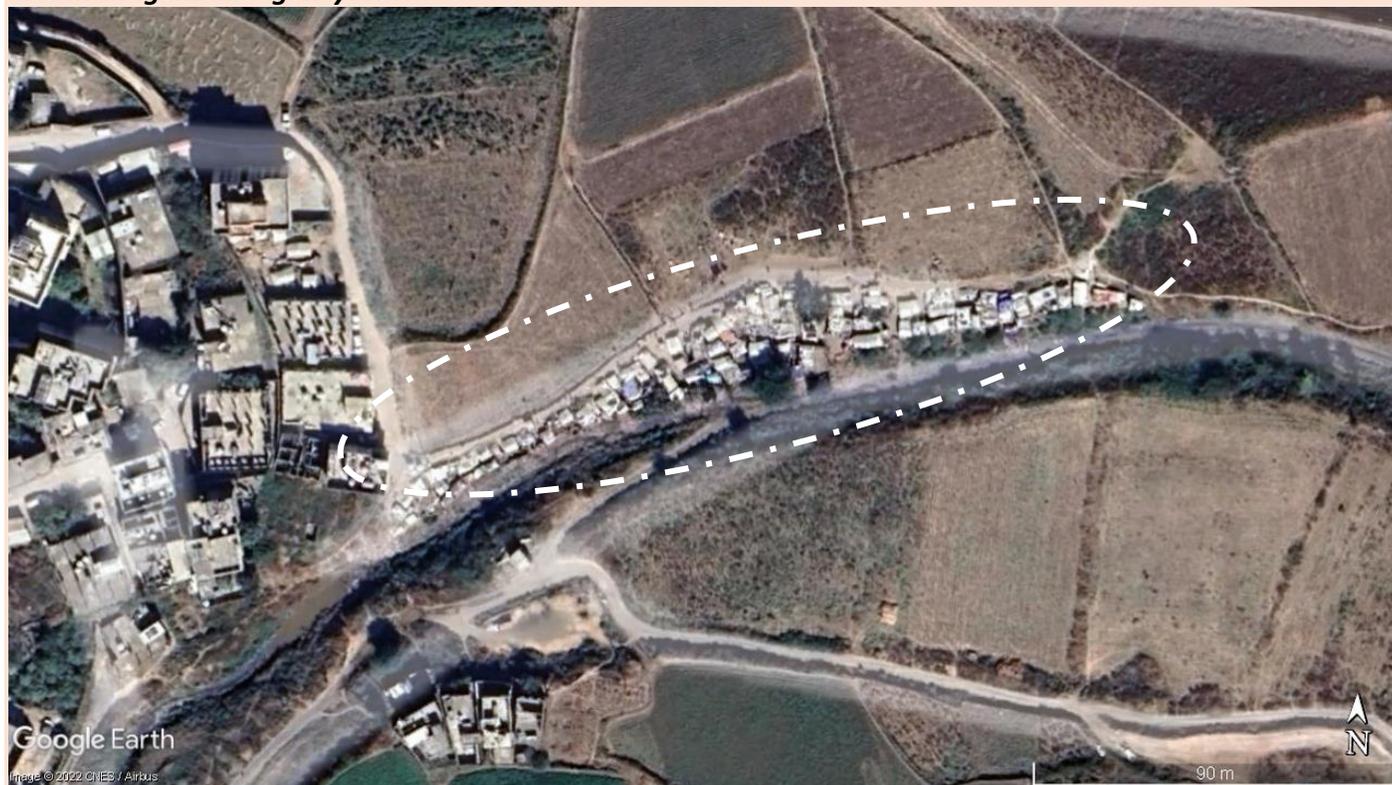
As we can see from the google earth image, this site is spontaneous and located on a turn of the river. From the Ouest side it's a host community suburb, the access is through a short track, making the access limited to large vehicle. From the North part, it's cultural field and IDPs are using an unuse location, following the river inner bank. the river dug for 3 to 4 meters down. Therefore, if the flash flood is more than 3m the site is at high risk of flood from the river source.

IOM implemented a mitigation measure to reduce exposure to flash flood coming from the river. The site is located in the close out bank, there IOM built a 1.5/2 meters high wall for a cost of 20'000 USD. This wall starts from the first shelter and finish with the last one. During the last flood, this wall protected the idp sites and the shelters (see picture red square), but was not high enough. The recommendation from IOM site manager is to increase the level of the whole. However, from the setting of the site and from the low number of IDP households, potential alternative solution could be found.

1. Provide small bins and tools to support community for cleaning campaign and waste management.
2. Site maintenance and shelter maintenance should be provided, to improve drainage. Some shelters should need additional tarpaulin to cover roofs and reduce water infiltration.
3. This site could be selected for relocation. Number of IDP households is not important. Potentially some other sites could host them. However, this solution should be selected only if the community is positive with the approach and if we could not find alternative solutions.
4. Provide tools for fire mitigation and establish fire committee (including training)
5. The site management agency should add some signs to increase communication and information sharing with the IDP community

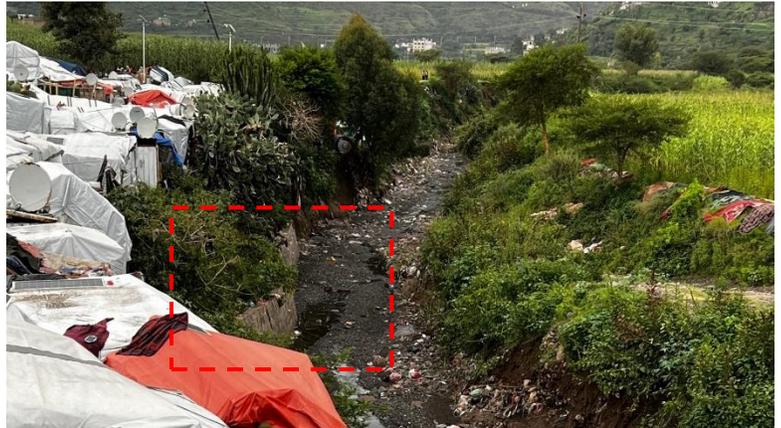
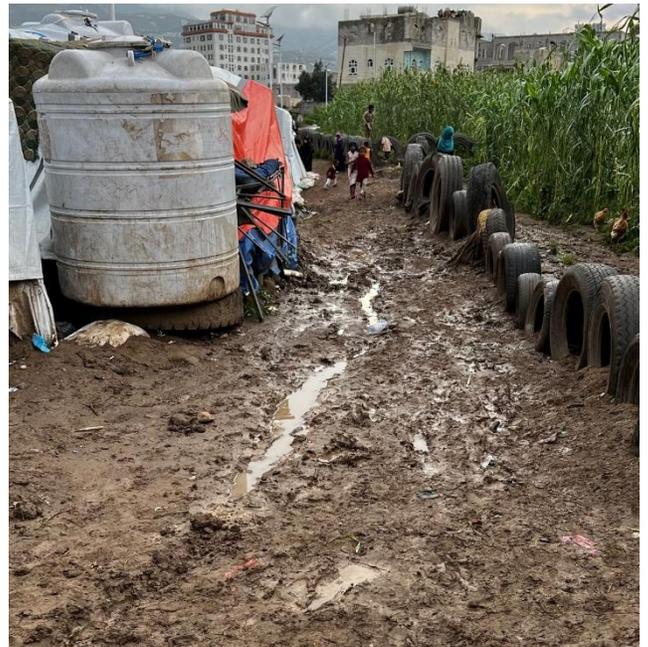
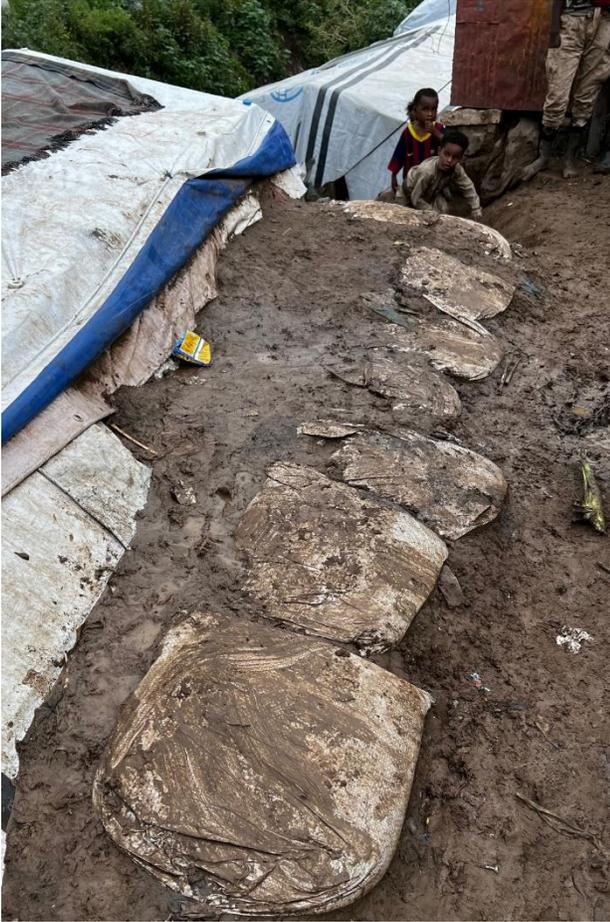
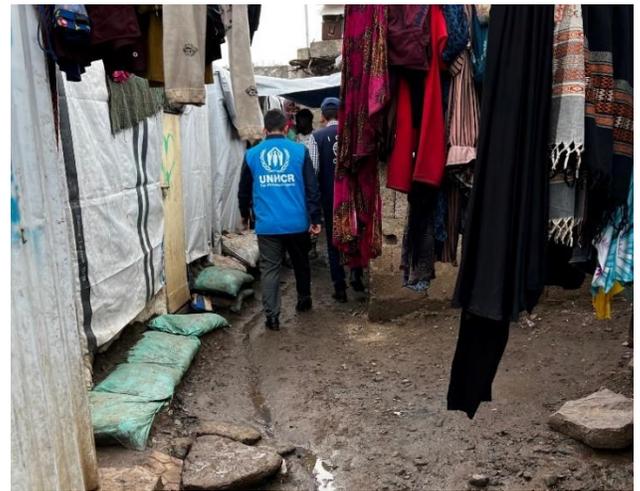
The CCCM unit noticed that no functional drainage system or maintenance was present in the site, and the site was still suffering from stagnating water and mud (see pictures) from the last rain. On top of it some protections, like sandbags would need to be replaced.

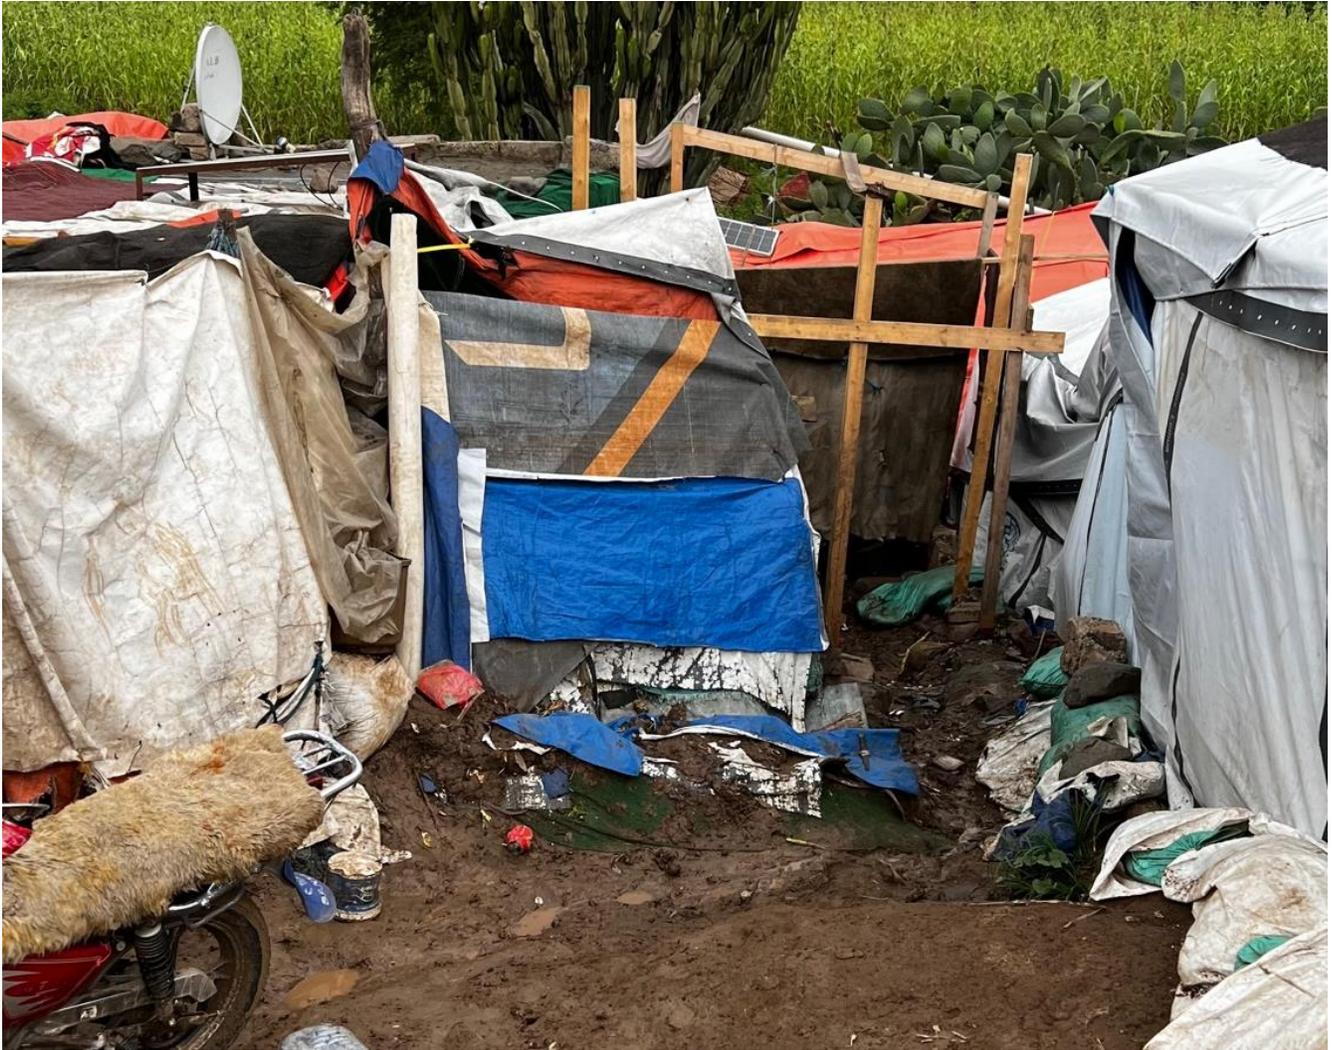
Some of the shelters are better protected with sandbags to avoid water to enter inside them (see picture), but the distance between shelter is reducing the capacity to implement flood measure for the drainage and could result to water infiltration and health issues.

Example in this site for need of site maintenance, and shelter rehabilitation. We can see that the drainage is improvised, the sandbags would have to be replaced, and the water flow will finish to another shelter. However, this part is not most of the situation of the site, and a lot of the shelter have been improved with additional tarpaulin.

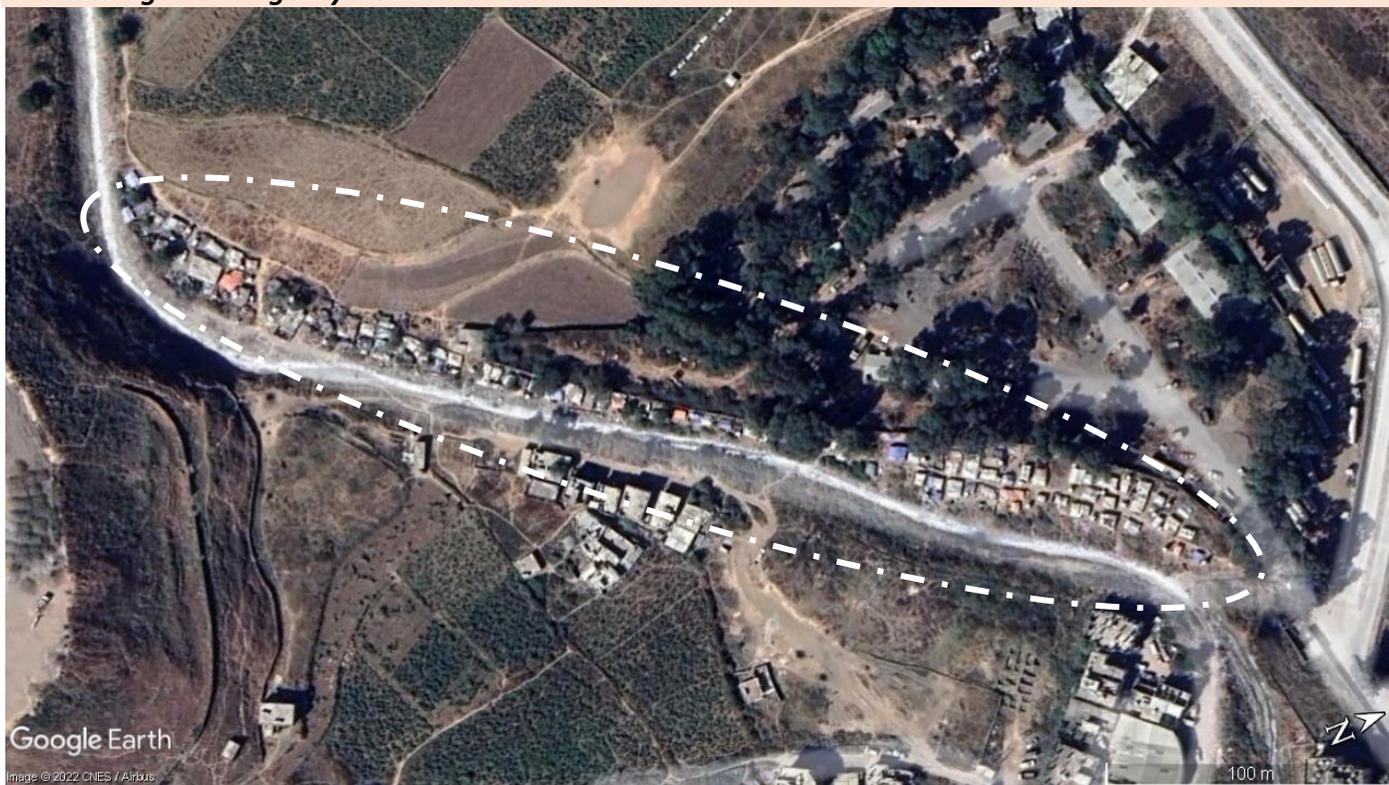
This site is blocked between the inner riverbank and a wall of the private land. It's organized on a line of 400 meters long. From the flood photo below we can see clearly the situation and the direct threads of flood to IDPs living in this site.

1. This site should be prioritized for relocation as the mitigation measure would be not efficient enough.
2. Coordination between CCCM and Protection should be organized as soon as possible to understand the water situation and to avoid protection issues.
3. Site maintenance should be organized to improve water drainage, shelter maintenance. Tools should be provided for the IDP committee to self-manage the maintenance.
4. Some information to the IDPs should be implemented to the site for risk reductions.
5. Distribution of plastic box could avoid IDPs to lose important belonging such as documents due to flood.

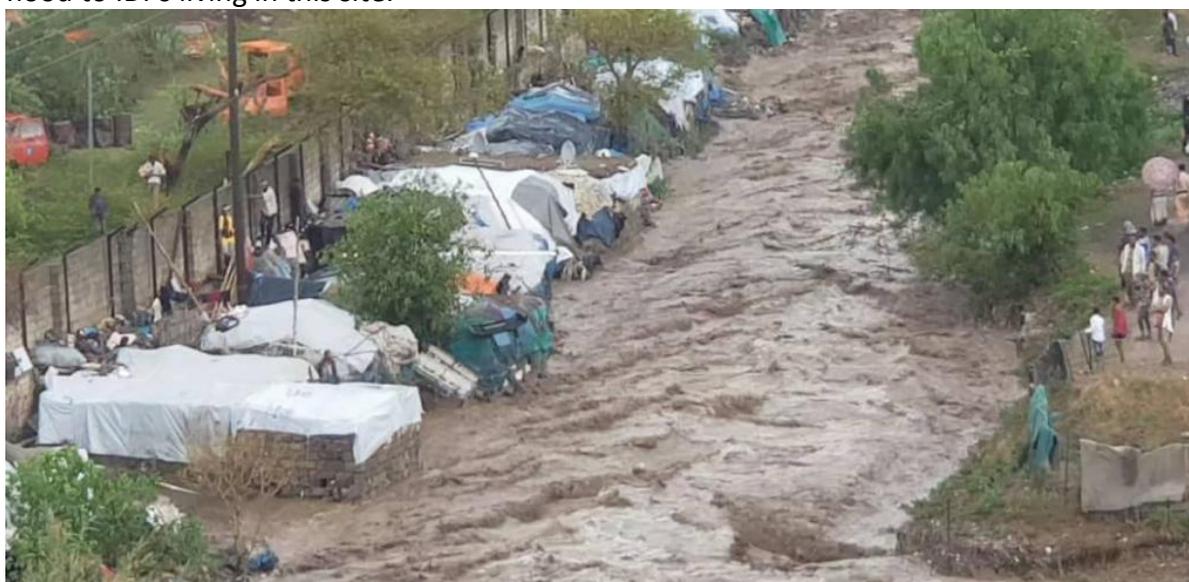
Here, the inner river is from 2meter down and lower. Therefore, the last flood affected directly the site. The CCCM noticed that a latrine and a water tank were taken away by the flood. In addition, a wall of one shelter was destroyed by the flood (see picture).

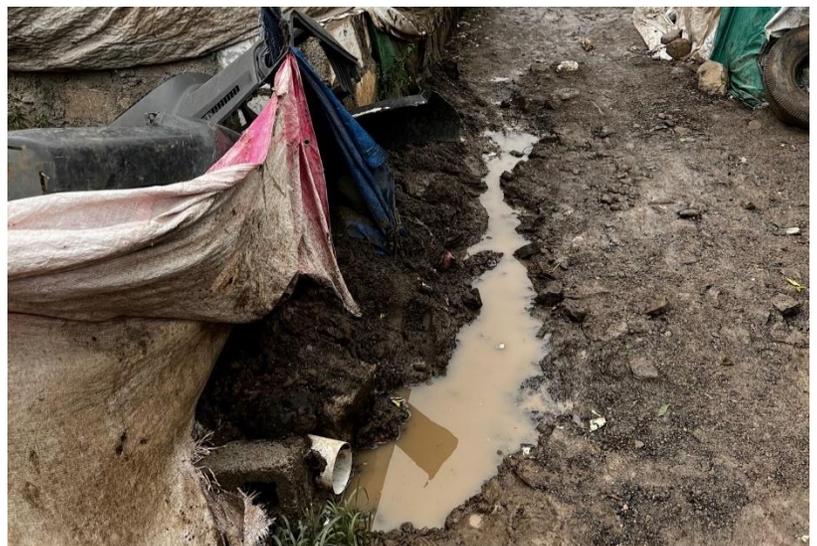
Some pipes have been set up in the site to extract the water perpendicular to the water flow and river. But the CCCM team noticed that this implementation revealed some technical issues. We noticed that not all pipes are working correctly due to lack of technical set-up (see picture). Therefore Water is not completely evacuated.

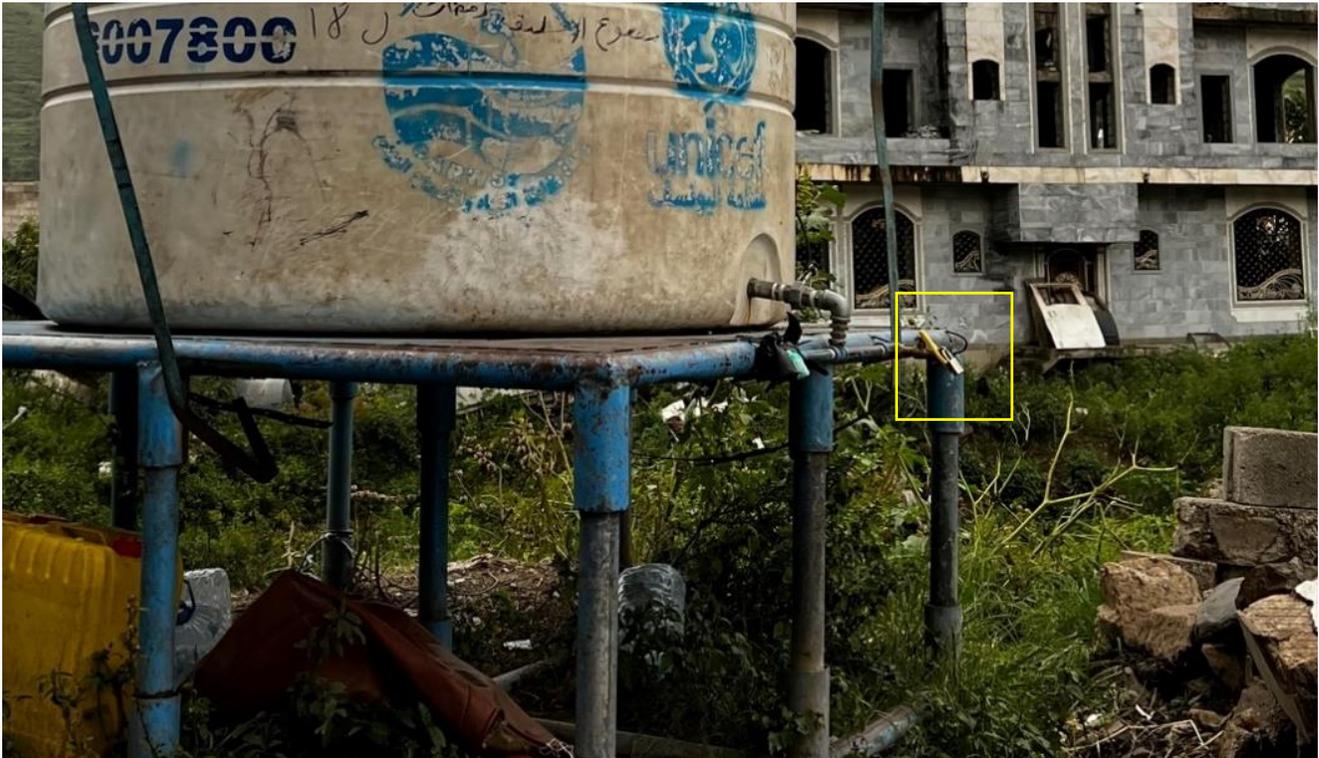
The CCCM team also noticed that like other sites drinking water stopped. In this site, a private supplier is providing the water. The IDPs have to pay for it, for a cost of 50USD for 3000 liters. One water tank was locked and the explanations from the site management agency or the IDP community were unclear (see

picture, yellow square for the lock). This should be followed by Protection team for clarification. Apparently one IDP household is having the keys of this lock, the concern could result to tension amount the IDP families.

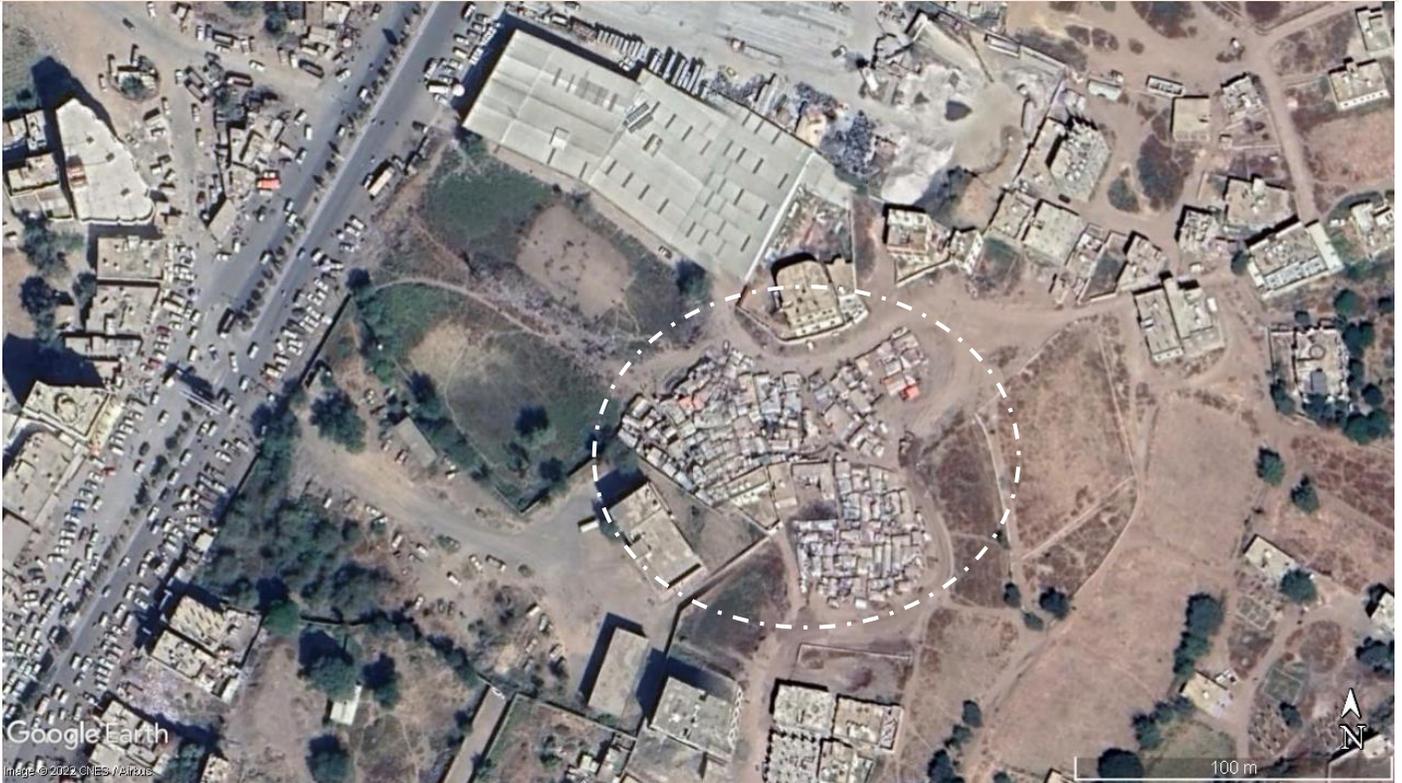
The sites affected by floods are not only the one in the inner or outer riverbank. Based on the topography, and availability of land, the land used by IDPs or the land available may be prompter to potential floods.

From the google earth image The site density is visible with shelters touching or attached to each other. Some families are even sharing the same self-settled made shelter. Shelter situations need improvement and plastic sheet are damaged. For several years this site has not received new plastic sheet to replace the first one provided. IDPs are using plastic found in random place to replace the broken parts (see picture).

1. Livelihood is the main recommendation for this site. The IDP communities is collecting plastic bottle but if they can transform it by grounding it, they profit would be 5 times more. Women also needs activities to generate incomes.
 2. Due to shelter situation CCCM and Shelter should coordinate to provide additional Emergency Shelter Kits, and plastic sheets. Also, coordination should be organized with Shelter for shelter improvement to mitigate floods.
 3. Site maintenance should be provided to add sandbags, tools for site maintenance, training on using the tools should be organized, in order to set up a proper drainage system.
-

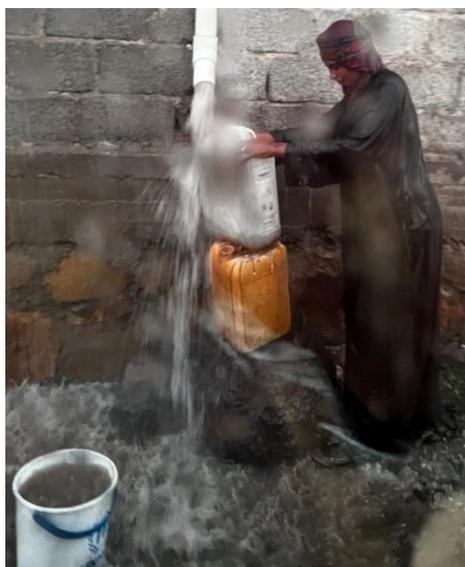
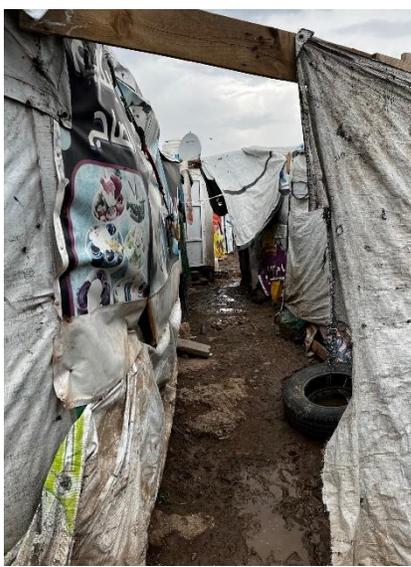
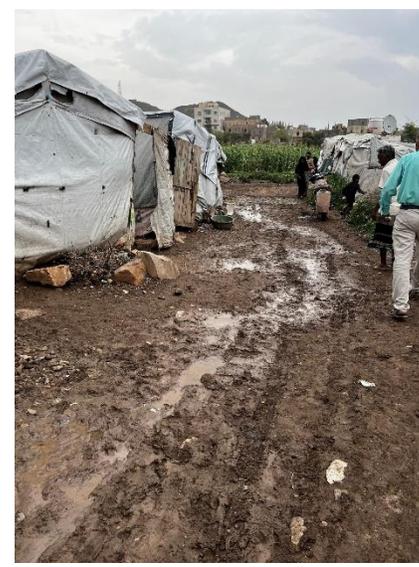
After the rain, the assessment took place. The CCCM team could see that in this site managed by DEEM, the flat place is not allowing natural drainage. No drainage systems are in place, and no sandbags were provided to avoid water infiltration in the shelters.

IDPs are reporting water infiltration from roof but also from the ground. See pictures:

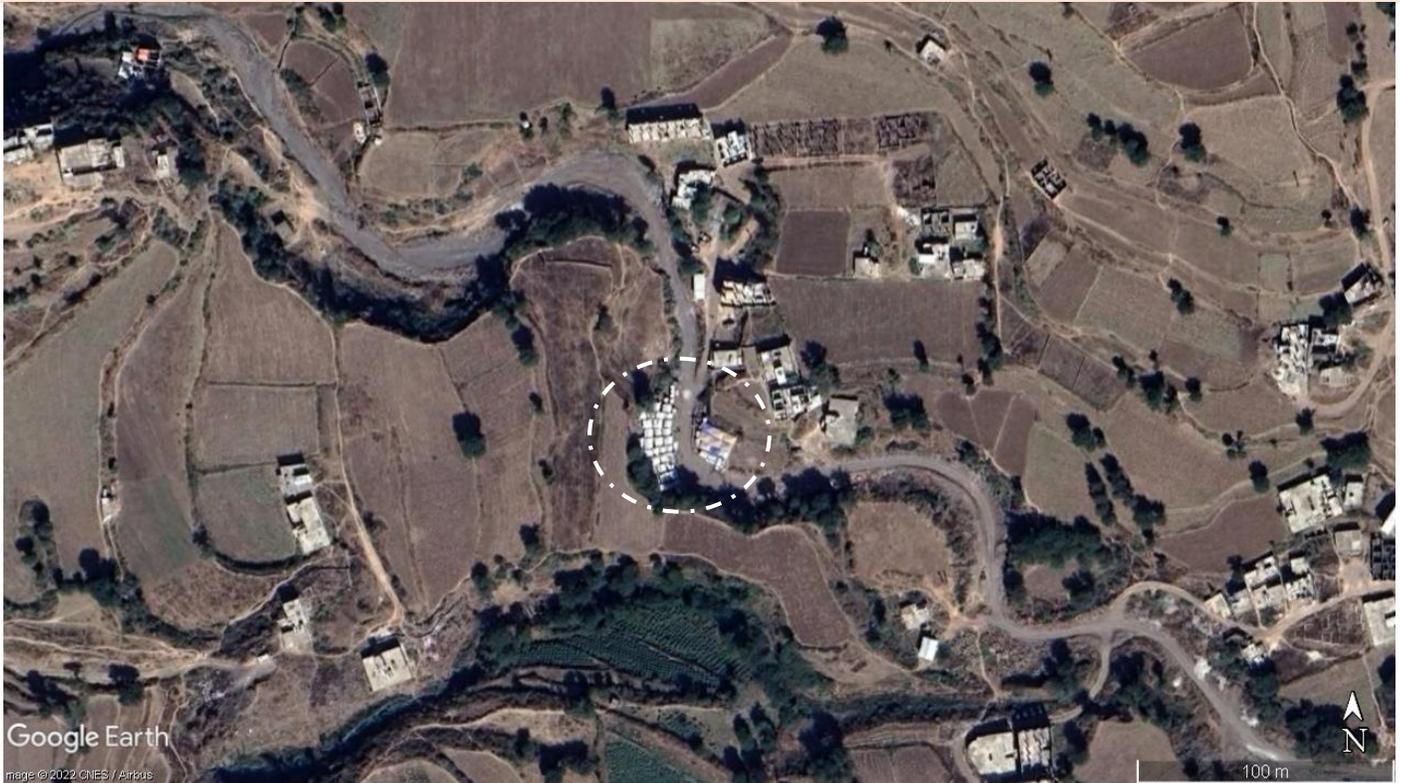
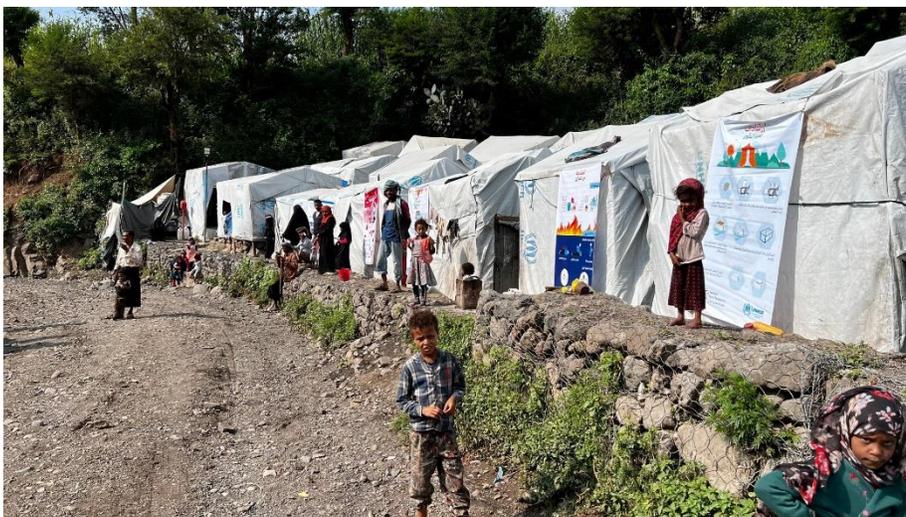
From the Google Earth image, we can notice that this site is separated in by the inner riverbank. This riverbank is also the access road to this site.

1. Increase the level of the gabions
2. Needs for some site and shelter maintenance
3. Improve the cooking area
4. Coordinate with WASH for the issues, including waste management
5. Establish evacuation road in case of flood

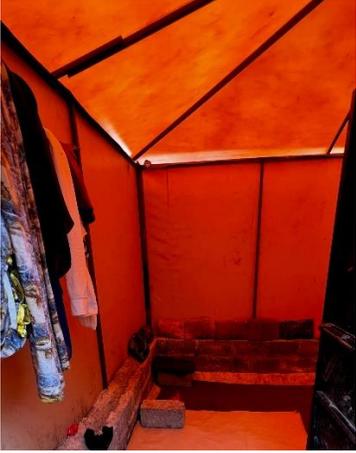
Based on the information provided from colleagues and from TYF site management team, the flood mitigation measures removed the shelters from the inner riverbank, and installed gabions to prevent flood and erosion. See photo.

The second part is constituted with ESK (see previous photo). Size of the shelter is less than for the second one, and the location of this part of the site is raising some potential structural and maintenance issues.

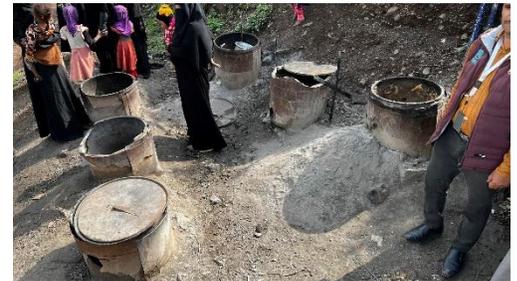
The management from TYF is showing a lot of positive aspects, from the complain box, to information messages. As well the site committee is well established with gender balance and badges. This site also has a dedicated cooking area with a good distance to the shelter to avoid fire incidents. According to TYF, they are also equipped with tools to reduce fire incidents. Request from the community would be to have the cooking area protected from weather.

The CCCM team noticed that the latrines are located in an area too close to the inner riverbank, on upstream of the camp, and with potential flood exposure. The request from TYF would be to increase the level of the gabions. The downstream of the site is used by IDPs as dump side for the trashes (see below picture). Therefore with flood, the trashes will be transported to the center of Ibb city, and potentially generate hygiene issues.

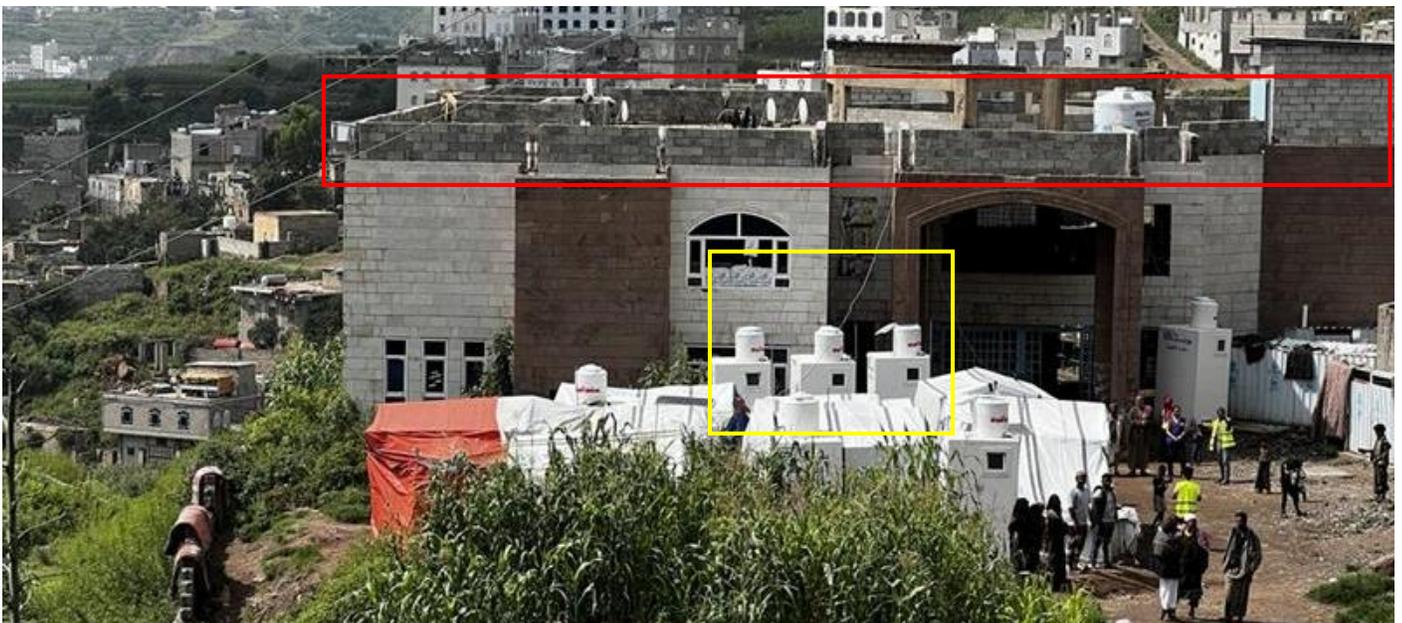
This problem can create some threats of evictions and affects the IDPs situations. This was the case of the site Waqeer, managed by IOM, where UNICEF implemented additional latrines without coordinating with the Site Manager. Where they installed the latrines in the stream channels and the torrential entered the IDPs's shelters. This site is mainly a collective center where IOM improve safety and ensured regular activities. This problem with WASH activities was not the only one occurred during the assessment of the sites. This lack of coordination and information provided by the sectoral partners is at the end a waste of resources, as some of the sites are getting too many latrines, when other sites are missing them, based on the SPHERE indicators.

This photo is highlighting the area where non-coordinated latrines were set-up (in yellow). In red is the safety measures on the roof implemented by IOM under site improvement activities.

1. Ensure that the site management team, in coordination with the site administrator, is organizing regular meetings with the service providers of the site, and with the site committees
2. Needs to ensure the role and responsibilities of the SMT vis-à-vis of the partners and the authorities
3. Improve the communication with the IDPs, and standardize the approach:
 - a. Complain box
 - b. Information on How is doing what
 - c. Awareness campaign for fire prevention / flood mitigation / hygiene

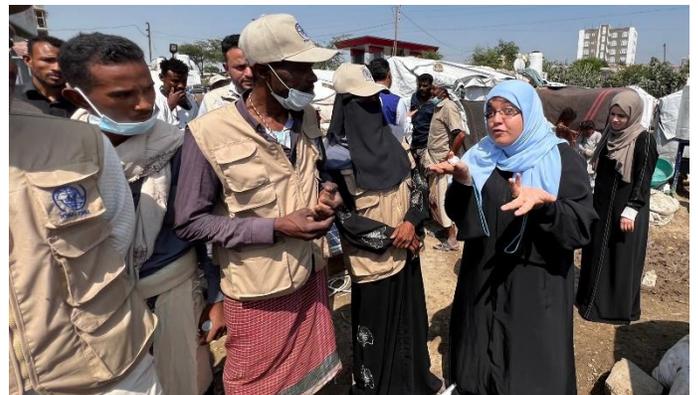
Another problem of coordination at site level is not only with providing hard services, but also soft services or information sharing. The CCCM teams noticed that some of the protection activities were creating some tension with the IDP community. This problem was highlighted particularly in a site Al Tumoh managed by IOM. There, our UNHCR protection colleagues, discussed this problem with the IDP communities' leaders.

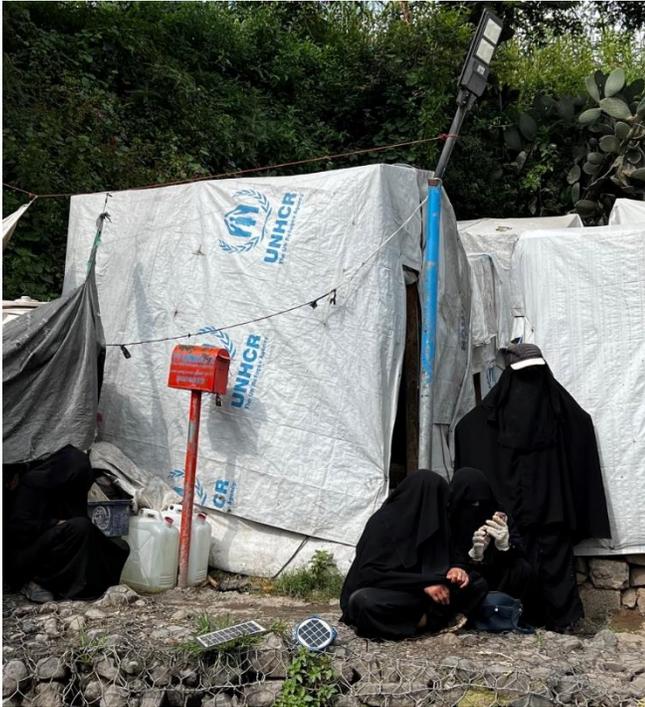
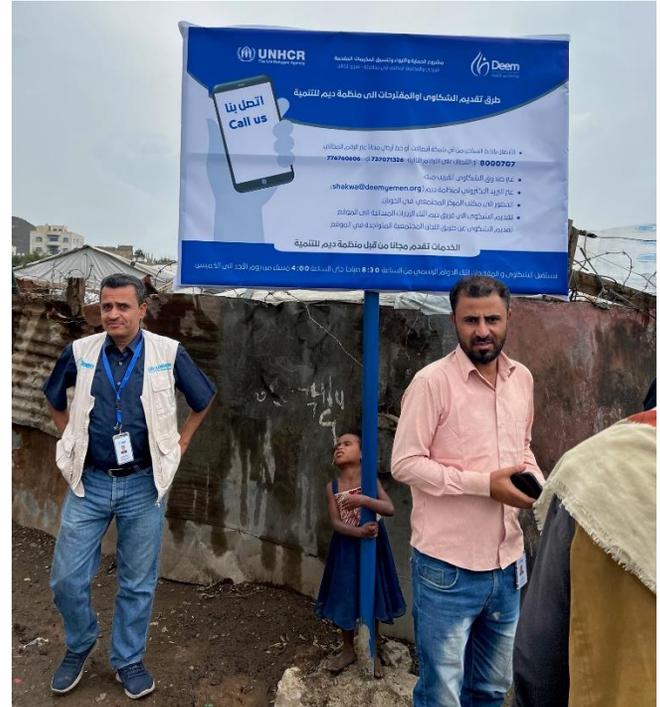
One last problem encountered during assessment and visit is the difference between the sites in term of communication with host community. Some of the sites, have information about the place, some have information on directly shared with the community. It was not clear how often the site management teams were meeting with the communities, and the purpose of the meetings. In some sites it seems that the meetings were not organized, reason of maybe some question and tensions about activities from sectoral partners. Not all the sites were equipped with complains boxes.

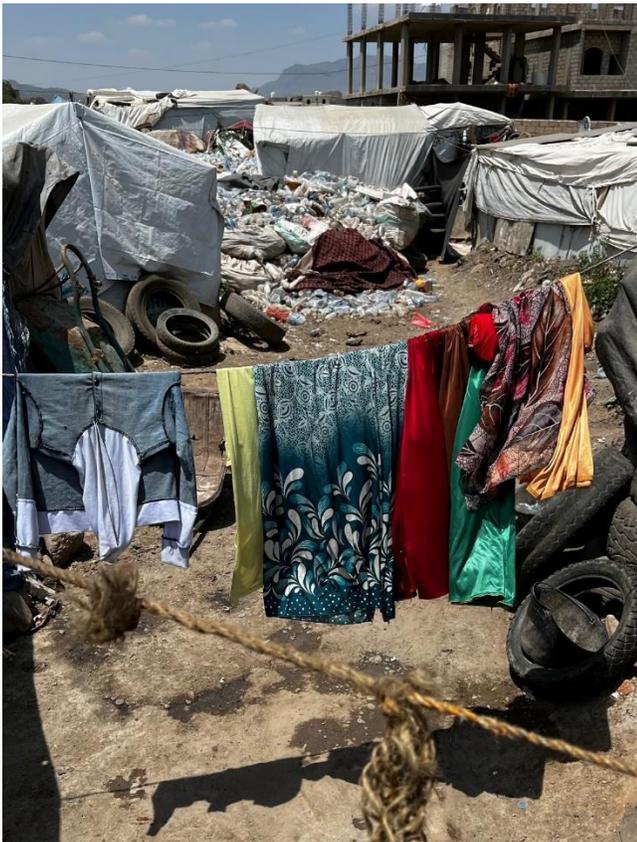
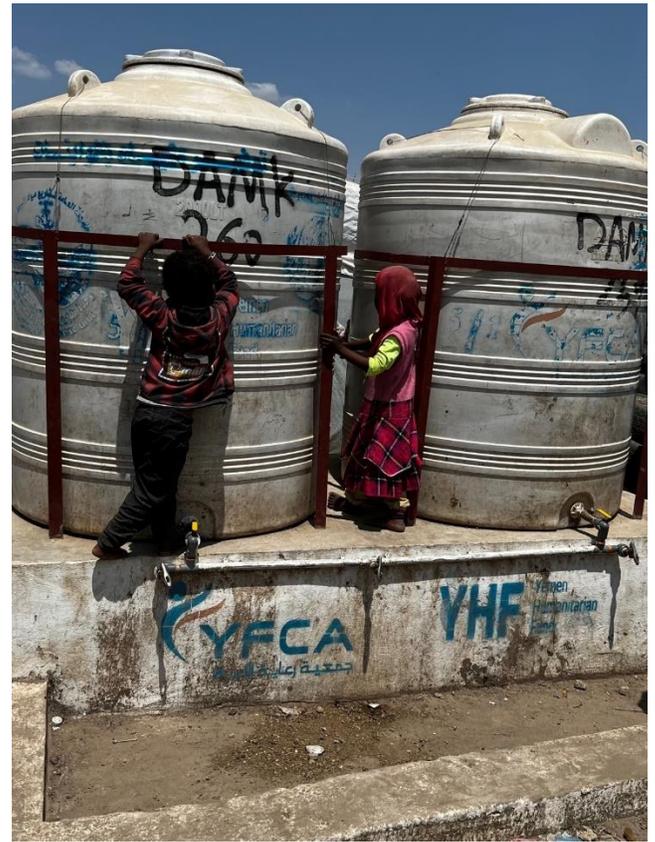
Situation in the non-managed sites in Al Dhale'e is similar between the sites. Needs for shelter maintenance, site maintenance, and improvement of infrastructure are visible. Same for the WASH with water trucking stopped, and a need to establish site committees to empower the community to do activities such hygiene campaigns.

1. Establish a light line of response of site management to cover this governorate with site management. This should be advocate to donors to obtain funds.
2. Raise the lack of coverage at ICCM national level
