Al Aswak Sahat Al Daftar

NEIGHBOURHOOD PROFILE

Haddadine, Tripoli

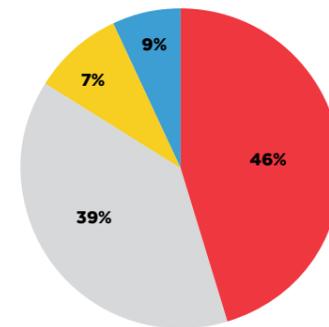
BUILDING STRUCTURE CONDITION

7% of the buildings show severe cracking or missing structural supporting elements. Buildings in critical state in need of urgent rehabilitation.

39% of the buildings show distinct signs of roof or wall leaks, water penetrating buildings, and visible rusted reinforcement. Attention needed to stop further damage.

46% of the buildings have minor shrinkage cracks in floors and/or walls with no intrusion back into building. Continual monitoring required.

9% of the buildings have no visible sign of distress or failure in the building.

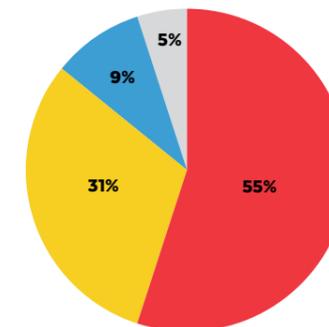
EXTERIOR BUILDING CONDITION (Foundation, walls, roof, windows, balconies, fixed features)

5% of the buildings have dilapidated exterior conditions with severe failure apparent resulting in extensive damage where emergency attention is called for.

31% of the buildings have a poor exterior condition with distinct signs of failure including water intrusion, cracks, deterioration which requires major repair.

55% of the buildings have fair exterior conditions with minor problems and slight cracks that are easily repaired. Continual monitoring is required.

9% of the buildings have good exterior conditions with no failure or problems of any kind apparent. Routine maintenance will be adequate.

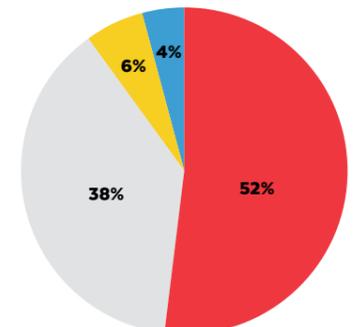
COMMUNAL SPACES (Means of exit, entrances, lighting, provisions for people with disabilities)

6% of the buildings have no and/or damaged gates or lighting at the entrances with significant obstructions to staircases that can't be easily removed in case of emergencies.

38% of the buildings have serious defects in the communal spaces including malfunctioning gates, electrical wiring problems, and blocked staircases by obstructions that can be removed.

52% of the buildings have minor defects in the communal spaces such as burnt light bulbs and minor problems in entrance gates.

4% of the buildings have functional communal spaces with gated entrances, lighting provided in all areas, and easily accessible exit doors and staircases.

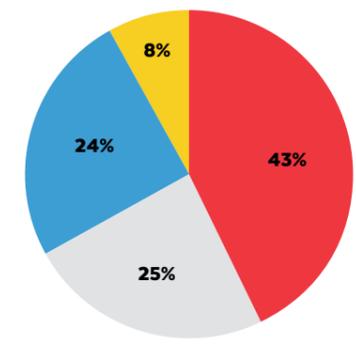
BUILDINGS CONNECTIONS TO STORMWATER NETWORK

8%
of the buildings are not connected to the municipal network and/or have missing/ blocked stormwater roof gutters or drains. No stormwater pipes installed and rainwater is leaking on external walls.

25%
of the buildings are not connected to the network. Stormwater pipes are installed but have serious defects, leaking and/or blocked, and discharge on street.

43%
of the buildings are not connected to the network. Stormwater pipes are properly installed on external walls but discharge on street.

24%
of the building are connected to the network. Stormwater pipes are properly installed and functional.

76% of the residential buildings are not connected to the stormwater network and discharge onto the streets. 70% of residents are exposed to seasonal flood risk.

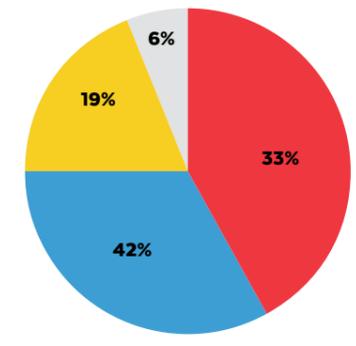
BUILDINGS CONNECTIONS TO WASTEWATER NETWORK

6%
of the buildings are not connected to a sewer and discharge their waste into open drains on the street.

19%
of the buildings are connected to the wastewater network and/or septic tanks with major leakages problems and/or blockages in plumbing system.

42%
of the buildings are connected to the wastewater network and/or septic tanks with minor leakages in the wastewater plumbing system.

33%
of the buildings are connected to the wastewater network and plumbing system is properly installed.

8% of residents are directly affected by the old and deteriorated wastewater network, dating back from the Ottoman period.

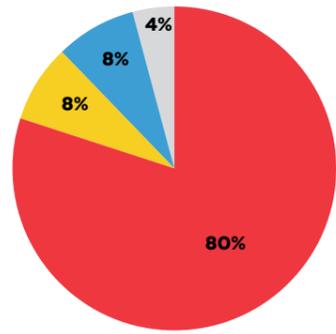
BUILDINGS CONNECTIONS TO DOMESTIC WATER SUPPLY

4% of buildings are not connected to water supply network, requires immediate attention

8% of the buildings are connected to the network but pipes have major leakages and are at the end of their lifecycle.

80% of buildings are connected to the water supply network but with minor leakages and/or inappropriate installation of water pumps.

8% of residential buildings are connected to water supply network with good quality pipes and no leakages.

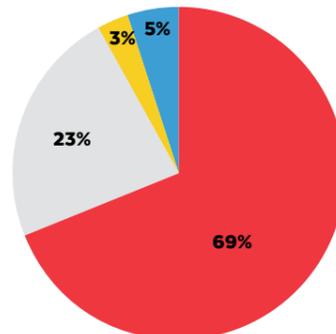
BUILDINGS CONNECTIONS TO ELECTRICAL GRID

3% of the buildings are not connected to the electrical grid.

23% of the buildings are connected, but have inadequate connections to the electrical grid, with electric wires causing danger to building residents.

69% of the buildings are connected, but have minor defects in their connection to the electrical grid, electric wires are installed externally with limited safety measures and weatherproofing..

5% of the buildings are connected with electric wires properly installed.

74% of residential buildings are connected to multi-building private generators.

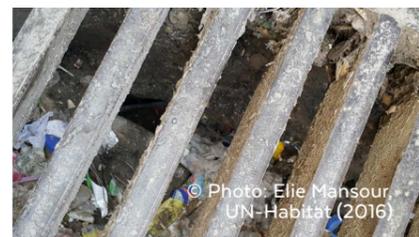
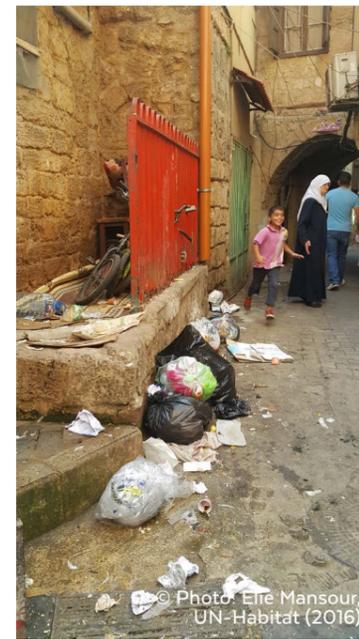
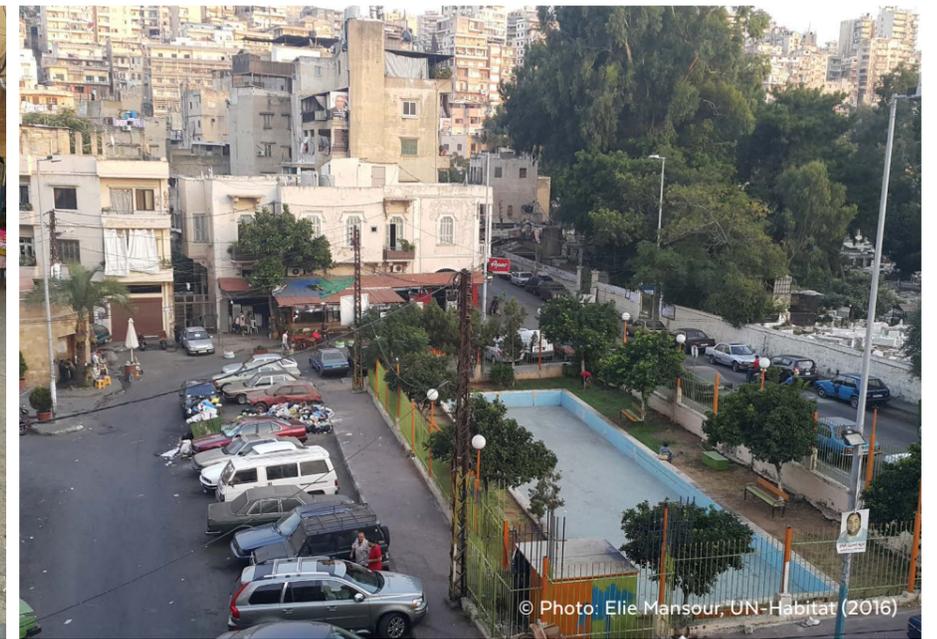
Across the neighbourhood, 20 bins and 7 dumpsters were identified. Waste is being collected three times per day according to the solid waste management company. Simple waste generation and collection capacity calculations suggest that the infrastructure and management routine is in principle sufficient to turn over all the waste generated in the neighbourhood. In contrast, the residents have reported that in practice waste is not always collected on a daily basis. Further, the distribution of trash containers may not be optimal, a limitation compounded by the lack of awareness of good solid waste management practices among inhabitants.
