FACTSHEET

FORTNIGHTLY WASH MONITORING

AL AZRAQ REFUGEE CAMP, JORDAN – VILLAGES 3 AND 6

3 – 7 AUGUST 2014

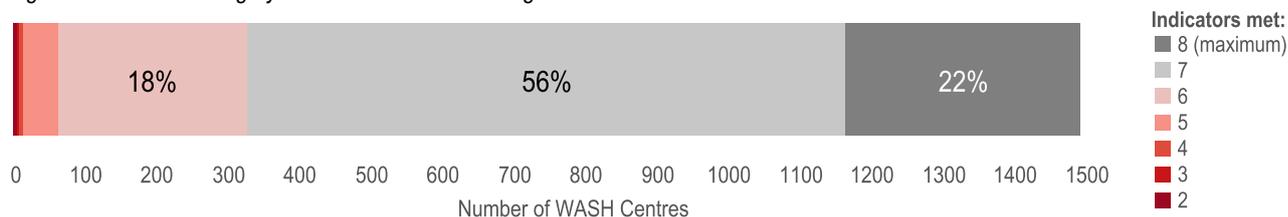
Figure 1: Structural integrity of WASH centres in Villages 4 and 6

- **78% of WASH centres met all or 7 out of 8 structural integrity indicators.** In total, 22% of WASH centres were fully intact.

- The 3 lowest-scoring indicators were **missing or broken desludging caps** (67% of all WCs), **holes in the walls** (14% of all WCs) and **missing or broken ventilation pipes** (8% of all WCs).
- **71% of all desludging caps were removed from the septic tanks in Village 6**, while 20% of the properly installed caps were broken. In Village 3, 45% of all desludging caps were missing, while 28% of the remaining caps were broken.
- **The ventilation pipe was removed in 64 WCs (7%) in Village 3 and 20 WCs (3%) in Village 6.**

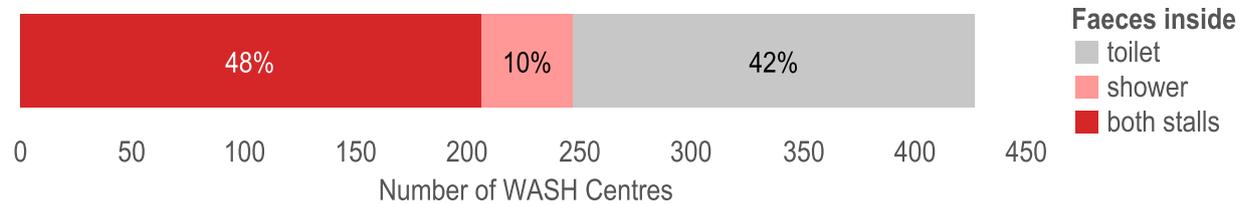
Figure 3: Prevalence of faeces inside WASH centres of Villages 3 and 6

- 51% of WASH centres met all hygiene indicators, while 80% WCs met 3 or all indicators.
- **In 554 WASH centres (37%) faeces were found in shower stalls, toilet stalls outside of the squat pan or outside the stalls.** [See Maps 1 and 2]
- **Faeces were found outside 268 WCs (18%) in Villages 3 and 6**, indicating open defecation is practiced in the camp. [See Maps 3 and 4]

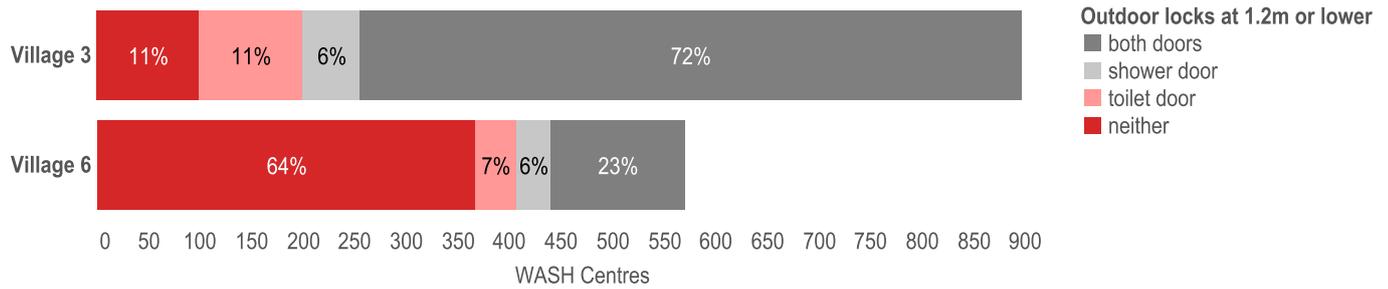
Figure 4: WASH centres with door handles and outside locks at 1.2m or lower

- **4% of all door handles in Village 6, and 15% of all door handles in Village 3 were placed at 1.2m or lower on both doors.**
- The lack of child-friendly door handles can be mitigated by the outside locks, which are the lowest handle on WCs and therefore most easily accessible to children. In Village 3, 72% of WCs had outdoor locks at 1.2m or lower. However, in Village 6, **64% of all WCs did not have outside locks placed at 1.2m or lower on both doors.** [See Maps 5 and 6]

¹ In most cases the outside door handles and locks were placed at 1.2m from the height of the concrete slab on which the WASH super-structure sits. However, this slab is often not big enough to step up onto when the door is shut, and is in most cases at a height above the ground. This makes the handles and locks difficult to reach for children.

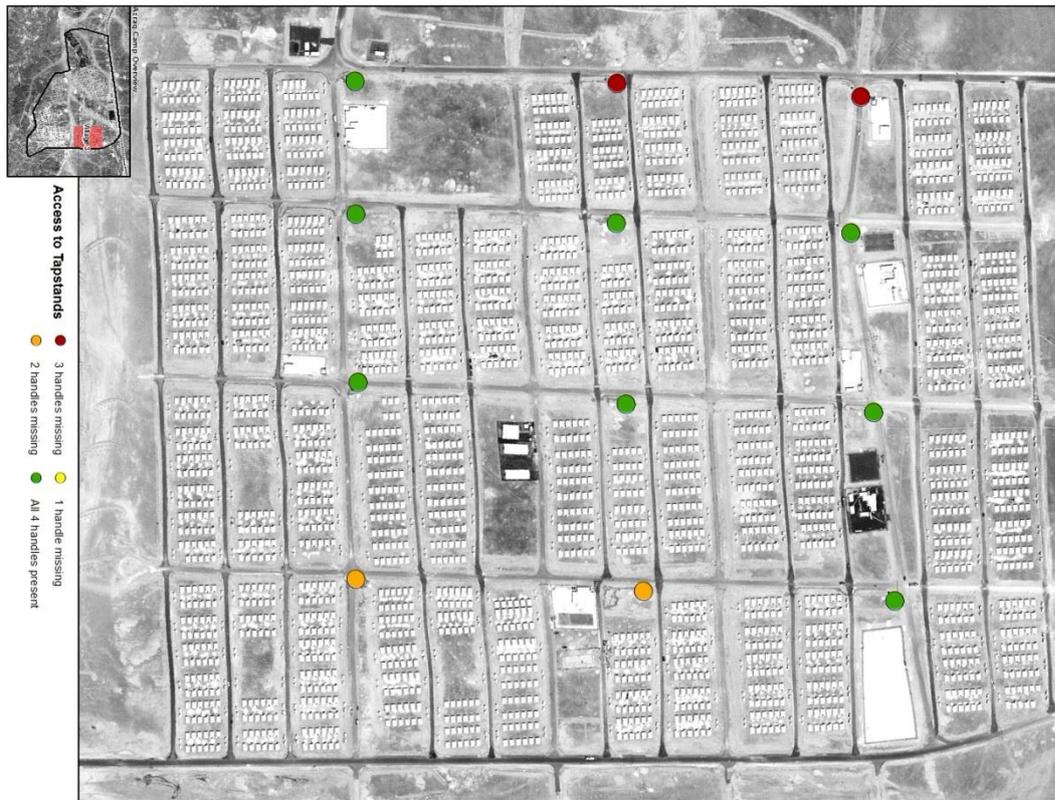
Map 7: Missing tapstand handles in Village 3

- **All taps were present and protected by an anti-theft guard.**
- **82% of all taps provided water when turned on** (three tap stands were out of water at 4pm – the time when they were assessed).
- In Village 3, two tapstands were missing 3 handles and two tapstands were missing 2 handles each. In Village 6, one tap handle was missing in total. [See Maps 7 and 8]

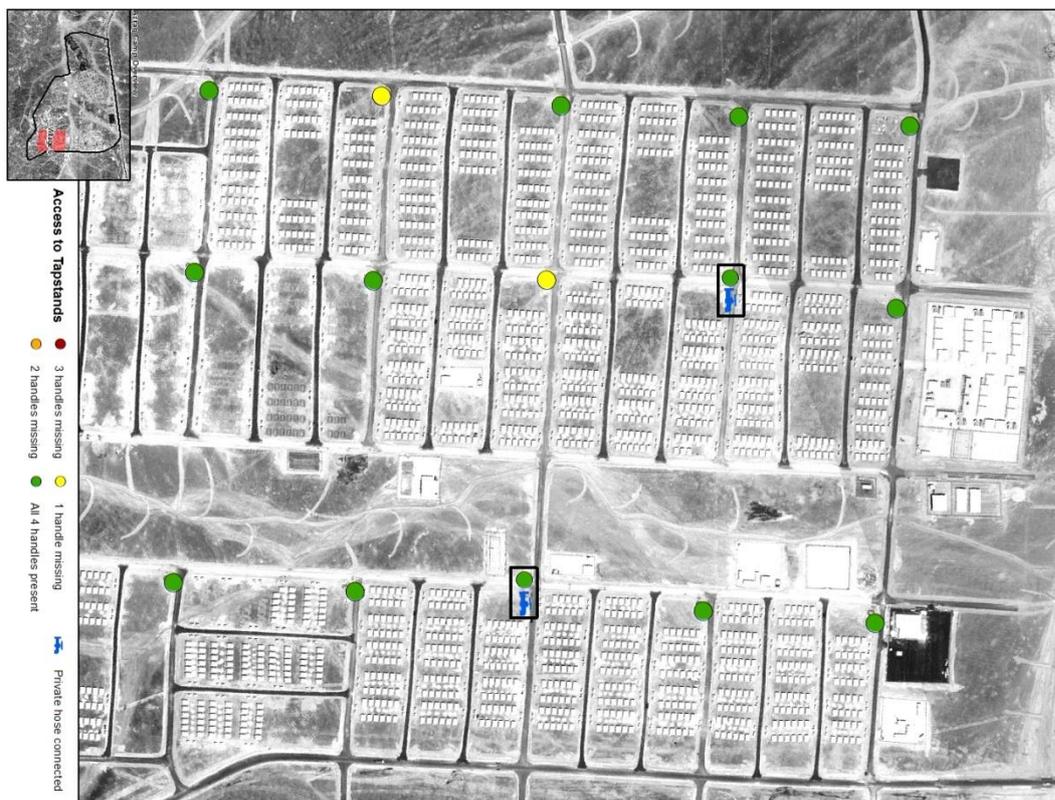
Map 8: Missing tapstand handles and private connections in Village 6

- **Faeces were found at three tapstands (17%) in Village 3.**
- A private hose was connected to an individual tap (1 out of 4) at 2 tapstands in Village 6. These hoses led to communal plots, not individual caravans. [See Map 8]
