### Al Azraq Refugee Camp: VILLAGE 3 & 6

### Al Azraq Refugee Camp: VILLAGE 3

### Al Azraq Refugee Camp: VILLAGE 6

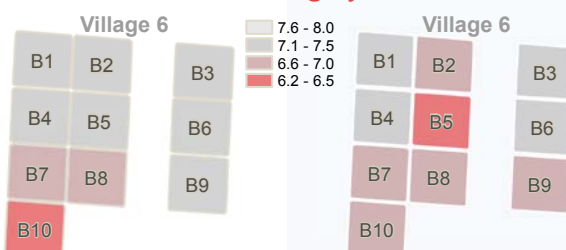
#### Structural Integrity Index

WASH CENTRES INDEXES**	This week	2 weeks ago	Trend
Structural Integrity	7.0 / 8	6.9	↑
Child and Disability Access	2.9 / 4	2.3	↑
Hygiene	3.0 / 4	3.5	↓

This Week	2 weeks ago
Doors securely attached to both shower and toilet stalls	587 (100%)	585 (99%)
Door handles attached to both shower and toilet doors	577 (98%)	577 (98%)
Locks present on inside of both shower and toilet stalls	570 (97%)	546 (93%)
Locks present on outside of both shower and toilet stalls	580 (98%)	563 (96%)
There are no holes or tears in the roof of the structure	570 (97%)	556 (94%)
There are no holes or tears in the walls of the structure	519 (88%)	531 (90%)
The desludging cap was present on the desludging pipe and intact	166 (28%) <sup>&gt;-5%</sup>	138 (23%)
Ventilation pipe is present and fully intact	580 (98%)	570 (97%)

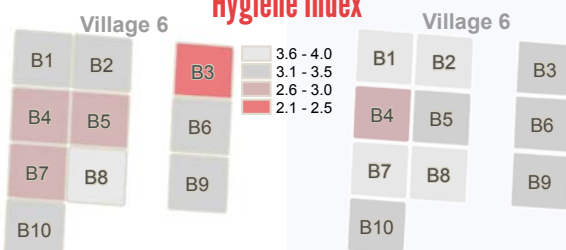
#### Hygiene Index

This Week	2 weeks ago
There is no rubbish inside both stalls	353 (60%) <sup>&gt;-5%</sup>	440 (75%)
There is no faeces inside both stalls	407 (69%) <sup>&gt;-5%</sup>	477 (81%)
There is no faeces outside the structure within 5m	453 (77%) <sup>&gt;-5%</sup>	552 (94%)
There is no standing water outside this structure within 5m	576 (98%)	581 (99%)

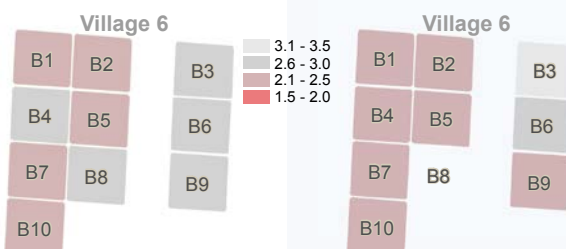
#### Child and Disability Access Index

This Week	2 weeks ago
Door handles are at a child-friendly height of (≤1.2m)	41 (7%)	37 (6%)
Outside locks on both doors are at a child-friendly height (≤1.2m)	506 (86%) <sup>&gt;-5%</sup>	239 (41%)
Inside locks on both doors are at a child-friendly height of (≤1.2m)	571 (97%) <sup>&gt;-5%</sup>	515 (87%)
Both WASH centre doors are not privately locked	584 (99%)	565 (96%)
# of WASH centres dedicated to disabled persons	61 (10%)	59 (10%)
# of WASH centres with finished access ramp	61 (10%)	59 (10%)
Disabled toilet is still present in toilets for disabled persons	22 (36%) <sup>&gt;-5%</sup>	33 (56%)

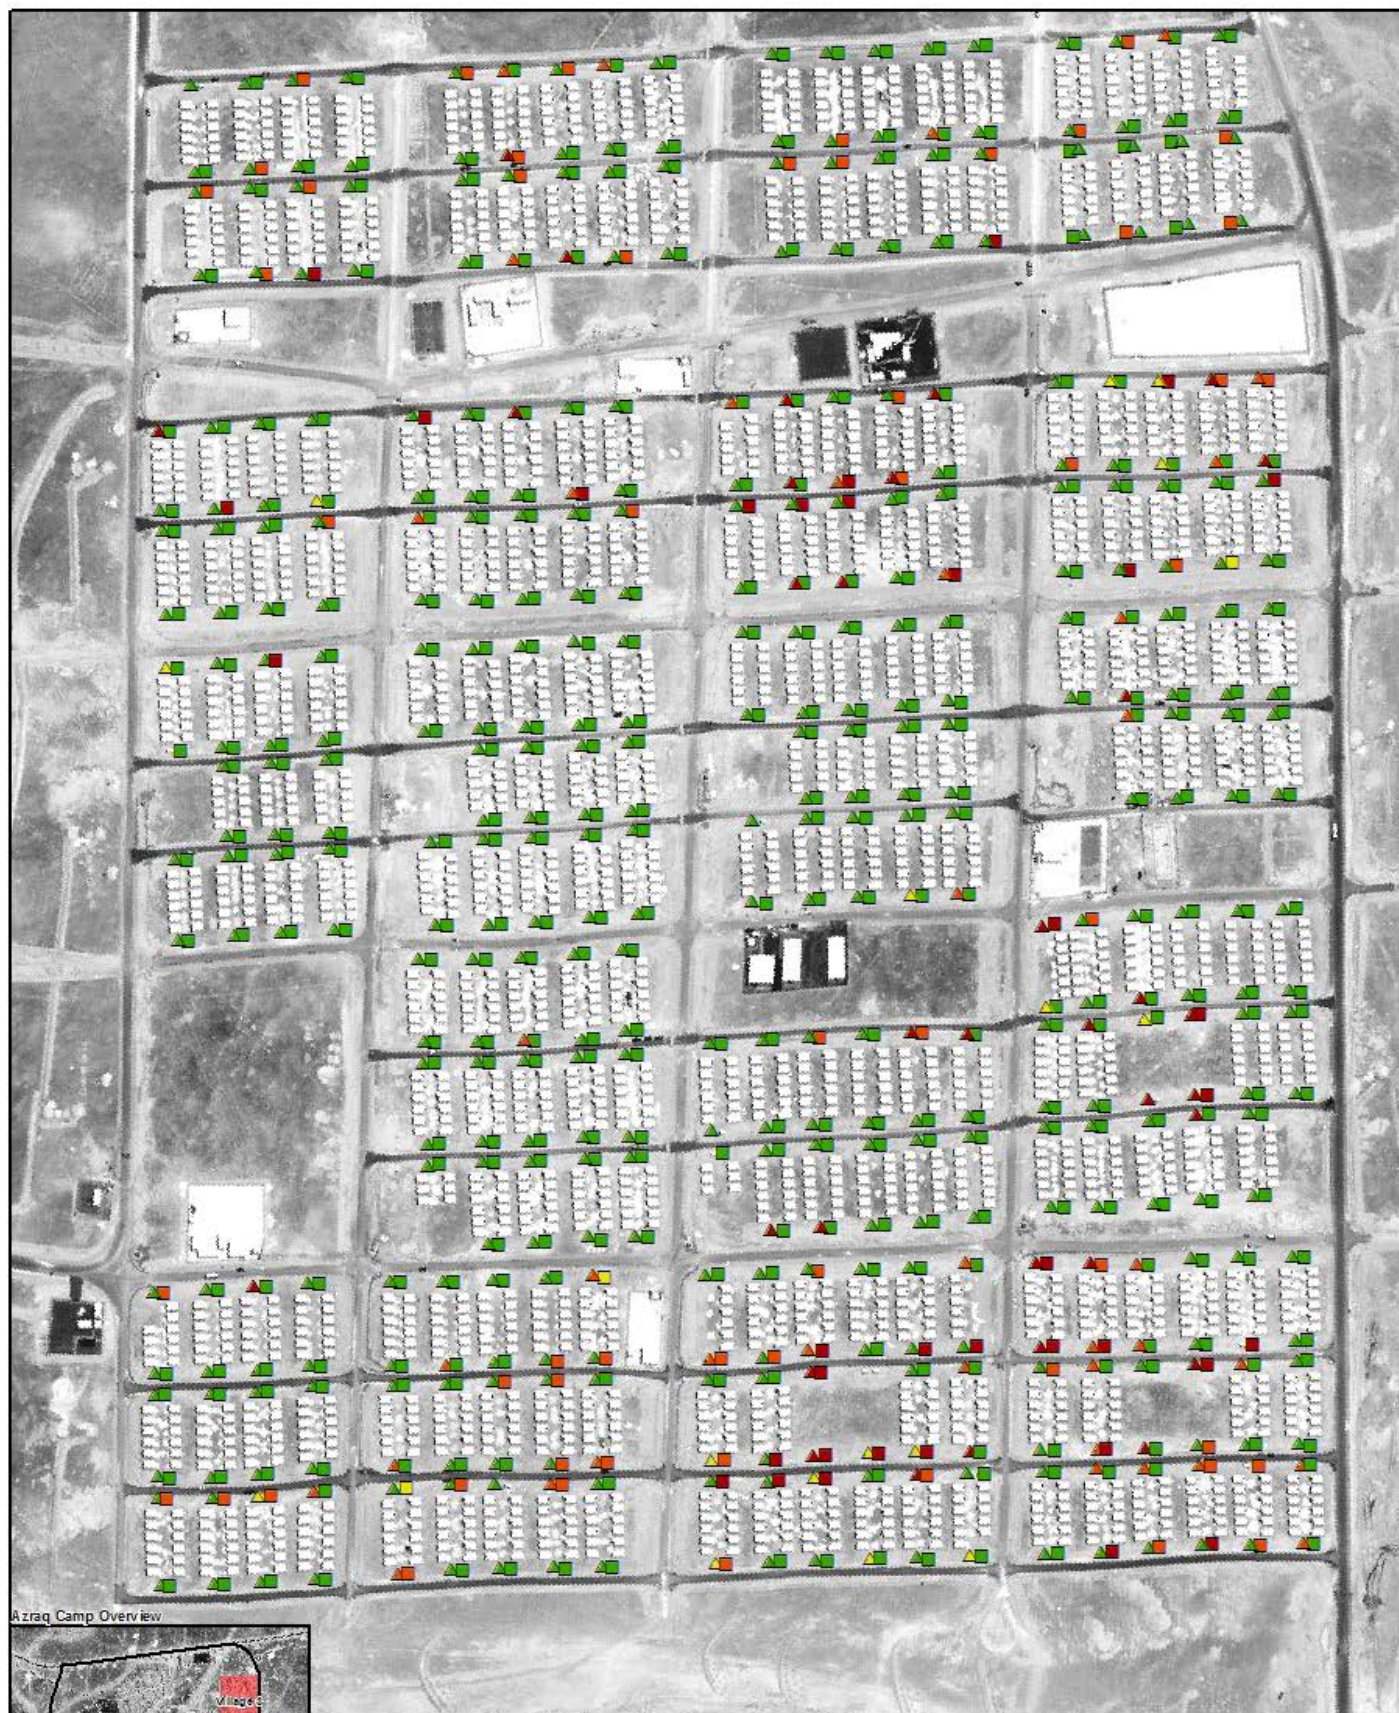
Map 1: Faeces found inside WASH centres in Village 3

This Week	2 weeks ago
There is no rubbish inside both stalls	657 (72%)	662 (72%)
There is no faeces inside both stalls	723 (79%) <span>-5%</span>	616 (67%)
There is no faeces outside the structure within 5m	800 (87%) <span>-5%</span>	740 (81%)
There is no standing water outside this structure within 5m	908 (99%)	902 (98%)

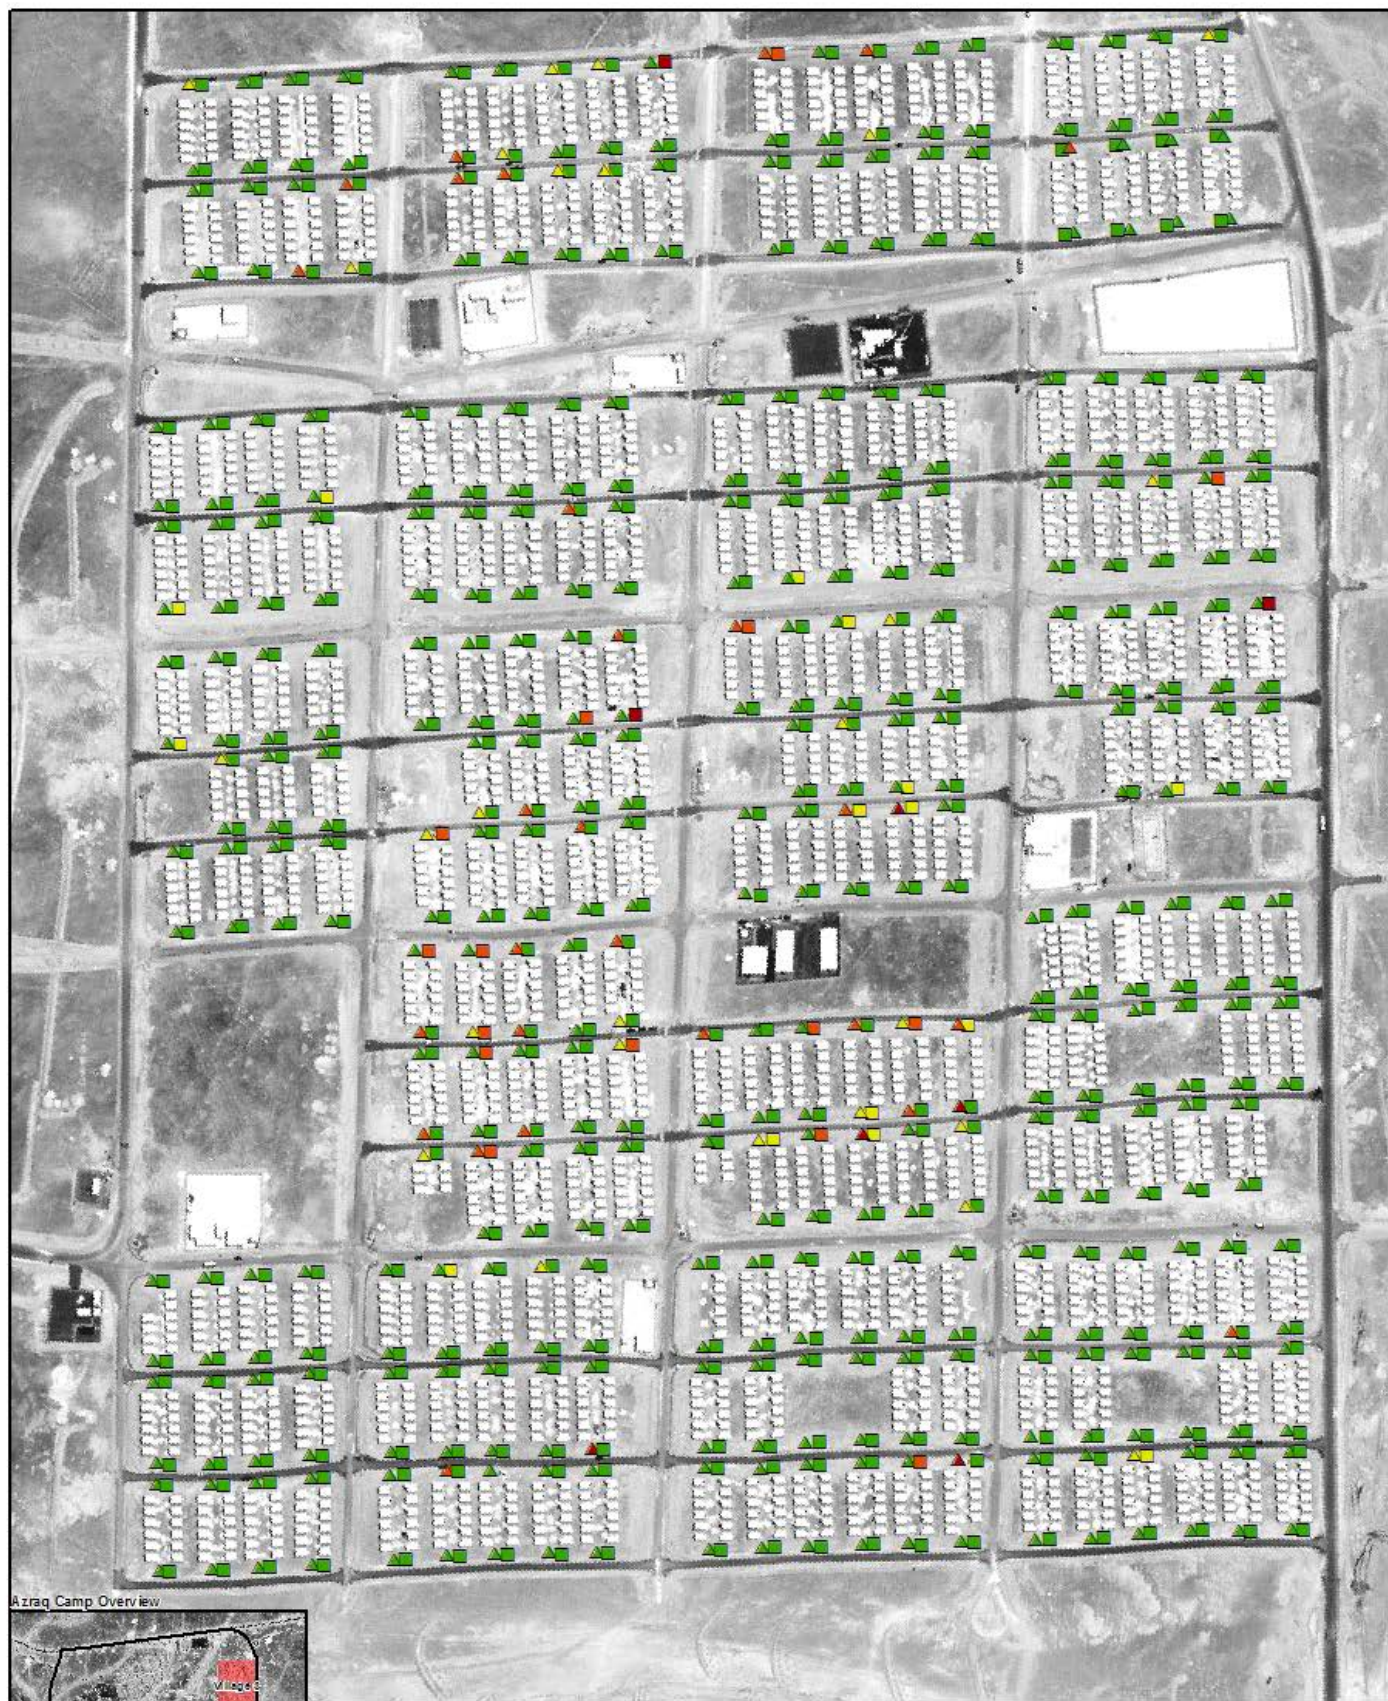
Map 5: Outside locks at the height of 1.2m from the ground or lower in Village 3

This Week	2 weeks ago
Door handles are at a child-friendly height (≤1.2m)	83 (9%)	88 (10%)
Outside locks on both doors are at a child-friendly height (≤1.2m)	824 (90%)	825 (90%)
Inside locks on both doors are at a child-friendly height (≤1.2m)	891 (97%)	861 (94%)
Both WASH centre doors are not privately locked	903 (99%)	890 (97%)
# of WASH centres dedicated to disabled persons	140 (15%)	138 (15%)
# of WASH centres with finished access ramp	139 (15%)	138 (15%)
Disabled toilet is still present in toilets for disabled persons	83 (59%) <span>-5%</span>	109 (79%)

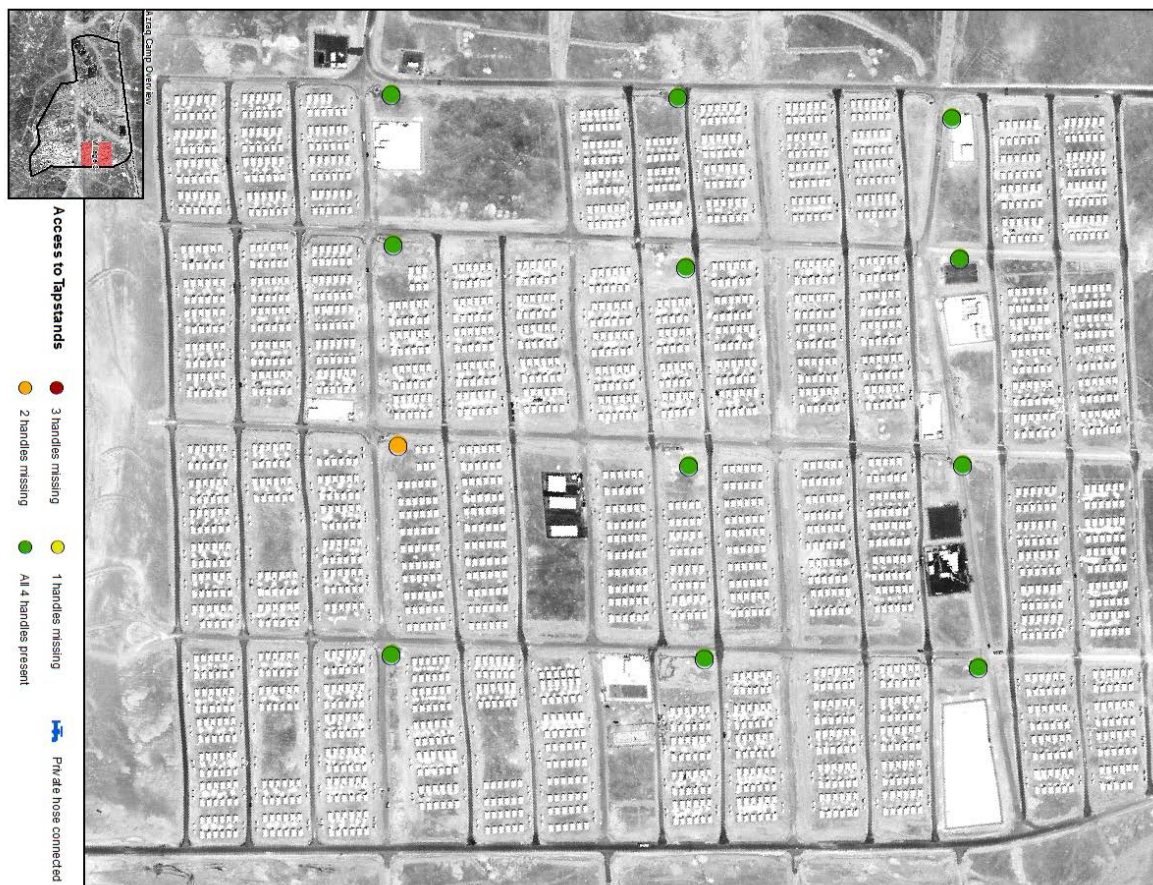
Map 7: Missing tapstand handles and private connections in Village 3

This Week	2 weeks ago
The tapstand provides water during its operational hours	12 (100%) <span>-10%</span>	10 (83%)
The tapstand has all 4 taps attached	12 (100%) <span>-10%</span>	10 (83%)
Tap handles are present on all remaining taps at the tapstand	11 (92%)	11 (92%)
All remaining taps on the tapstand provide water when turned on	12 (100%)	12 (100%)
All remaining taps at the tap stand are protected by tap guards	10 (83%)	11 (92%)
The concrete base of the tapstand is in decent shape*	12 (100%)	12 (100%)

This Week	2 weeks ago
There is no faeces on the ground within 10m of this tapstand	12 (100%) <span>-10%</span>	10 (83%)
# of private hoses connected to individual taps	0	1
Average # of people queuing at the tapstand	7.6	3
Flow calculation based on # of seconds it takes to fill a 1L bottle	0.21	0.26

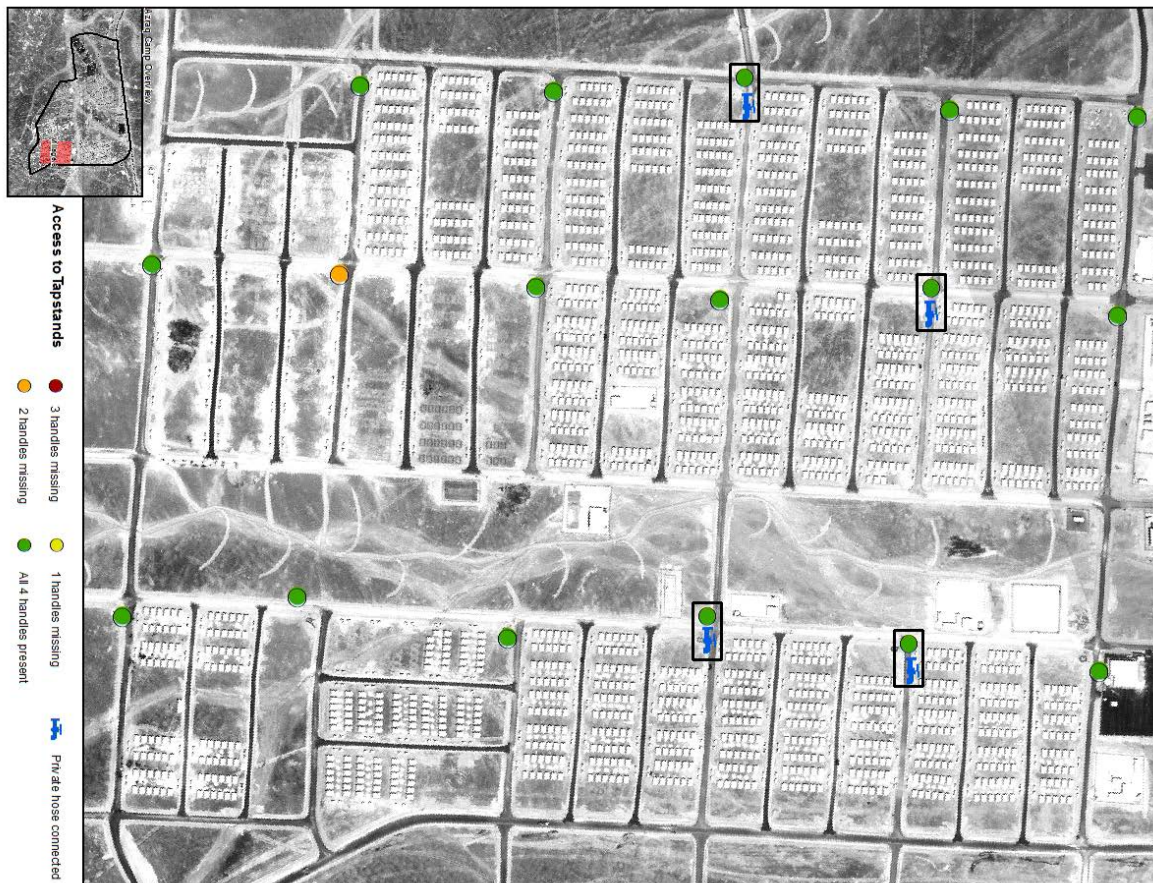
Map 8: Missing tapstand handles and private connections in Village 6

This Week	2 weeks ago
The tapstand provides water during its operational hours	18 (100%)	17 (94%)
The tapstand has all 4 taps attached	18 (100%)	18 (100%)
Tap handles are present on all remaining taps at the tapstand	16 (89%)	16 (89%)
All remaining taps on the tapstand provide water when turned on	15 (83%) <sup>&gt;-10%</sup>	18 (100%)
All remaining taps at the tap stand are protected by tap guards	18 (100%)	17 (94%)
The concrete base of the tapstand is in decent shape*	18 (100%)	18 (100%)

This Week	2 weeks ago
There is no faeces on the ground within 10m of this tapstand	15 (83%)	16 (89%)
# of private hoses connected to individual taps	4	2
Average # of people queuing at the tapstand	0.39	1.50
Flow calculation based on # of seconds it takes to fill a 1L bottle	0.22	0.19
