# Satellite-Detected Areas of Fire-Burn Scars and Building Destruction in Baga, Borno State, Nigeria (as on January 10, 2015)

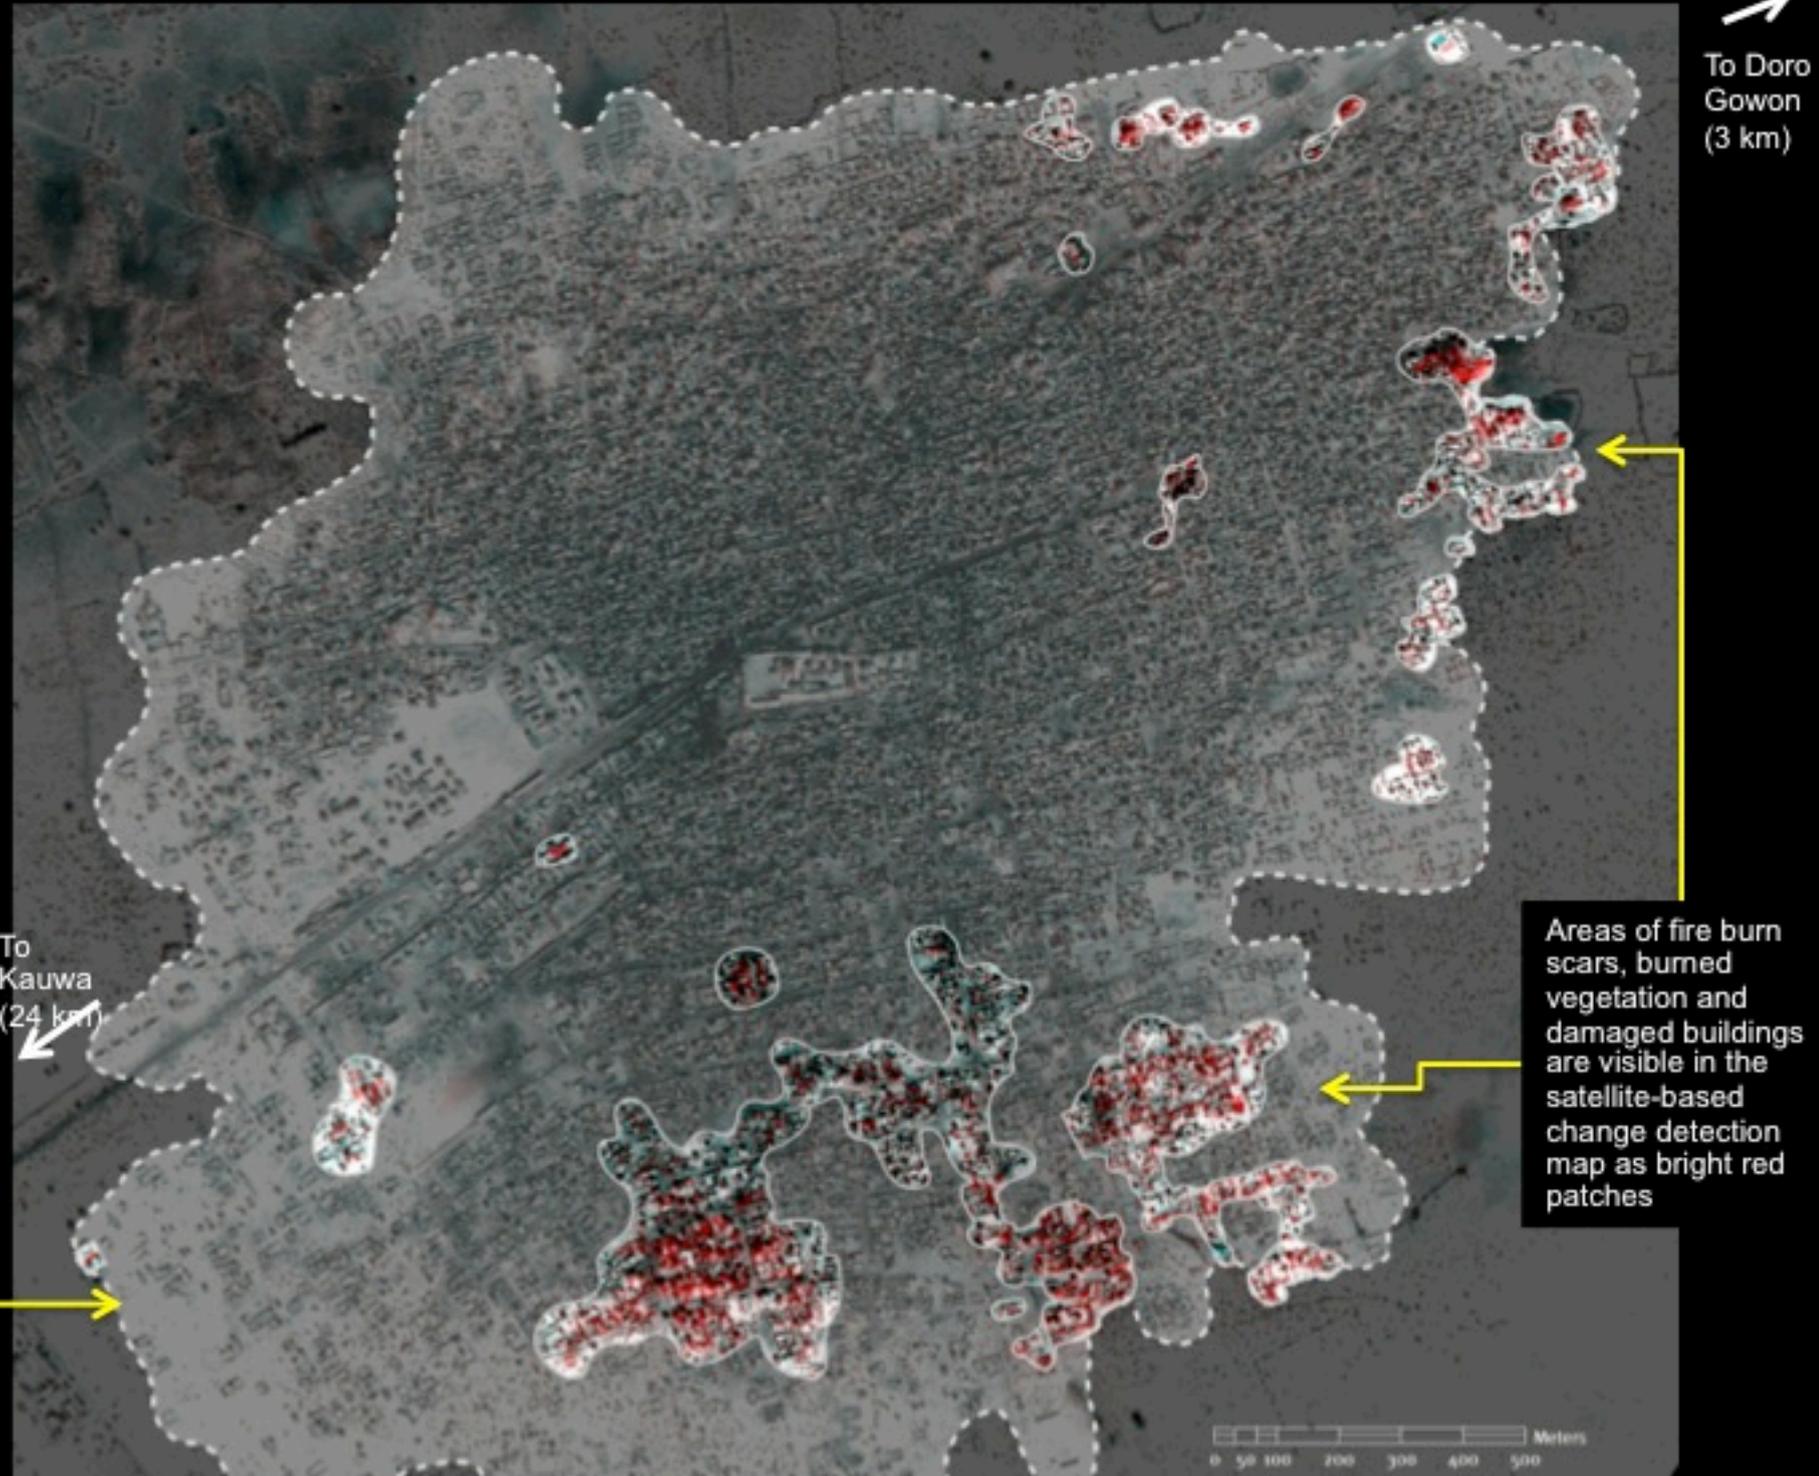
A change detection analysis of satellite imagery recorded on the mornings of December 29, 2014 and January 10, 2015 provides compelling evidence of substantial areas of fire burn scars and related building damages affecting approximately 11% of the town of Baga, Borno State. The scale and nature of these damages is fully consistent with a sustained and widespread campaign of arson, resulting in the probable destruction several hundred predominantly residential buildings, concentrated in the south and east of the town.

Areas of fire burn scars, burned vegetation and damaged buildings are visible in the satellite-based change detection map as bright red patches

The dashed grey line represents the approximate town extent
