Key Findings of Weekly WASH Assessment

Za'atari Refugee Camp, Jordan

09 – 01 – 2014

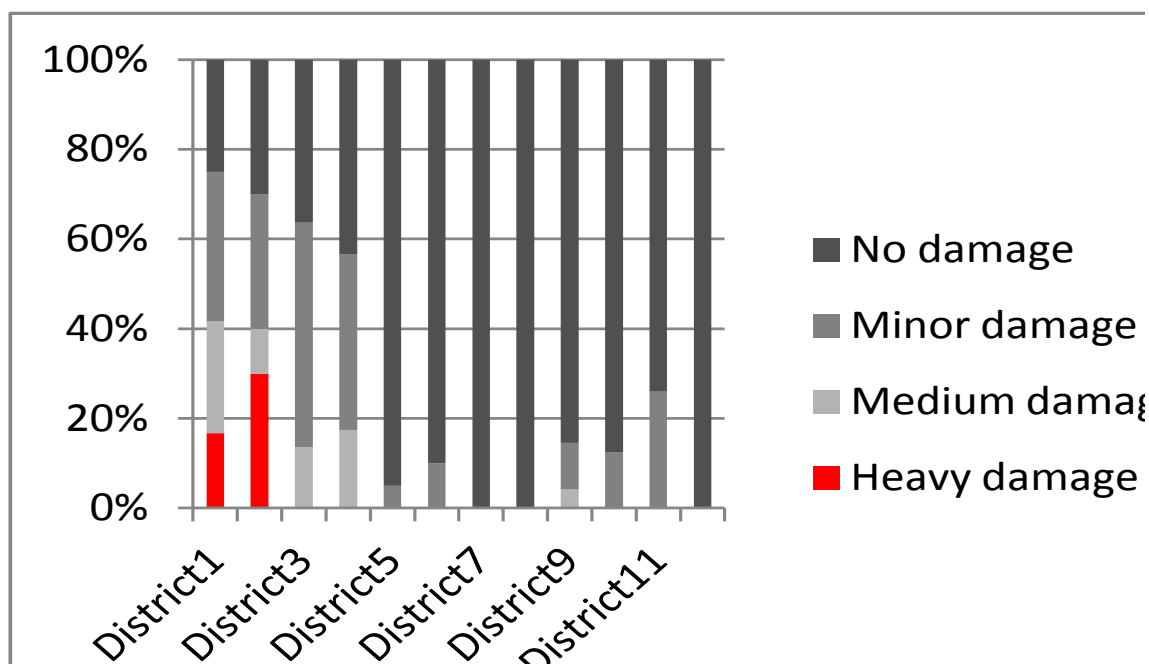
Figure 2: Structural damage to WASH centres by district

- Only two districts had WASH centres showing heavy damage, District 1 (17%) and District 2 (30%). These were the same two Districts that showed heavy damage during the last WASH centre monitoring, but the number has increased in District 2 by 10%, and decreased in District 1 by 5%.
- Districts 7, 8 and 12 showed no damage on any of their WASH centres, as during the previous monitoring, and District 5, which previously also did not show any damage to its WASH centres, had merely 1 centre which showed minor damage.
- The trend of inequality between levels of damage in Districts 1-4 (with an average of only 34% of WASH centres undamaged) and the rest of the camp (with an average of 91% of WASH centres undamaged) continues.

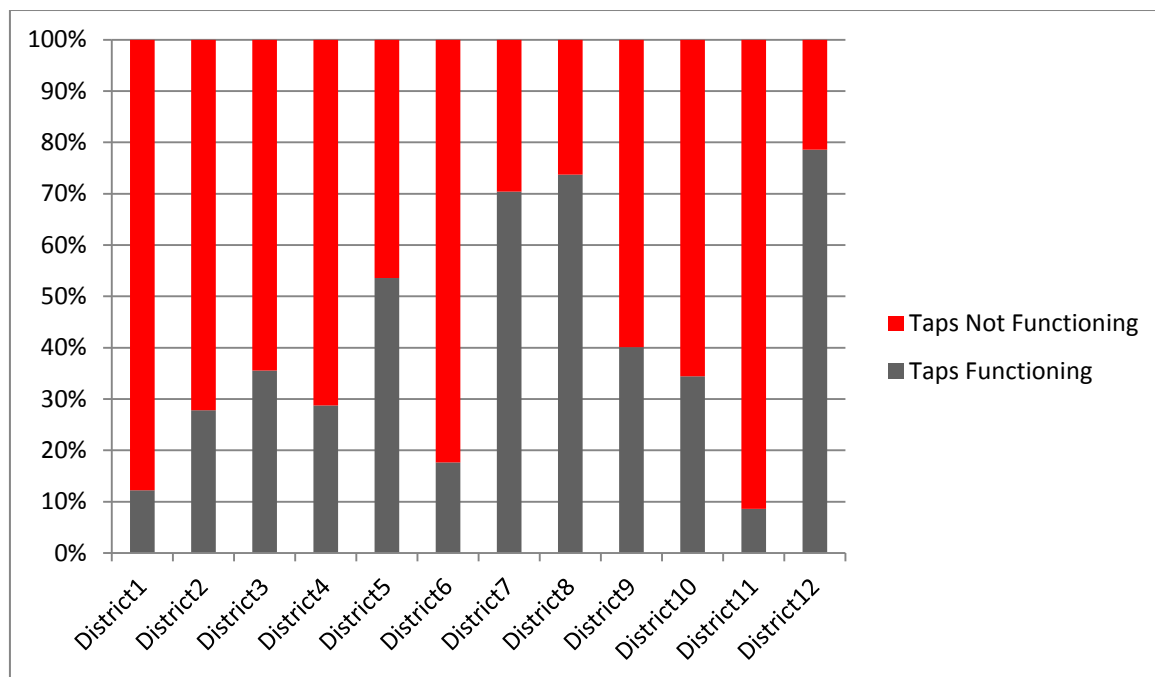
Figure 4: Percentage of Tap-stands that are functioning and not functioning by District

- In District 1, the number of functioning taps rose from only **5%** during the last WASH monitoring to **12%** (see above Figure 4).
- The percentage of working taps varies widely between Districts, ranging from only **8%** in District 11 (**7%** during previous monitoring) to **79%** in District 12 (**82%** during previous monitoring).

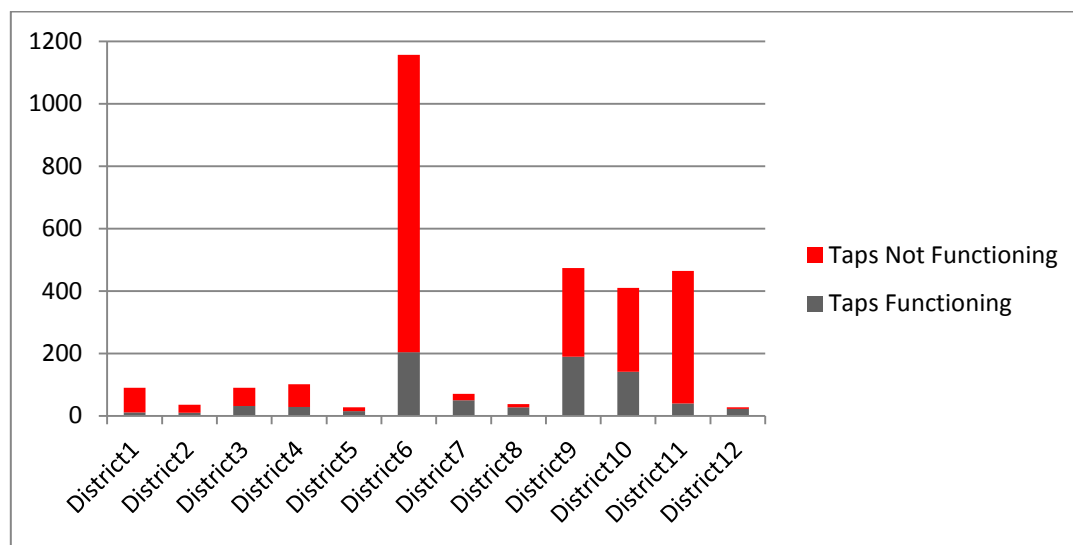
Figure 5: Number of Tap-stands **functioning** and **not functioning** by District

- Overall, the assessment found **62** fewer taps than during the previous assessment
- Inequality between Districts remained the same, with vastly different numbers of taps available in different areas, as shown by Figure 5 above

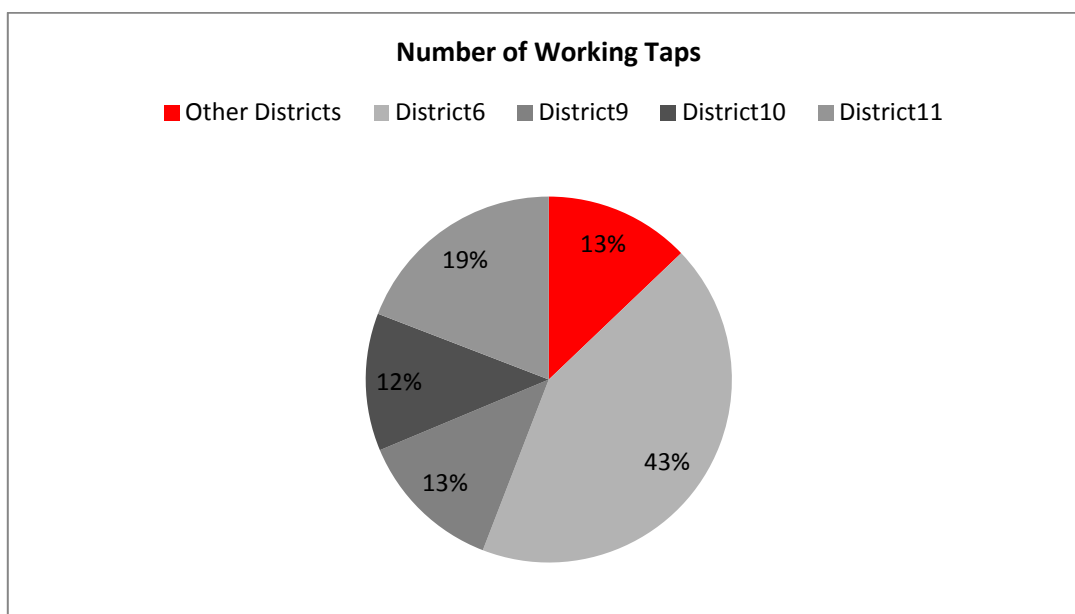
Figure 6: Total Numbers of Working Taps by District

- As can be seen in Figure 6 above, Districts 6, 9, 10 and 11 contain far more working taps than other Districts, making up between them **87%** of working taps in the camp.

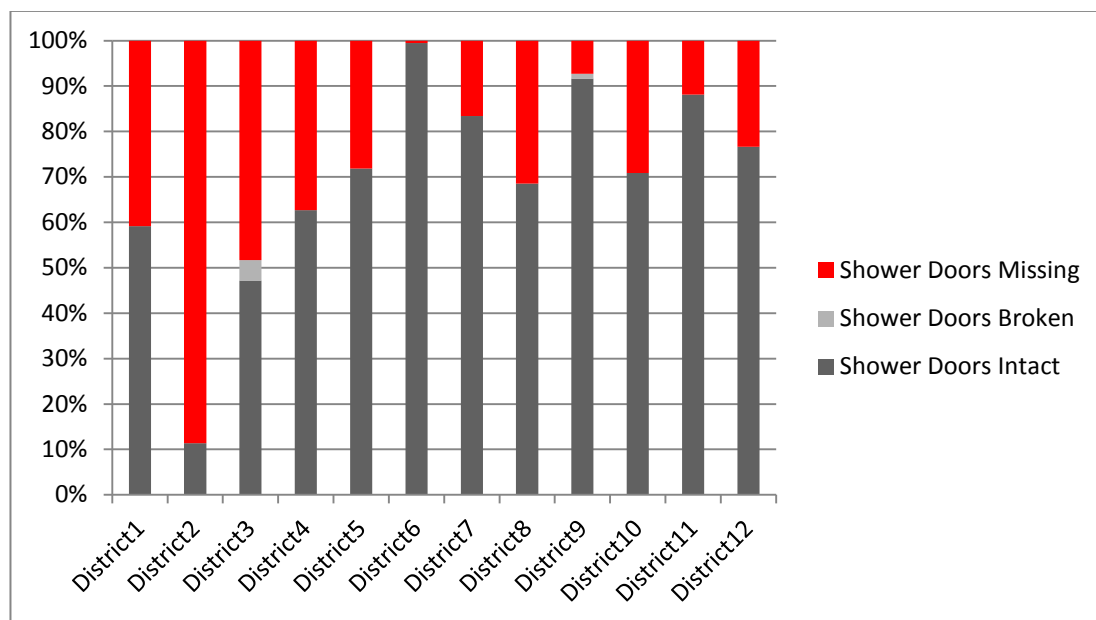
Figure 7: Percentage of Shower Doors Missing, Broken or Intact by District

- Across the camp, **30%** of shower doors were missing, as shown in Figure 7 above.
- This percentage ranged from a high of **89%** of doors in District 2 to a low of **0.5%** in District 6, demonstrating the differences between Districts.

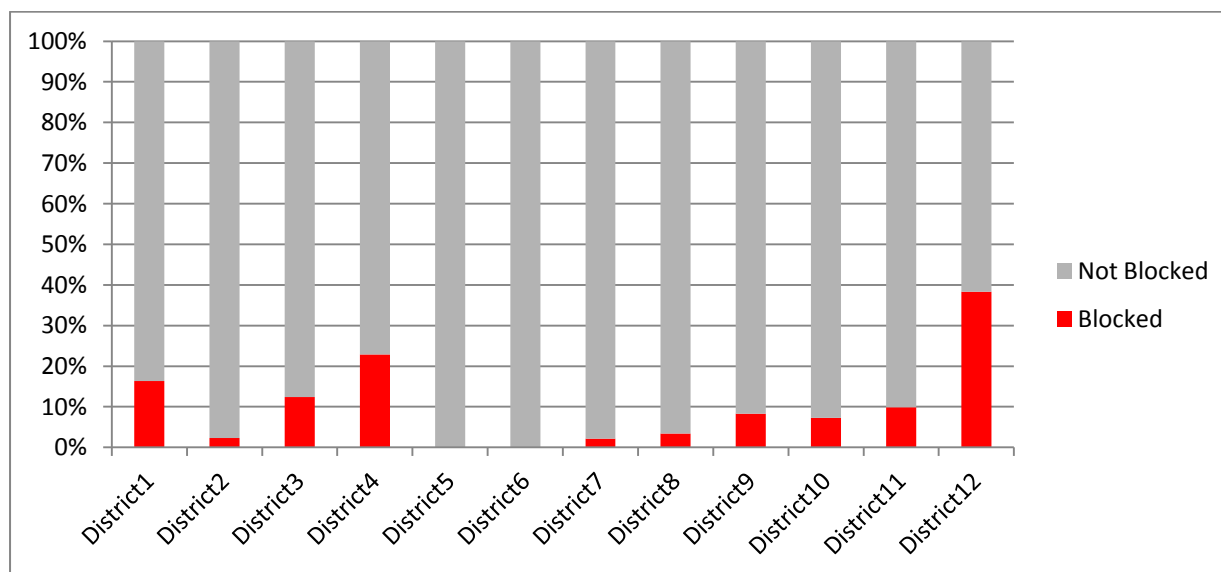
Figure 8: Percentage of Shower drains Blocked or Not Blocked by District

- Across the camp, **90%** of shower drains are not blocked, a decrease of **2%** from the previous monitoring exercise, as shown in Figure 8 above.

- Districts 5 and 6 had no drains blocked, whereas the Districts with the highest percentage of blocked drains were District 12 (38%) and District 4 (23%).

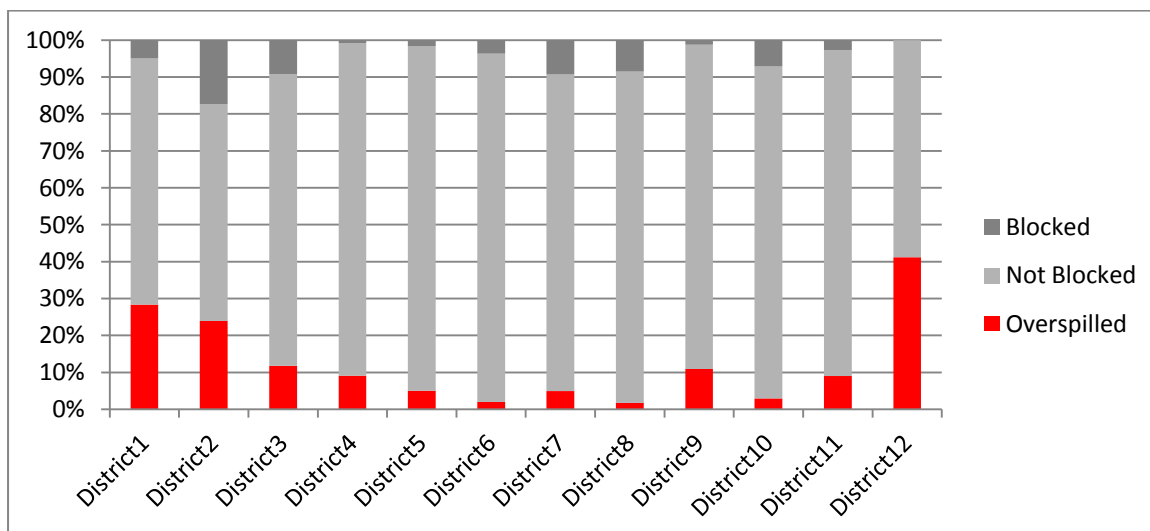
Figure 10: Percentage of blocked, over-spilling and working toilets by District

- The majority of toilets in all Districts were in a good condition (82% of toilets across the camp), ranging from 59% of toilets in Districts 2 and 12 to 94% in District 6, as shown in Figure 10 above.
- Over-spillage is greatest in District 12 (41%), whereas blockages were most common in District 2 (17%).
