FACTSHEET

WEEKLY WASH CENTRE MONITORING

AL ZA'ATARI REFUGEE CAMP, JORDAN

22 – 28 JUNE 2014

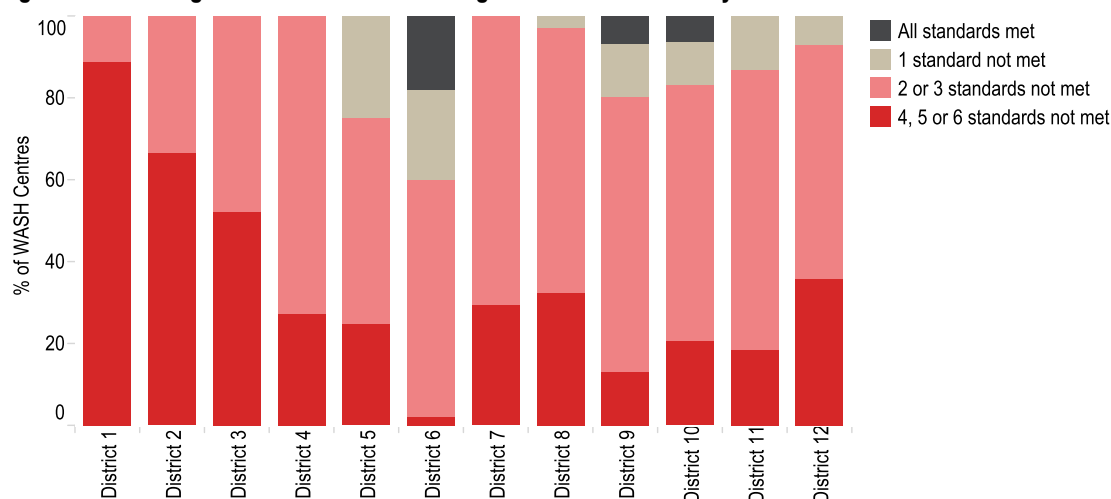
Figure 1: Percentage of WASH centres meeting minimum standards by district

- The majority of the centres meeting the minimum standards were in District 6. Districts 9 and 10 each had three centres meeting the minimum standards, while the remaining 9 districts did not have any centres meeting the minimum standards (see Figure 1 below and annexed Map 1).

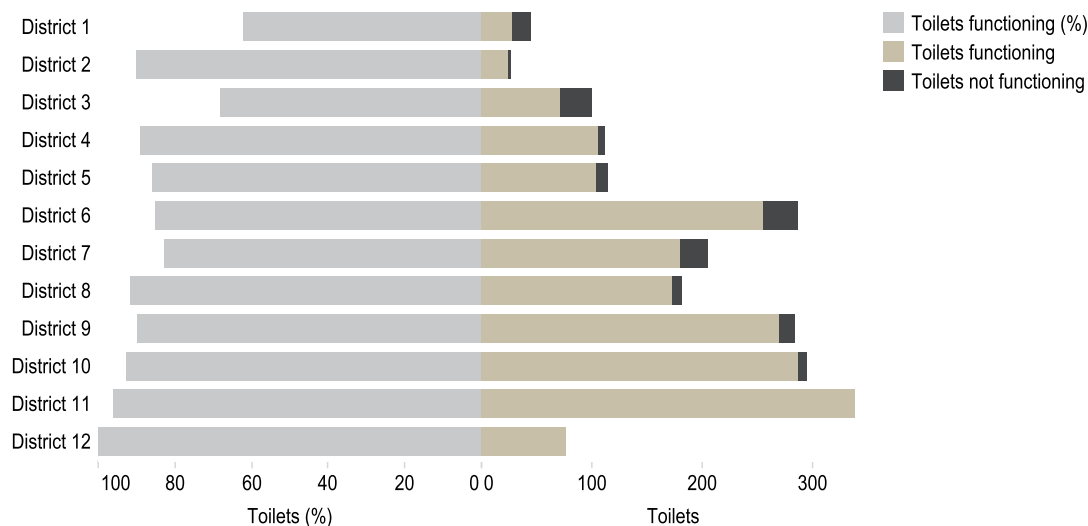
Figure 2: Functioning toilets per district

- **88% (1,814) of WASH centre toilets were functional**, a 4% increase from the previous week.
- The proportion of functional toilets ranged from 62% in District 1 to over 95% in districts 11 and 12 (see Figure 2 below).
- There was **one functioning toilet per 47 people**,² meeting the minimum standard which states that in communal facilities latrines should be available at a rate of one functional toilet per 50 people.
- Key changes this week included an increase in the proportion of functional toilets in districts 2, 5 and 12, with a decrease in District 3.

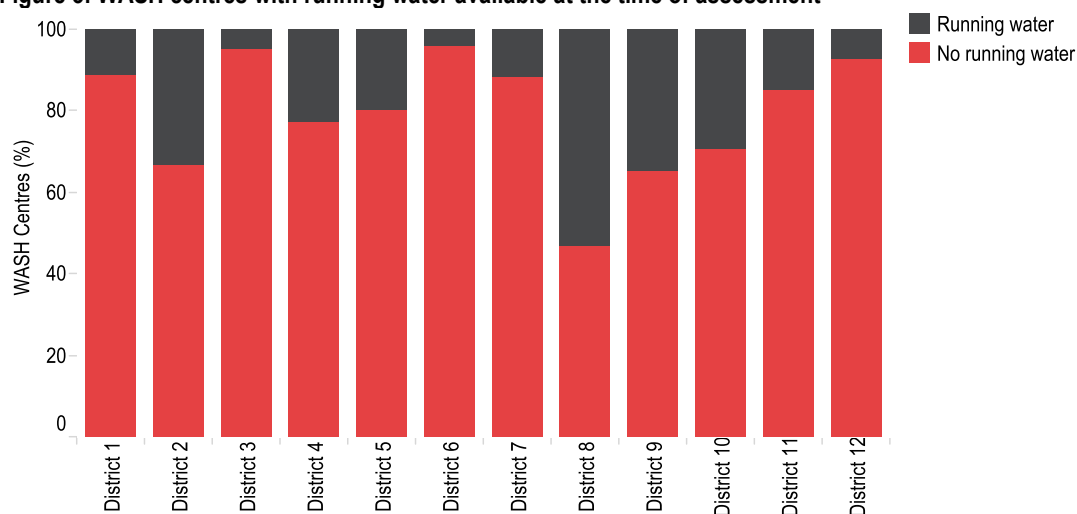
Figure 3: WASH centres with running water available at the time of assessment

- **79% of WASH centres did not have running water available at the time of assessment**, a 3% decrease from the previous week.
- Only one district had running water available in more than 35% of its WASH centres (see Figure 3 below and annexed Map 4).
- The lack of running water could indicate issues with water delivery, and could also be due to people immediately draining public water tanks in order to store water at household level. Not having running water available at WASH centres is likely to impact the ability of refugees to maintain personal hygiene (including hand-washing practices). It may also have an impact on the cleanliness of centres, by making it more difficult for committees to clean facilities and for individuals to flush toilets after use.

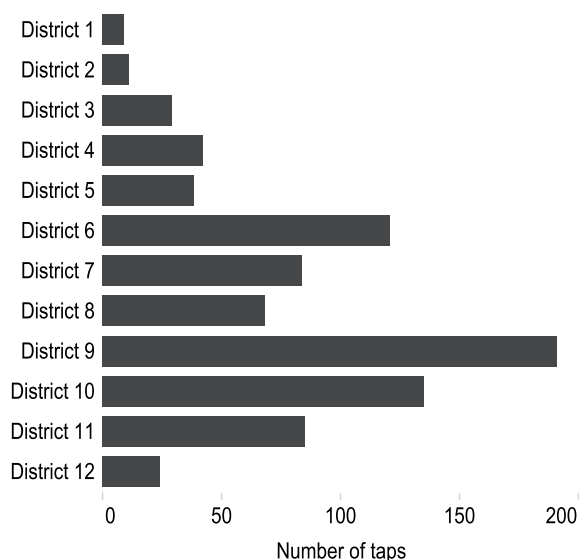
Figure 4: Total number of WASH centre taps by district

- **WASH centres had an average of 2 taps each. 86 WASH centres (24%) had no taps at all**, which was nonetheless a 7% improvement from the previous week.
- The distribution of taps was uneven, with districts 9, 10 and 6 accounting for 53% of all WASH centre taps (see Figure 4 below). This was a similar pattern to the previous week.

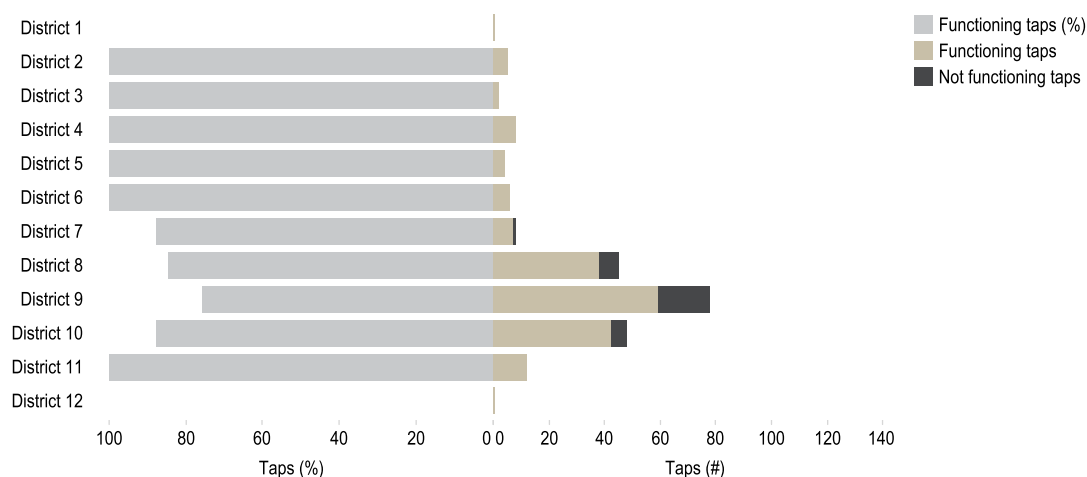
Figure 5: Functioning taps in WASH centres with running water

- The distribution of functioning taps was uneven: District 9 had 59 functioning WASH centre taps, while eight districts had less than 10 functioning WASH centre taps, including two districts with no functioning WASH centre taps (see Figure 5 below). This pattern is similar to the previous week.

- Where taps existed and running water was available to test them, the majority were found to be working: **85% of taps in centres with running water available were functioning**, a 9% decrease from the previous week. In 5 districts, 100% of taps in WASH centres with running water available were functional (see Figure 5 below).

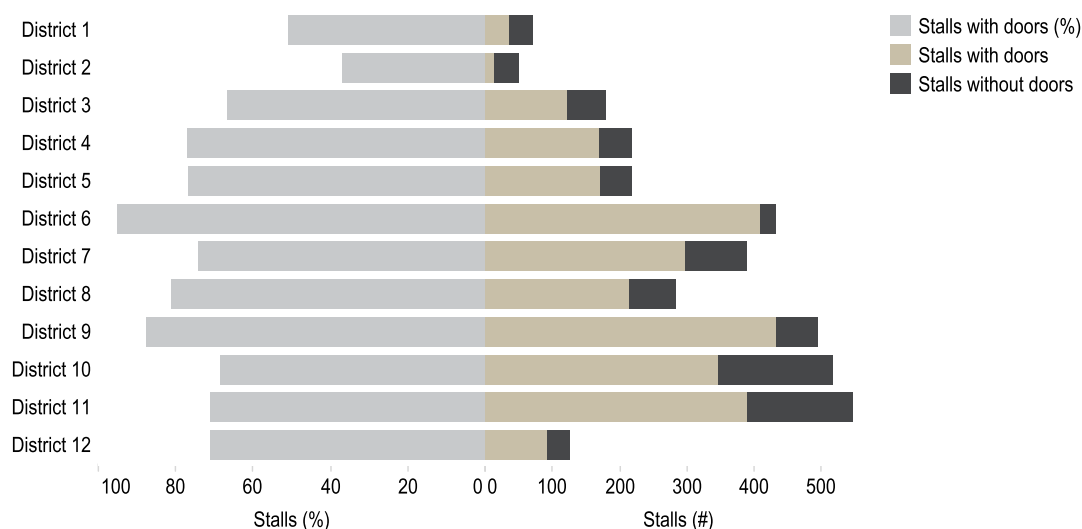
Figure 6: Toilet and shower stalls with doors

- **55% of WASH centres failed to meet the minimum standard of having doors for all toilet and shower stalls**, a similar proportion to the previous week.
- There was significant variation between the districts, from 37% of stalls having doors in District 2 to 95% in District 6 (see Figure 6 below). The overall pattern is very similar to the previous week.
- 36% of centres not meeting the standard were female WASH centres, the same proportion as the previous week.

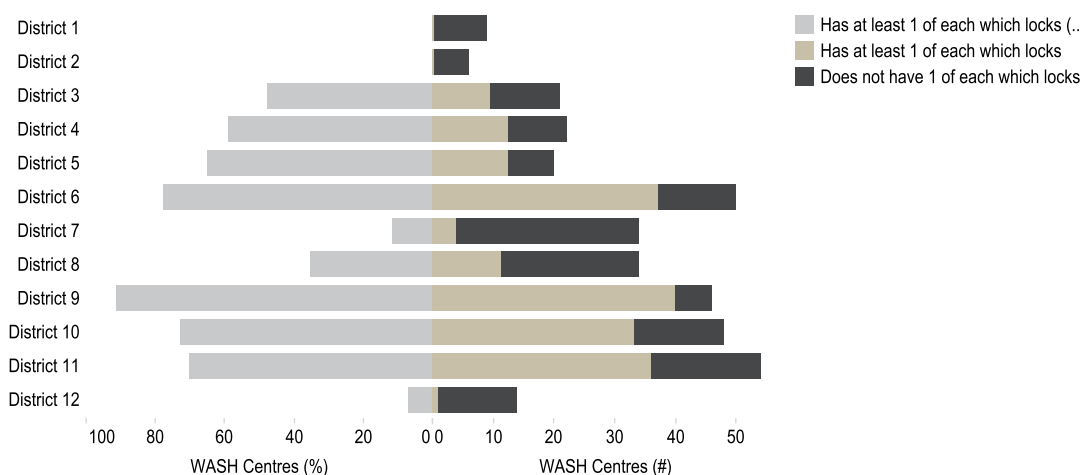
Figure 7: WASH centres with at least one shower and one toilet cubicle with a functioning internal lock

- **58% of WASH centres met the minimum standard of having at least one shower and one toilet cubicle with a functioning internal lock**, a similar proportion to the previous week. This figure varied from 0% in districts 1 and 2 to 91% in District 9 (see Figure 7 below).
- 44% of centres not meeting the standard were female WASH centres, up from 37% the previous week.
- 57% of toilet stalls and 43% of shower stalls had lockable doors, very similar to the previous week.

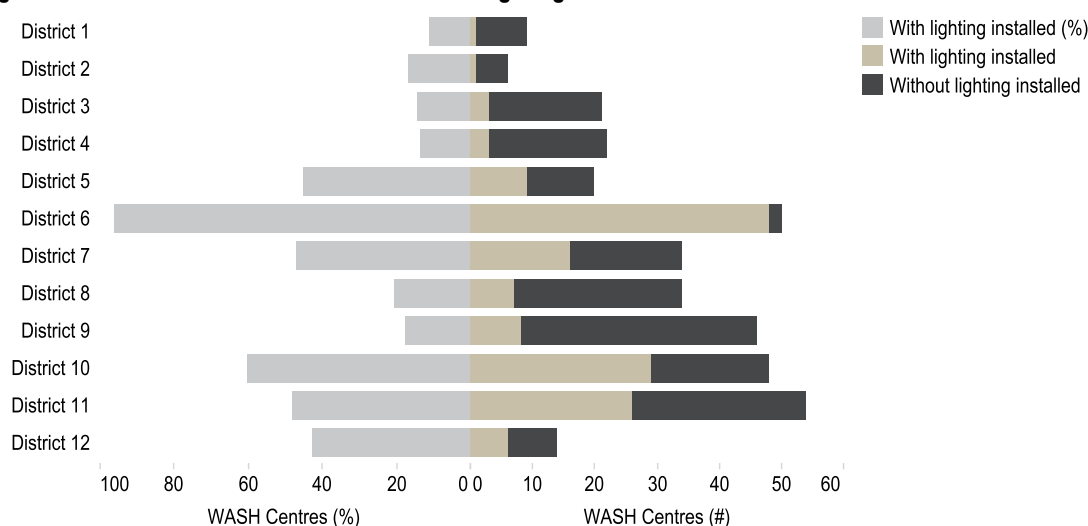
Figure 8: WASH centres with internal or external lighting installed

- **44% of WASH centres had internal or external lighting installed**,⁸ a similar proportion to the previous week.
- The proportion of centres with lighting installed ranged from 11% in District 1 to 96% in District 6 (see Figure 8 below and annexed Map 6).
- Of the 201 WASH centres that had no internal or external lighting, 33% were female centres, a similar proportion to the previous week.
- Key changes this week included a decrease in the proportion of centres with lighting installed in districts 2 and 12.

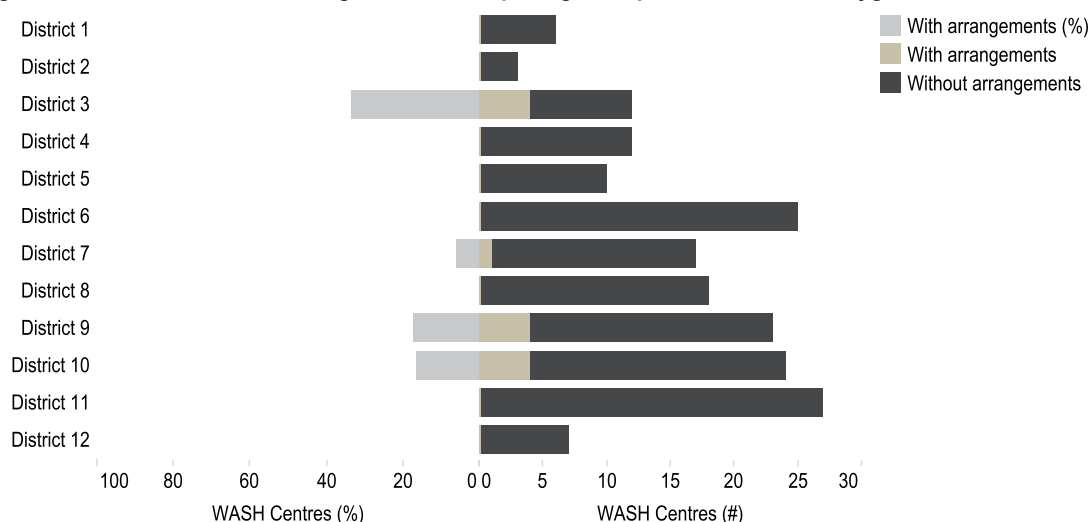
Figure 9: WASH centres with arrangements for disposing of diapers and menstrual hygiene materials

- 174 female WASH centres (93%) failed to meet the minimum standard of having an arrangement for disposing of diapers and menstrual hygiene materials, which was 18% more than the previous week.⁹
- Disposal arrangements were only available in districts 3, 7, 9 and 10 (see Figure 9 below).
- The most dramatic change was in District 6, which went from over 90% of female centres having disposal arrangements the previous week to zero this week. Districts 2, 4 and 12 also saw a decrease in the proportion of female centres with disposal arrangements, while districts 7 and 9 saw an increase from the previous week.

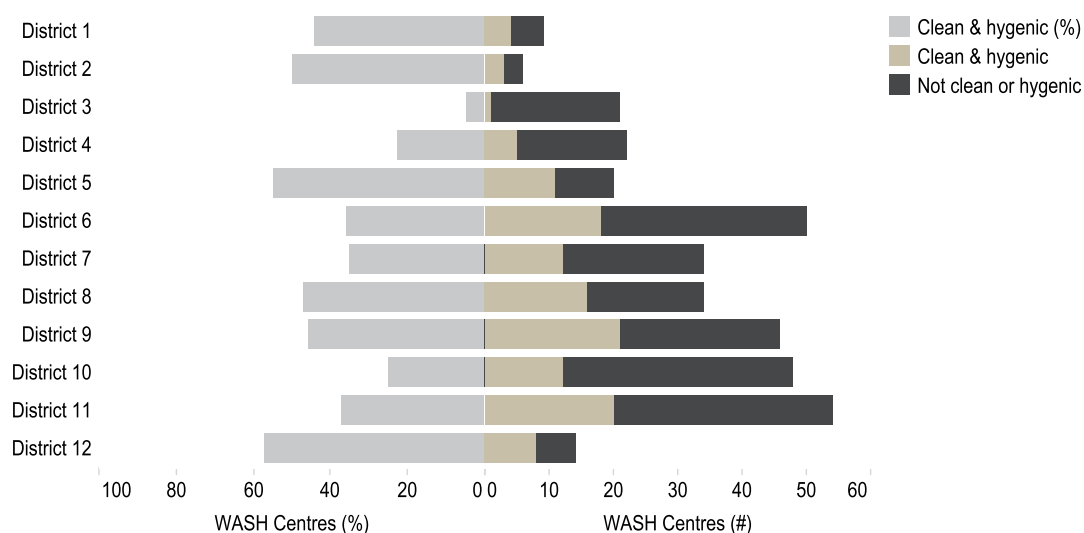
Figure 10: Clean and hygienic WASH centres

- **37% of WASH centres were considered clean and hygienic,**¹⁰ a similar proportion to the previous week.
- District 12 had the highest proportion of clean and hygienic centres, while District 3 had the lowest (see Figure 10 below).
- Districts 5, 7, 9 and 12 saw an increase in the proportion of clean and hygienic centres compared to the previous week, while districts 3 and 8 saw a decrease.

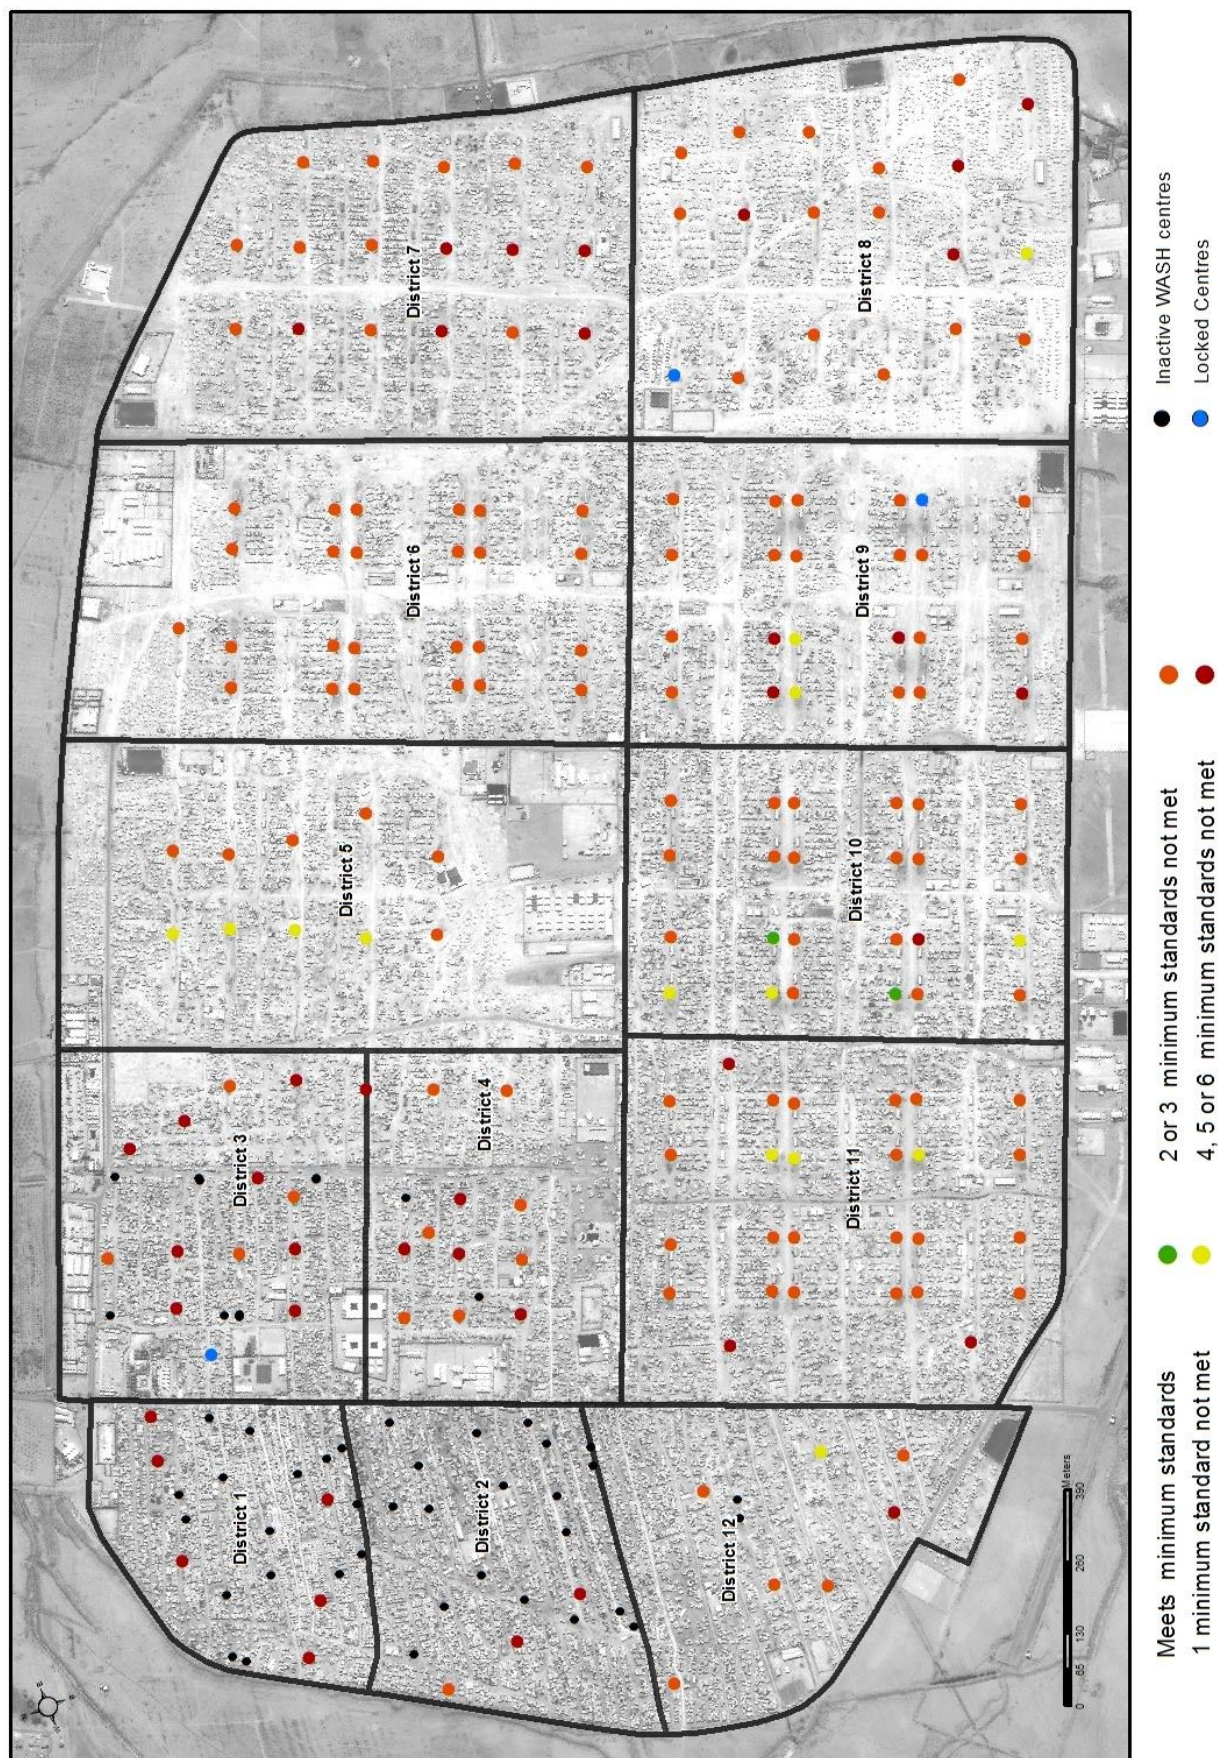
Map 2: Female WASH centres meeting minimum standards

- 90% of female and 78% of male centres failed to meet 2 or more minimum standards (see annexed Maps 2 and 3). Compared to the previous week, this represented a significant deterioration in female WASH centres and a slight improvement for male centres.
