Key Findings of Weekly WASH Assessment

Za'atari Refugee Camp, Jordan

23 – 01 – 2014

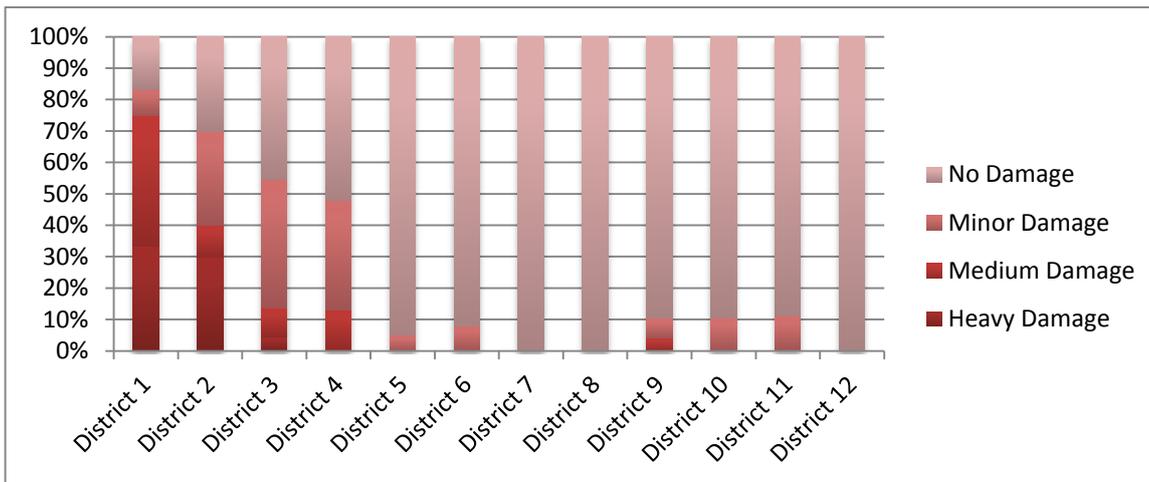
Figure 2: Structural damage to WASH centres by district

- Only three districts had WASH centres showing heavy damage, District 1 (30%), District 2 (33%) and District 3 (5%). These old camp WASH centres show an ongoing tendency to be the worst damaged within the camp.
- Districts 7, 8 and 12 showed no damage on any of their WASH centres, as in previous weeks.

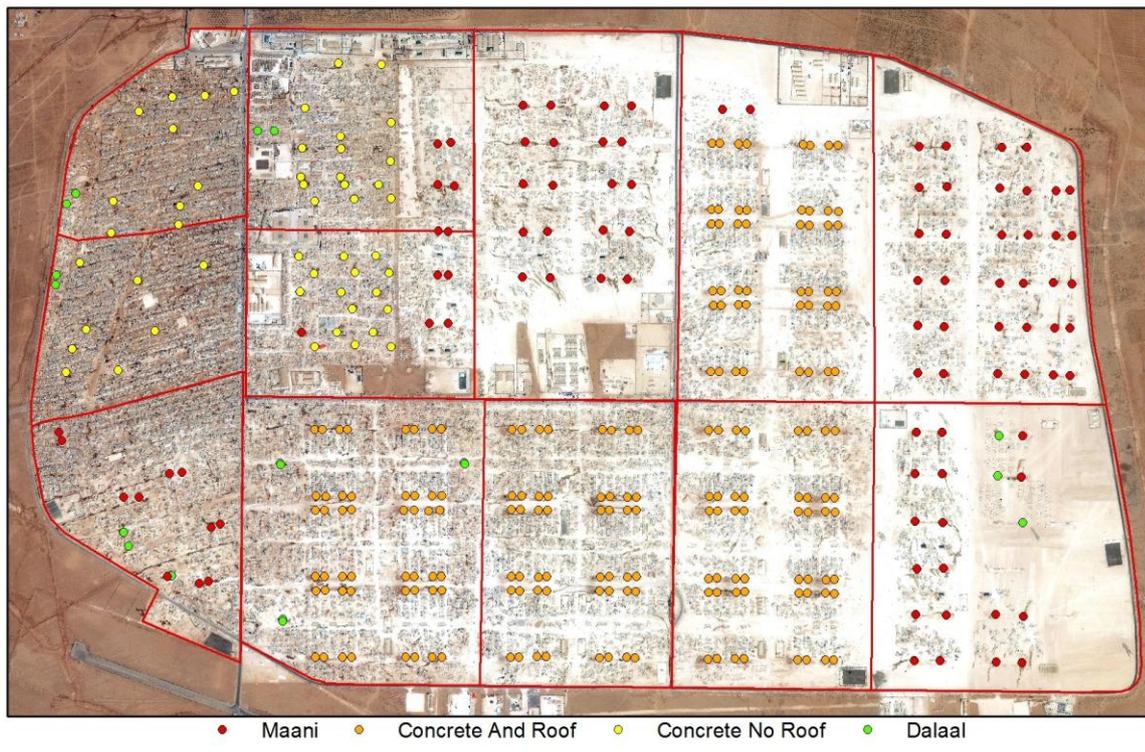
Figure 3 Type of WASH centre

- Pre-fabricated WASH centres remain far less prone to damage, with 98% of pre-fabricated WASH centres showing no damage, as opposed to only 76% of concrete ones, as shown in Table 1 above.

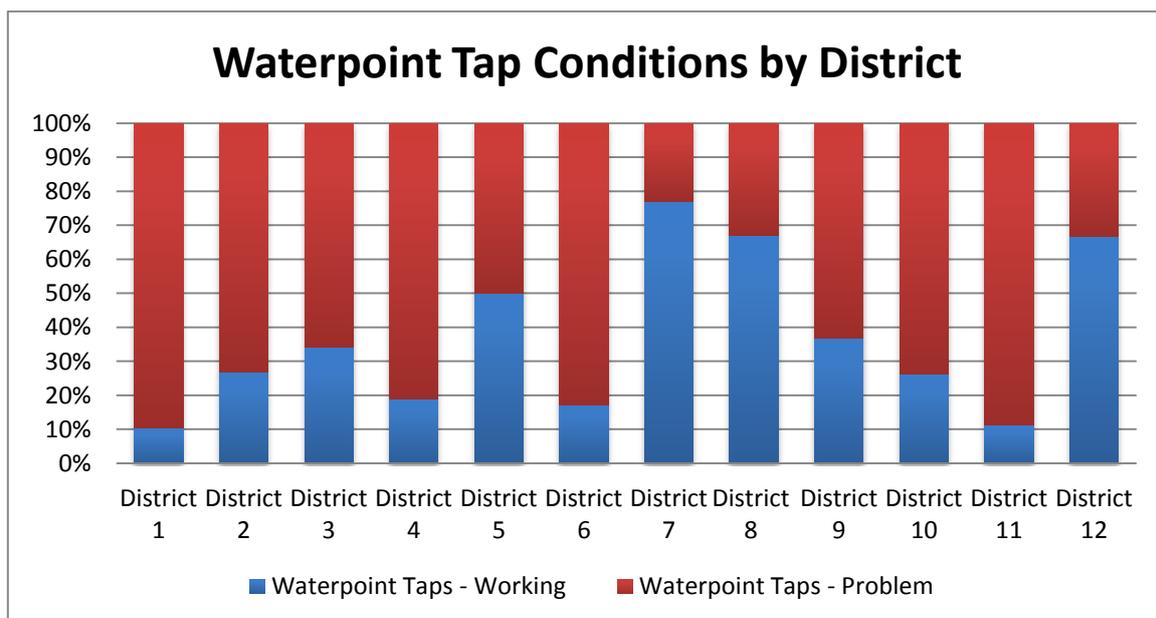
Figure 4: Percentage of Tap-stands that are functioning and not functioning by District

- In District 1, the number of functioning taps has dropped from earlier in the month, to only 10% of total taps available

- The percentage of working taps varies widely between Districts, ranging from only **10%** in District 1 to **78%** in District 7.

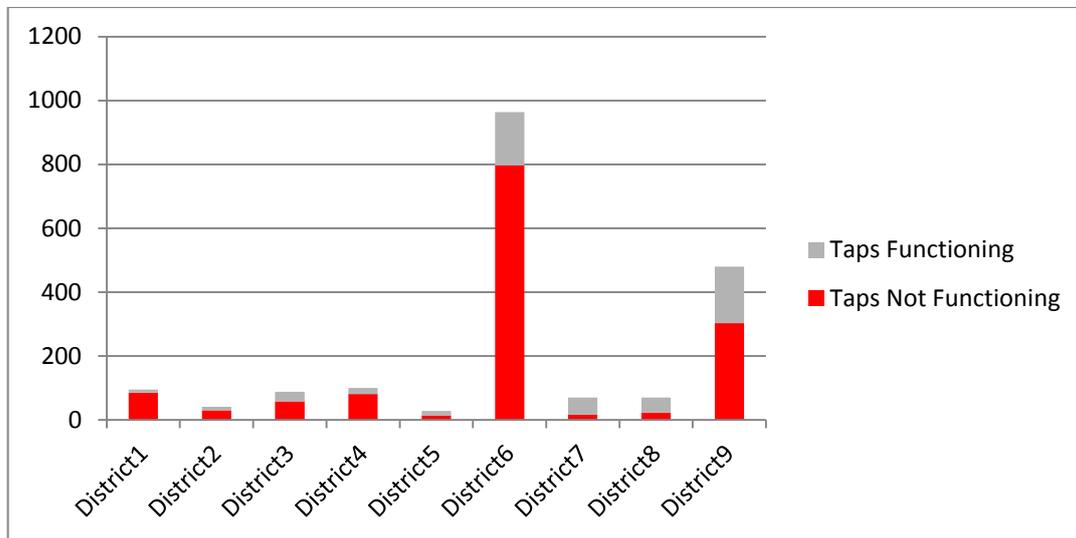
Figure 5: Number of Tap-stands **functioning and not functioning** by District

- The majority of taps in the camp (**75%**) were not functioning.
- Inequality between Districts remained the same, with vastly different numbers of taps available in different areas, as shown by Figure 3 above. District 6 remains the District with the largest number of taps by far.

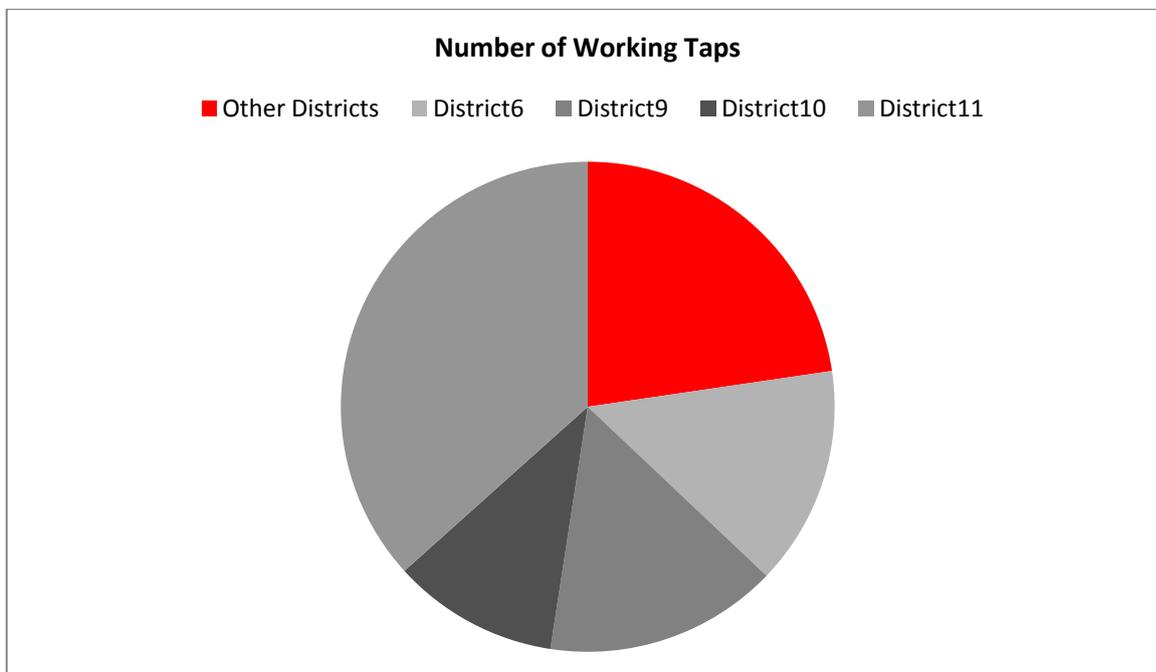
Figure 6: Total Numbers of Working Taps by District

- As can be seen in Figure 4 above, Districts 6, 9, 10 and 11 contain far more working taps than other Districts, making up between them **87%** of working taps in the camp.

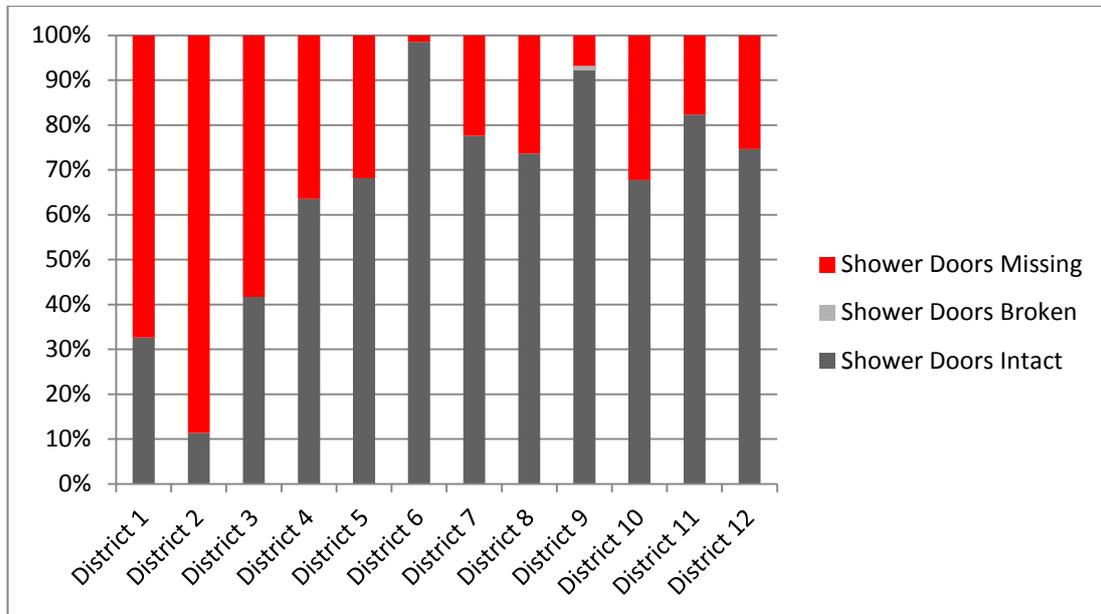
Figure 7: Percentage of Shower Doors Missing, Broken or Intact by District

- Across the camp, **35%** of shower doors were missing, as shown in Figure 5 above, an increase of five percent within the past two weeks.
- This percentage ranged from a high of **89%** of doors in District 2 to a low of **1.5%** in District 6, which are consistently the two outliers of this variable.

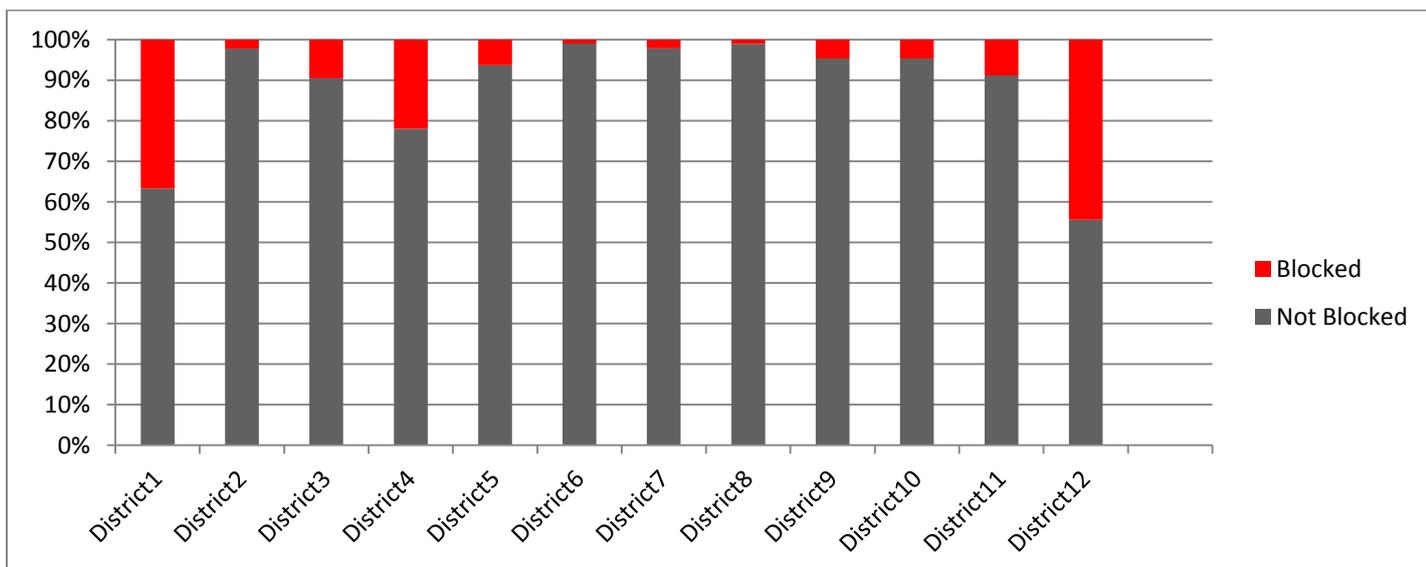
Figure 9 Percentage of Shower drains Blocked or Not Blocked by District

- Across the camp, **88%** of shower drains are not blocked, a figure which has been decreasing over the past weeks, as shown in Figure 6 above.
- Unlike in previous weeks, all Districts had some drains that were blocked, rising from a low of only 1% in District 11 to a high of 88% in District 3.

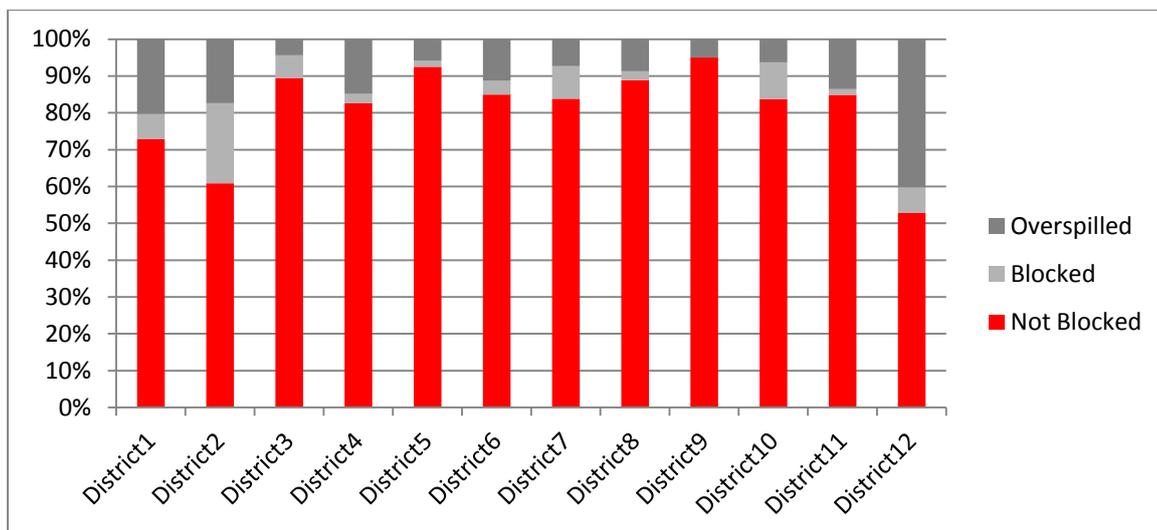
Figure 11 Percentage of blocked, over-spilling and working toilets by District

- The majority of toilets in all Districts were in a good condition (85% of toilets across the camp), ranging from 53% of toilets in Districts 12 to 95% in District 9.
