FACTSHEET

FORTNIGHTLY WASH CENTRE MONITORING

AL ZA'ATARI REFUGEE CAMP, JORDAN

29 JUNE – 10 JULY 2014

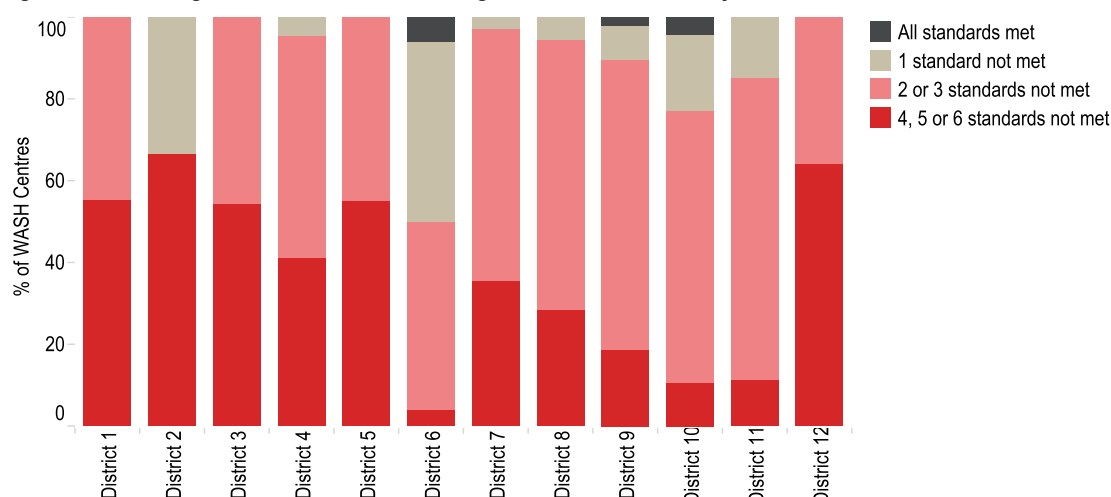
Figure 1: Percentage of WASH centres meeting minimum standards by district

- Centres meeting the minimum standards were found in districts 6 (3 centres), 9 (1 centre) and 10 (2 centres). The other 9 districts did not have any centres meeting the minimum standards (see Figure 1 below and annexed Map 1).

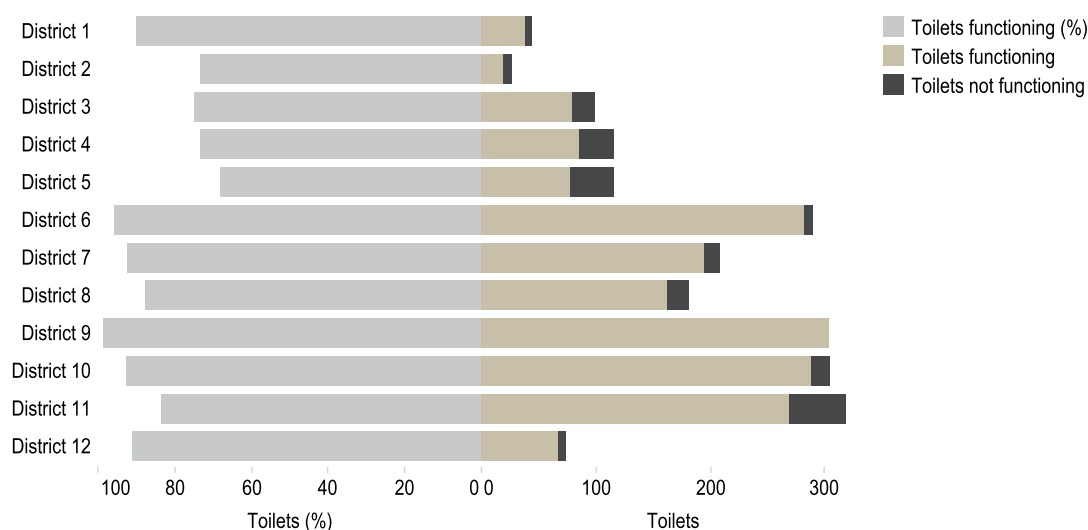
Figure 2: Functioning toilets per district

- **88% (1,837) of WASH centre toilets were functional**, the same proportion as the previous fortnight.
- The proportion of functional toilets ranged from 68% in District 5 to 99% in District 9 (see Figure 2 below).
- There was **one functioning toilet per 47 people**,² meeting the minimum standard which states that in communal facilities latrines should be available at a rate of one functional toilet per 50 people.
- Key changes this fortnight included an increase in the proportion of functional toilets in districts 1, 6 and 9, with a decrease in districts 2, 4, 5, 11 and 12.

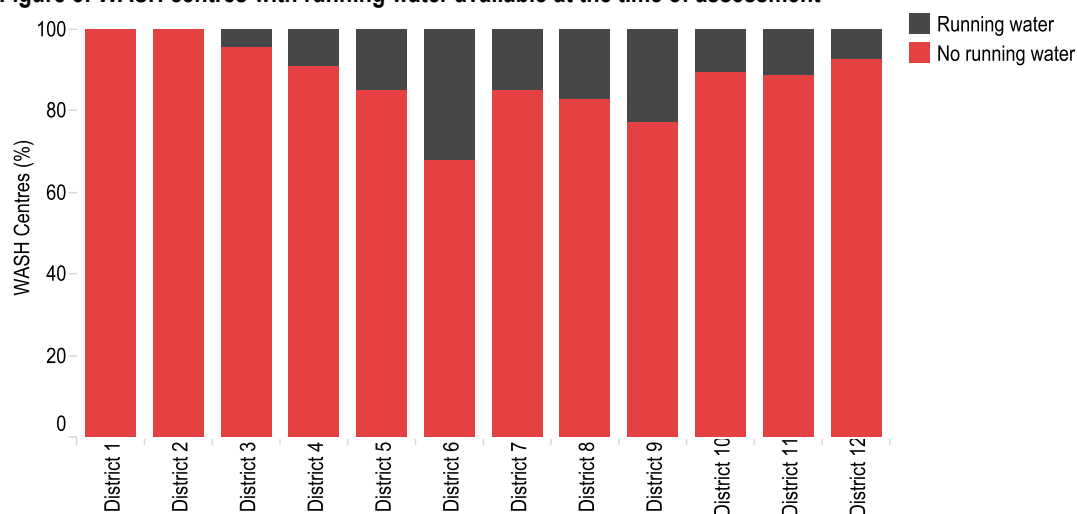
Figure 3: WASH centres with running water available at the time of assessment

- **85% of centres did not have running water available at the time of assessment**, a 6% increase from the previous fortnight.
- Only one district had running water available in more than 23% of its WASH centres, and districts 1 and 2 did not have any centres with running water at the time of assessment (see Figure 3 below and annexed Map 4).
- The lack of running water could indicate issues with water delivery, and could also be due to people immediately draining public water tanks in order to store water at household level. Not having running water available at WASH centres is likely to impact the ability of refugees to maintain personal hygiene (including hand-washing practices). It may also have an impact on the cleanliness of centres, by making it more difficult for committees to clean facilities and for individuals to flush toilets after use.

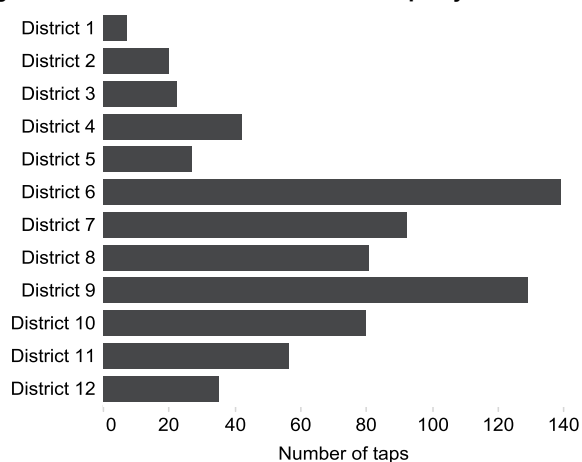
Figure 4: Total number of WASH centre taps by district

- **WASH centres had an average of 2 taps each.³ 112 WASH centres (31%) had no taps at all**, which was 26 centres more than the previous fortnight.
- **The distribution of taps was extremely uneven, with only 7 taps in total in District 1, and three districts accounting for 49% of all WASH centre taps** (see Figure 4 below). This was a similar pattern to the previous fortnight.

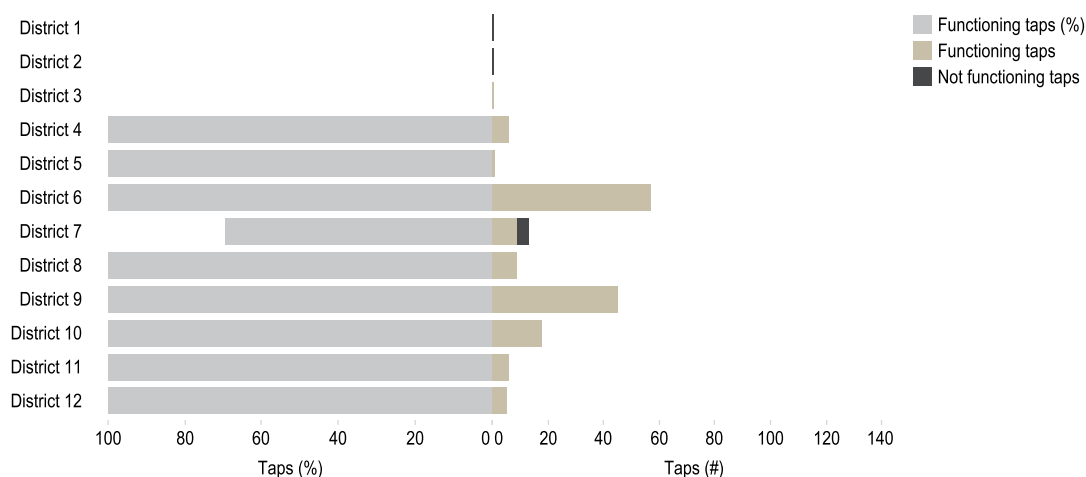
Figure 5: Functioning taps in WASH centres with running water

- The distribution of functioning taps was uneven: District 6 had 57 functioning WASH centre taps, while nine districts had less than 10 functioning WASH centre taps, including three districts with no functioning WASH centre taps (see Figure 5 below).

- Where taps existed and running water was available to test them, the vast majority were found to be working: **98% of taps in centres with running water available were functioning**, a 13% increase from the previous fortnight. In 8 districts, 100% of taps in WASH centres with running water available were functional (see Figure 5 below).

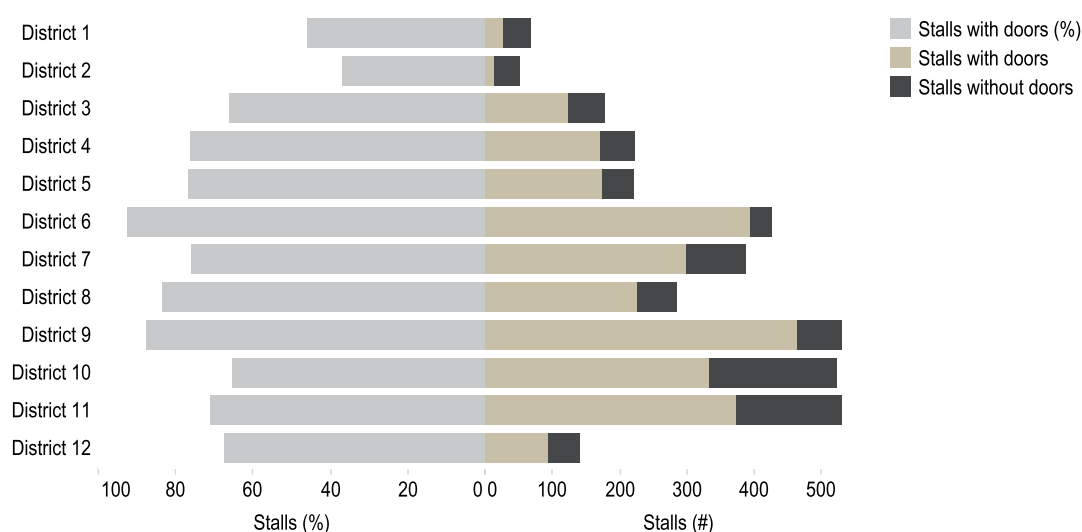
Figure 6: Toilet and shower stalls with doors

- **57% of WASH centres failed to meet the minimum standard of having doors for all toilet and shower stalls,** a similar proportion to the previous fortnight.
- There was significant variation between the districts, from 37% of stalls having doors in District 2 to 93% in District 6 (see Figure 6 below). The overall pattern is very similar to the previous fortnight.
- 39% of centres not meeting the standard were female WASH centres, a slight increase (3%) from the previous fortnight.

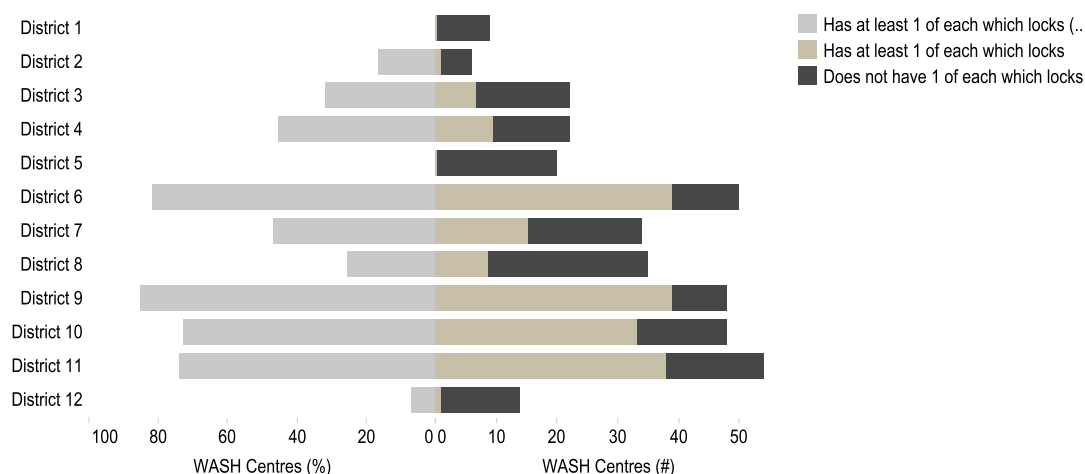
Figure 7: WASH centres with at least one shower and one toilet cubicle with a functioning internal lock

- **56% of WASH centres met the minimum standard of having at least one shower and one toilet cubicle with a functioning internal lock,** a similar proportion to the previous fortnight. This figure varied from 0% in districts 1 and 5 to 85% in District 9 (see Figure 7 below).
- 44% of centres not meeting the standard were female WASH centres, the same as the previous fortnight.
- 54% of toilet stalls and 40% of shower stalls had lockable doors, a slight (3%) decrease in both from the previous fortnight.

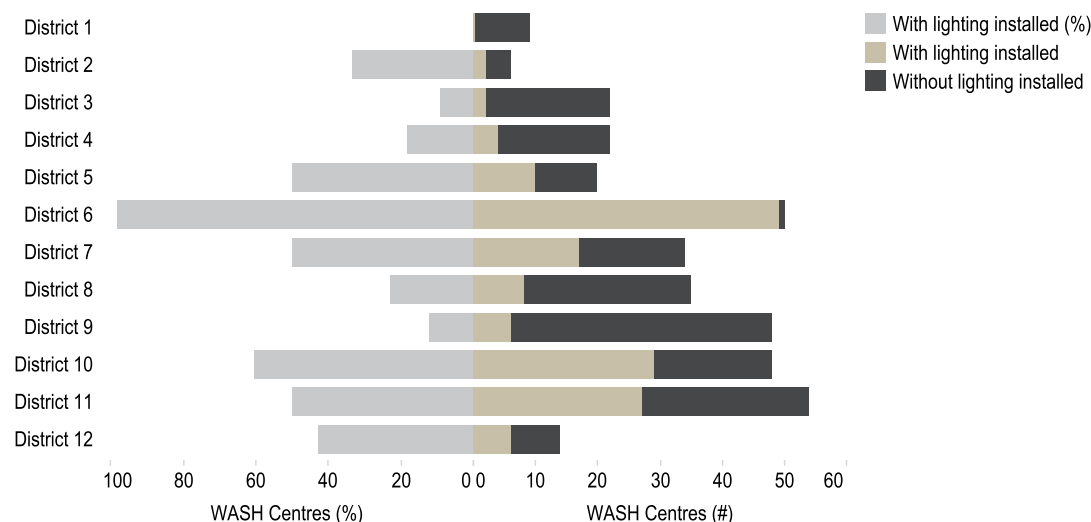
Figure 8: WASH centres with internal or external lighting installed

- **44% of WASH centres had internal or external lighting installed,**⁹ the same as the previous fortnight.
- The proportion of centres with lighting installed ranged from 0% in District 1 to 98% in District 6 (see Figure 8 below and annexed Map 6).
- Of the 202 WASH centres that had no internal or external lighting, 33% were female centres, the same as the previous fortnight.
- Key changes this fortnight included a decrease in the proportion of centres with lighting installed in District 1 and an increase in District 2.

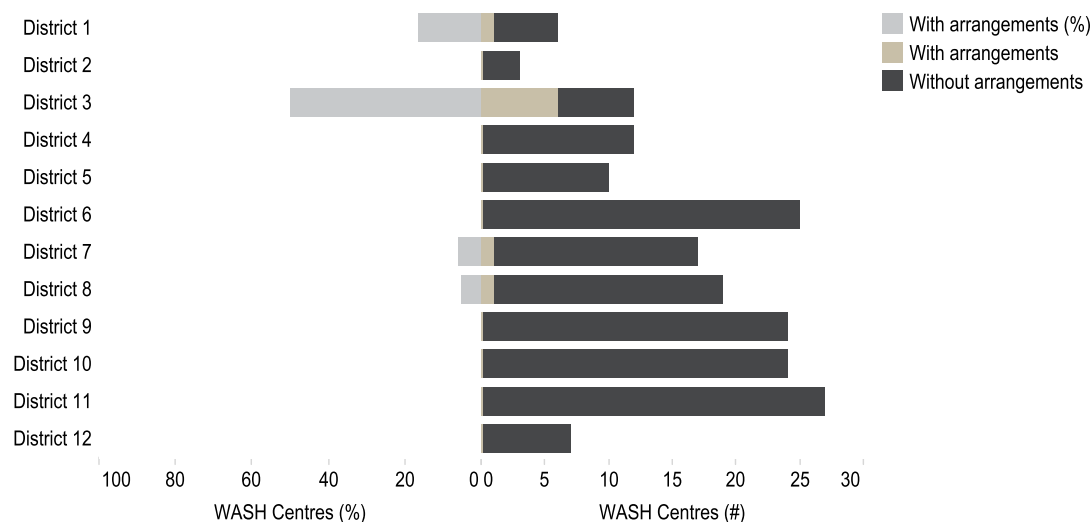
Figure 9: WASH centres with arrangements for disposing of diapers and menstrual hygiene materials

- **177 female WASH centres (95%) failed to meet the minimum standard of having an arrangement for disposing of diapers and menstrual hygiene materials**, a similar proportion to the previous fortnight.¹⁰
- Disposal arrangements were only available in districts 1, 3, 7 and 8 (see Figure 9 below).
- Districts 1, 3 and 8 saw an increase in the proportion of female centres with disposal arrangements, while districts 9 and 10 saw a decrease from the previous fortnight.

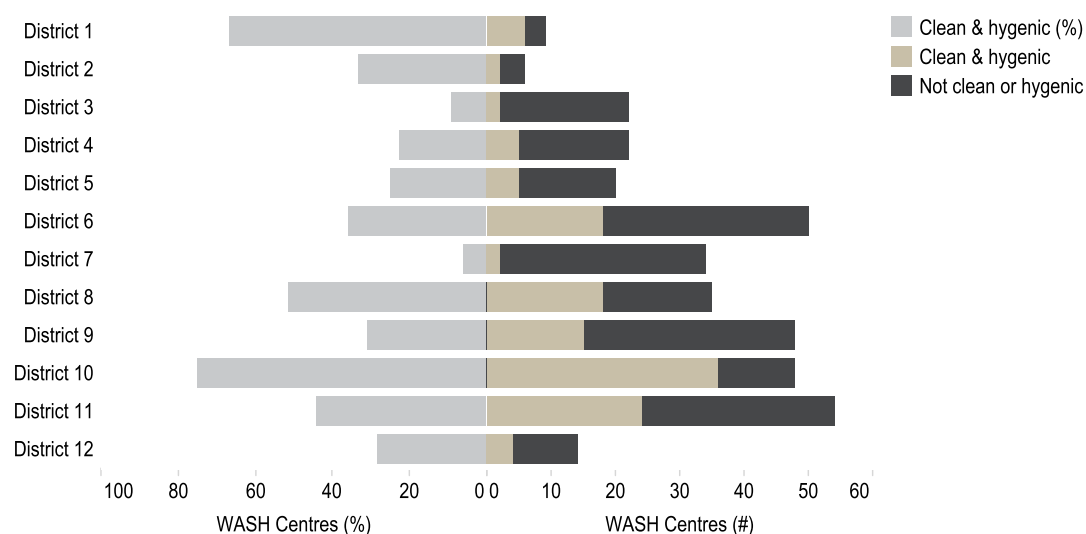
Figure 10: Clean and hygienic WASH centres

- **38% of WASH centres were considered clean and hygienic**,¹¹ a similar proportion to the previous fortnight.
- District 10 had the highest proportion of clean and hygienic centres, while District 7 had the lowest (see Figure 10 below).
- Districts 1 and 10 saw an increase in the proportion of clean and hygienic centres compared to the previous fortnight, while districts 2, 5, 7, 9 and 12 saw a decrease.

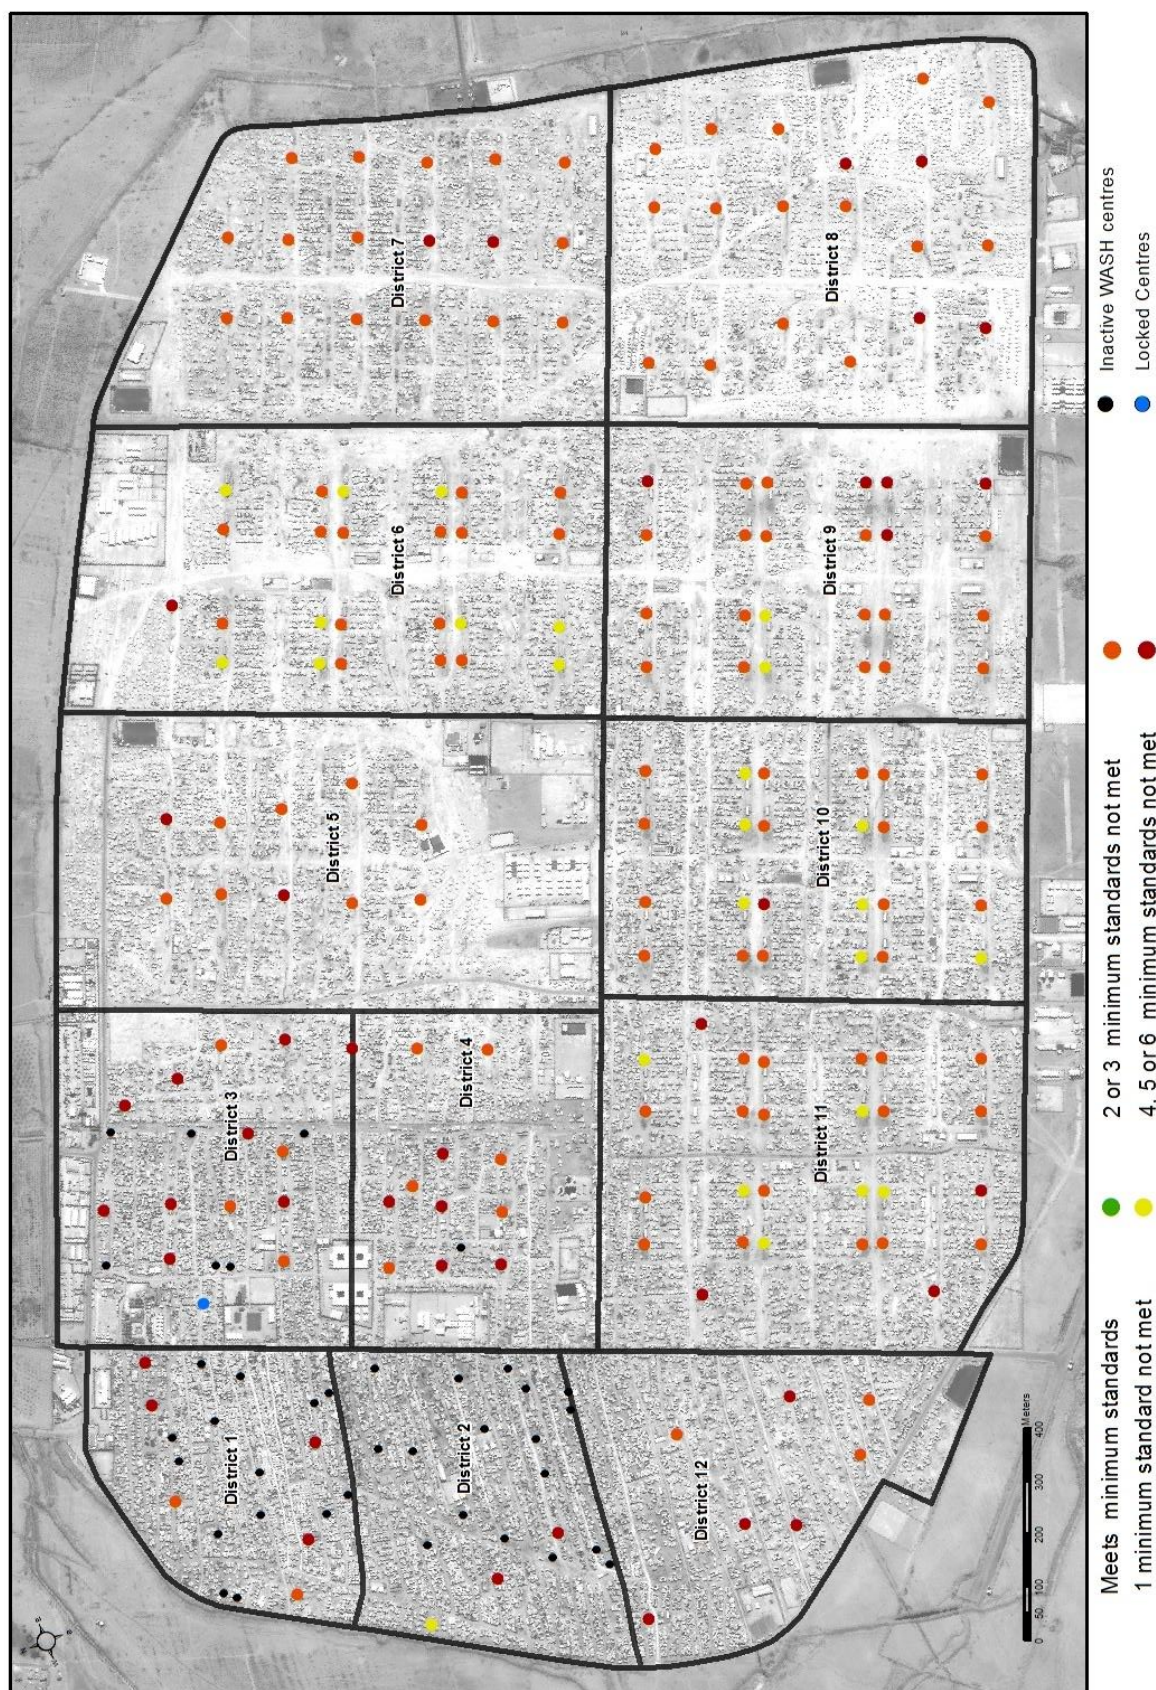
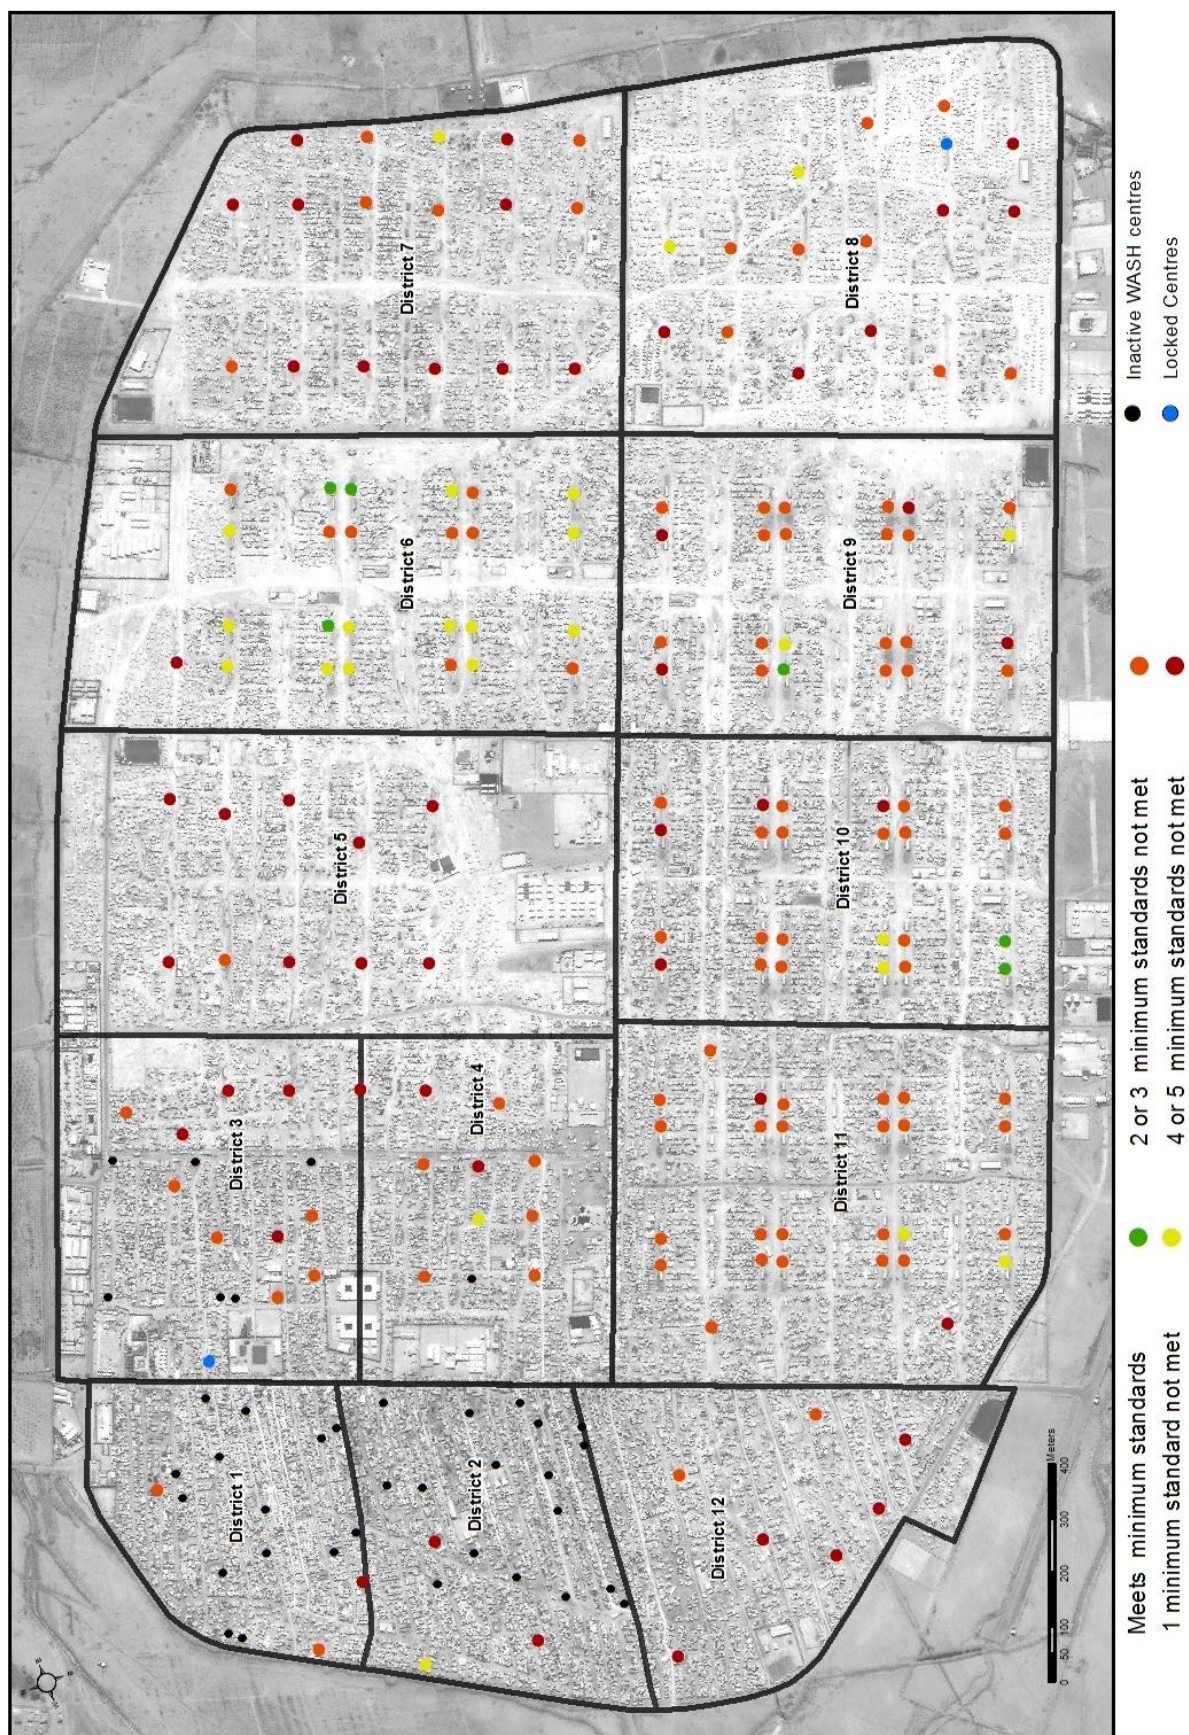
- 86% of female and 82% of male centres failed to meet 2 or more minimum standards (see annexed Maps 2 and 3). This represented a slight improvement in female centres and a slight deterioration in male centres since the previous fortnight.

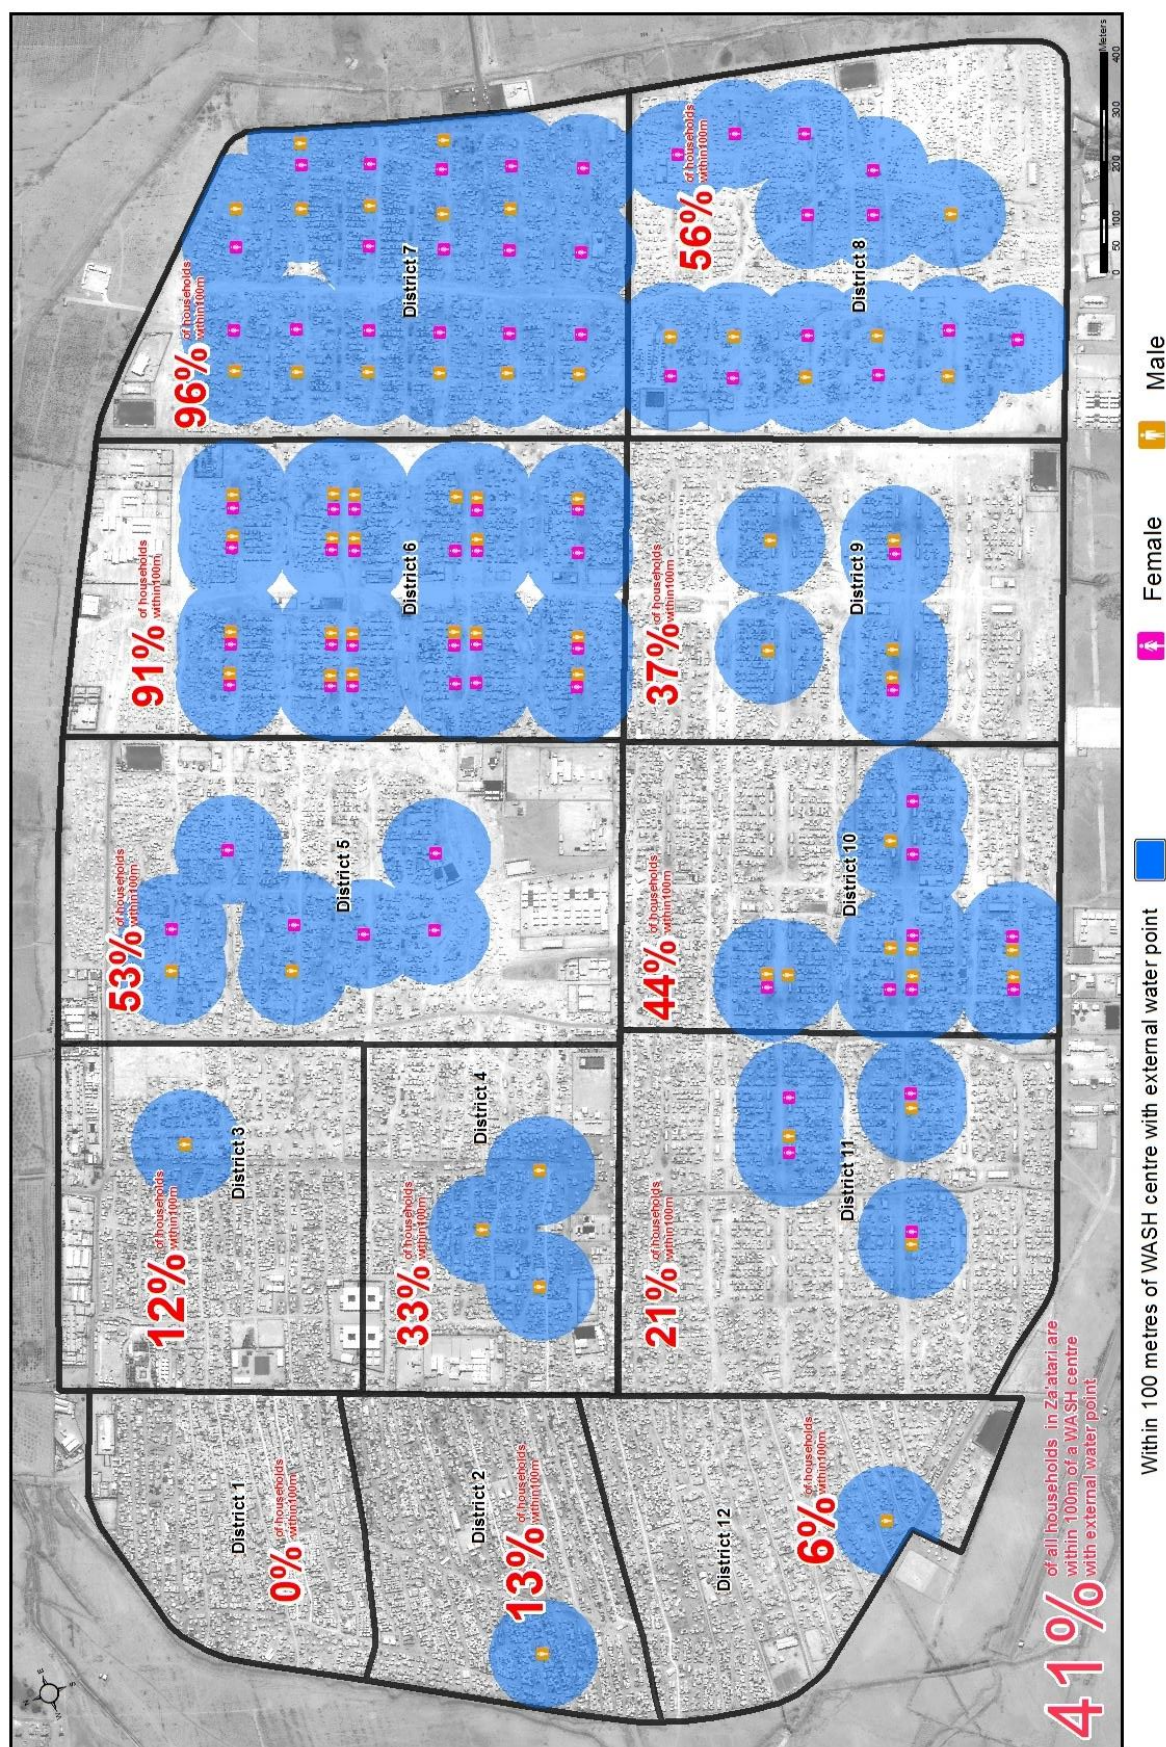
Map 5: Shelters within 100m of a WASH centre with external water point

- **Only 41% of households are within 100m of a WASH centre with an external water point**, the same proportion as the previous fortnight. This indicates that the minimum standard of having 100% of households within 100m of the nearest functional external water point is not being met.⁵ The proportion of households within 100m ranges from 0% in District 1 to 96% in District 7 (see annexed Map 5).
